Geotechnical Feasibility Report Craig Harbor Navigation Improvements

Craig, Alaska, Alaska District, Pacific Ocean Division

November 2014

SUBJECT: Geotechnical Feasibility Report for Craig Harbor Navigation Improvements, Craig, Alaska

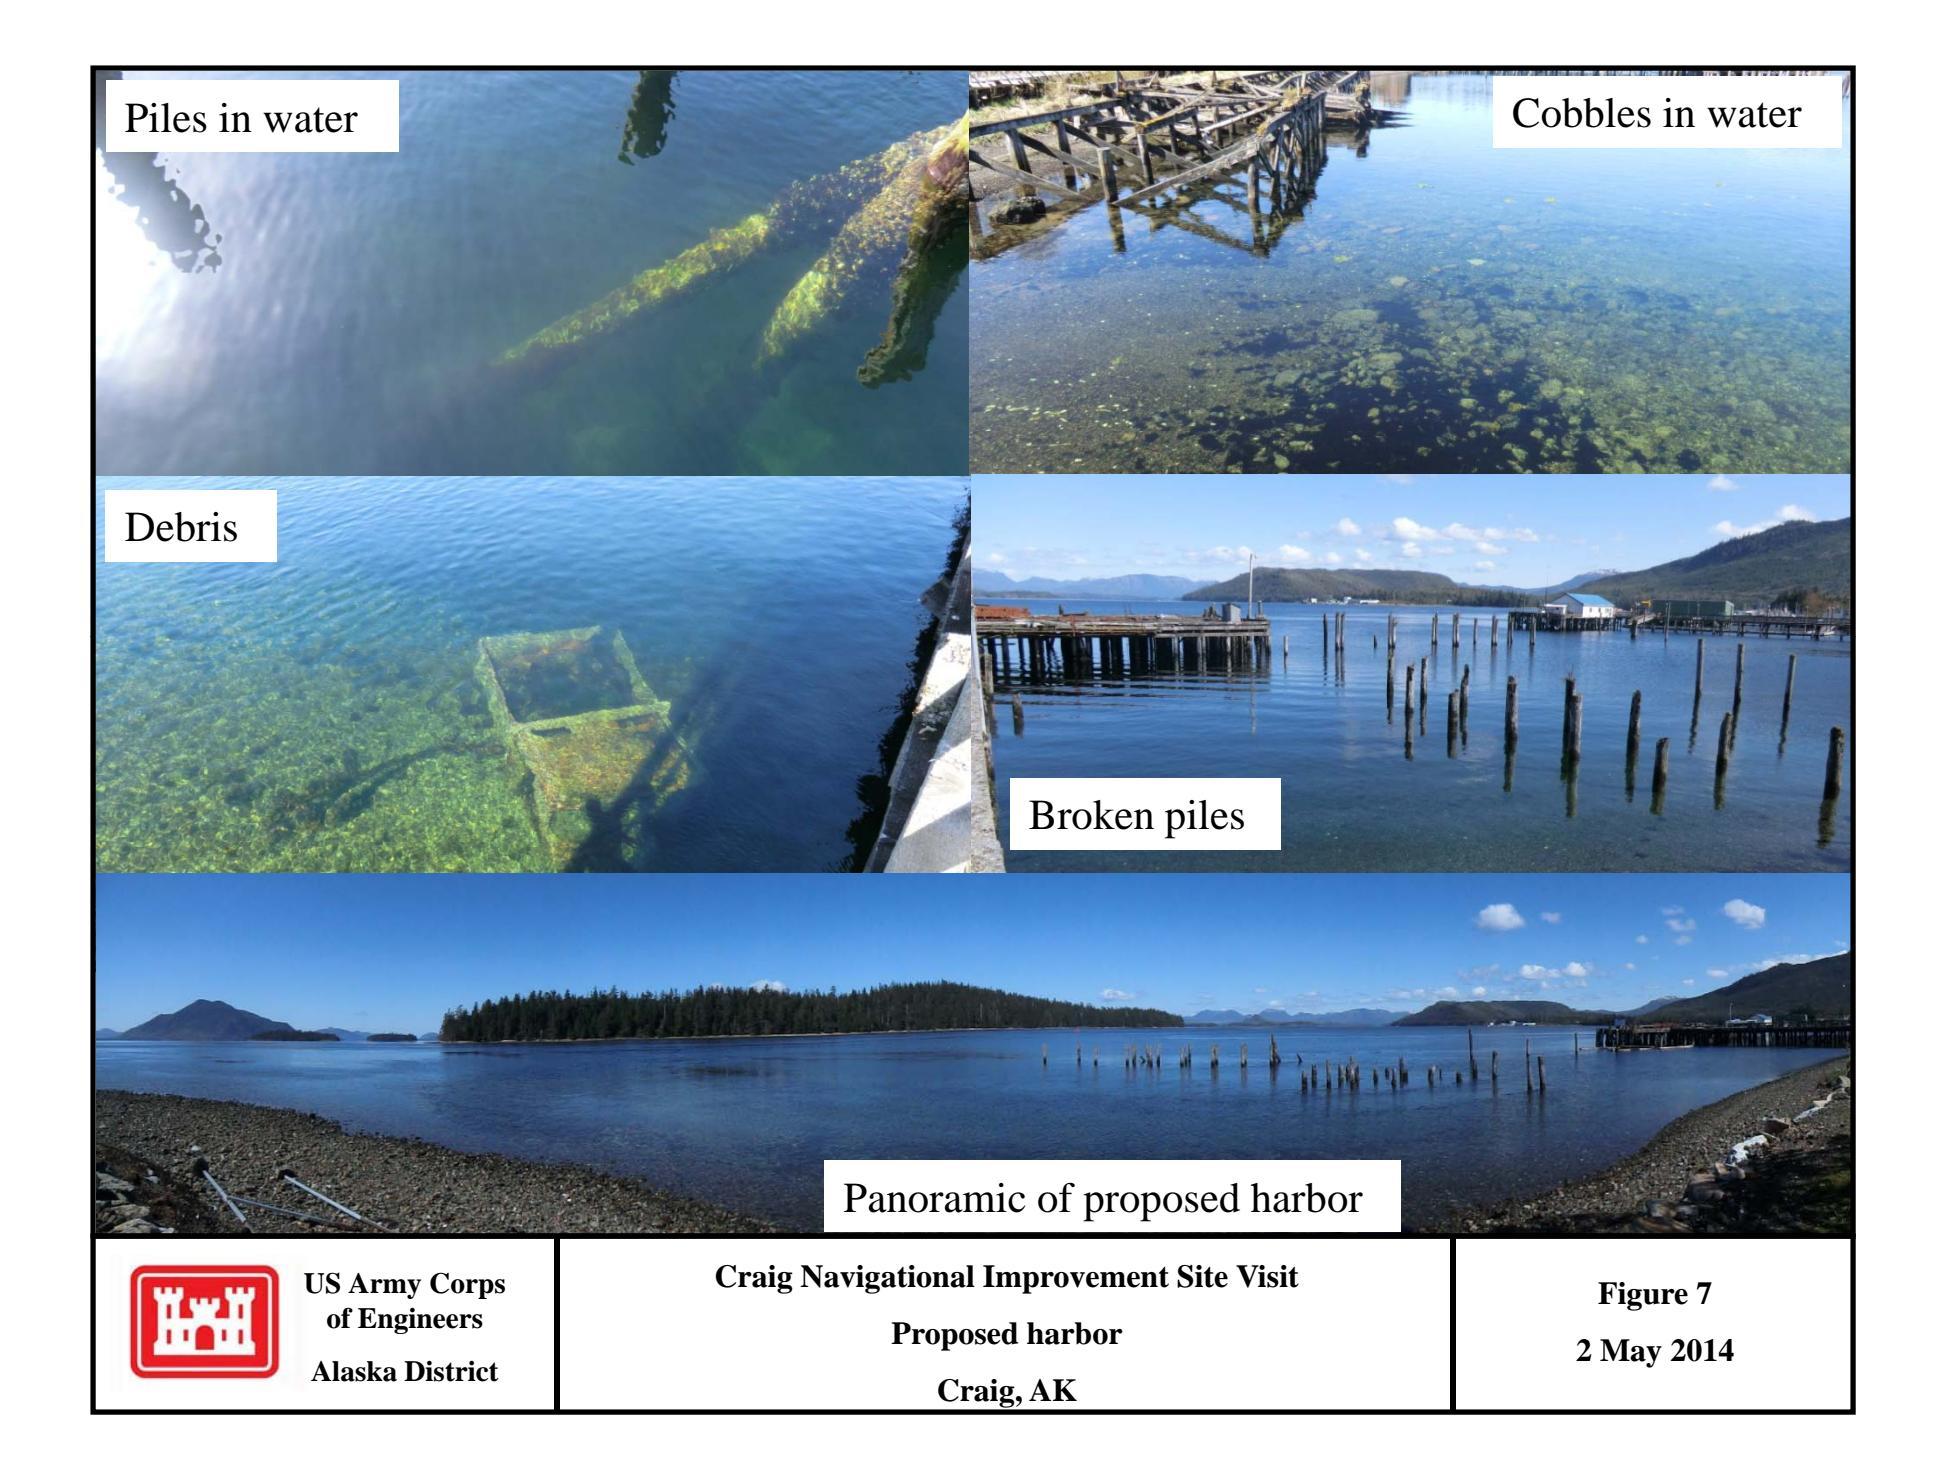
- c. <u>Harbor location –</u> The team walked the proposed harbor (Figure 7) location from wharfs, land, and also made a stop along the outside of the wharfs when returning from St. Johns quarry by boat. Below the water surface and on the beach cobbles and various boulders were noted that may cause issues while dredging although dredging may not be necessary for this project. During construction, and the demolition phase, it will be necessary to remove all of the old piling from the existing and past wharfs. Some of the wharfs are still intact and others are long gone but the creosote piling remains. There is also evidence of metal debris and trash along the bottom that will have to be removed during demolition but the extent and content is unknown at this time. It is recommended that the use of an underwater camera be used to get an understanding of the extent of the debris along the bottom. There are also several open places within 500 feet and directly upland of the proposed harbor that could be used to stock pile material during construction.
