U.S. Army Corps
of Engineers
Alaska District

ALASKA BASELINE EROSION ASSESSMENT

Erosion Information Paper - Big Delta, Alaska

Current as of November 15, 2007

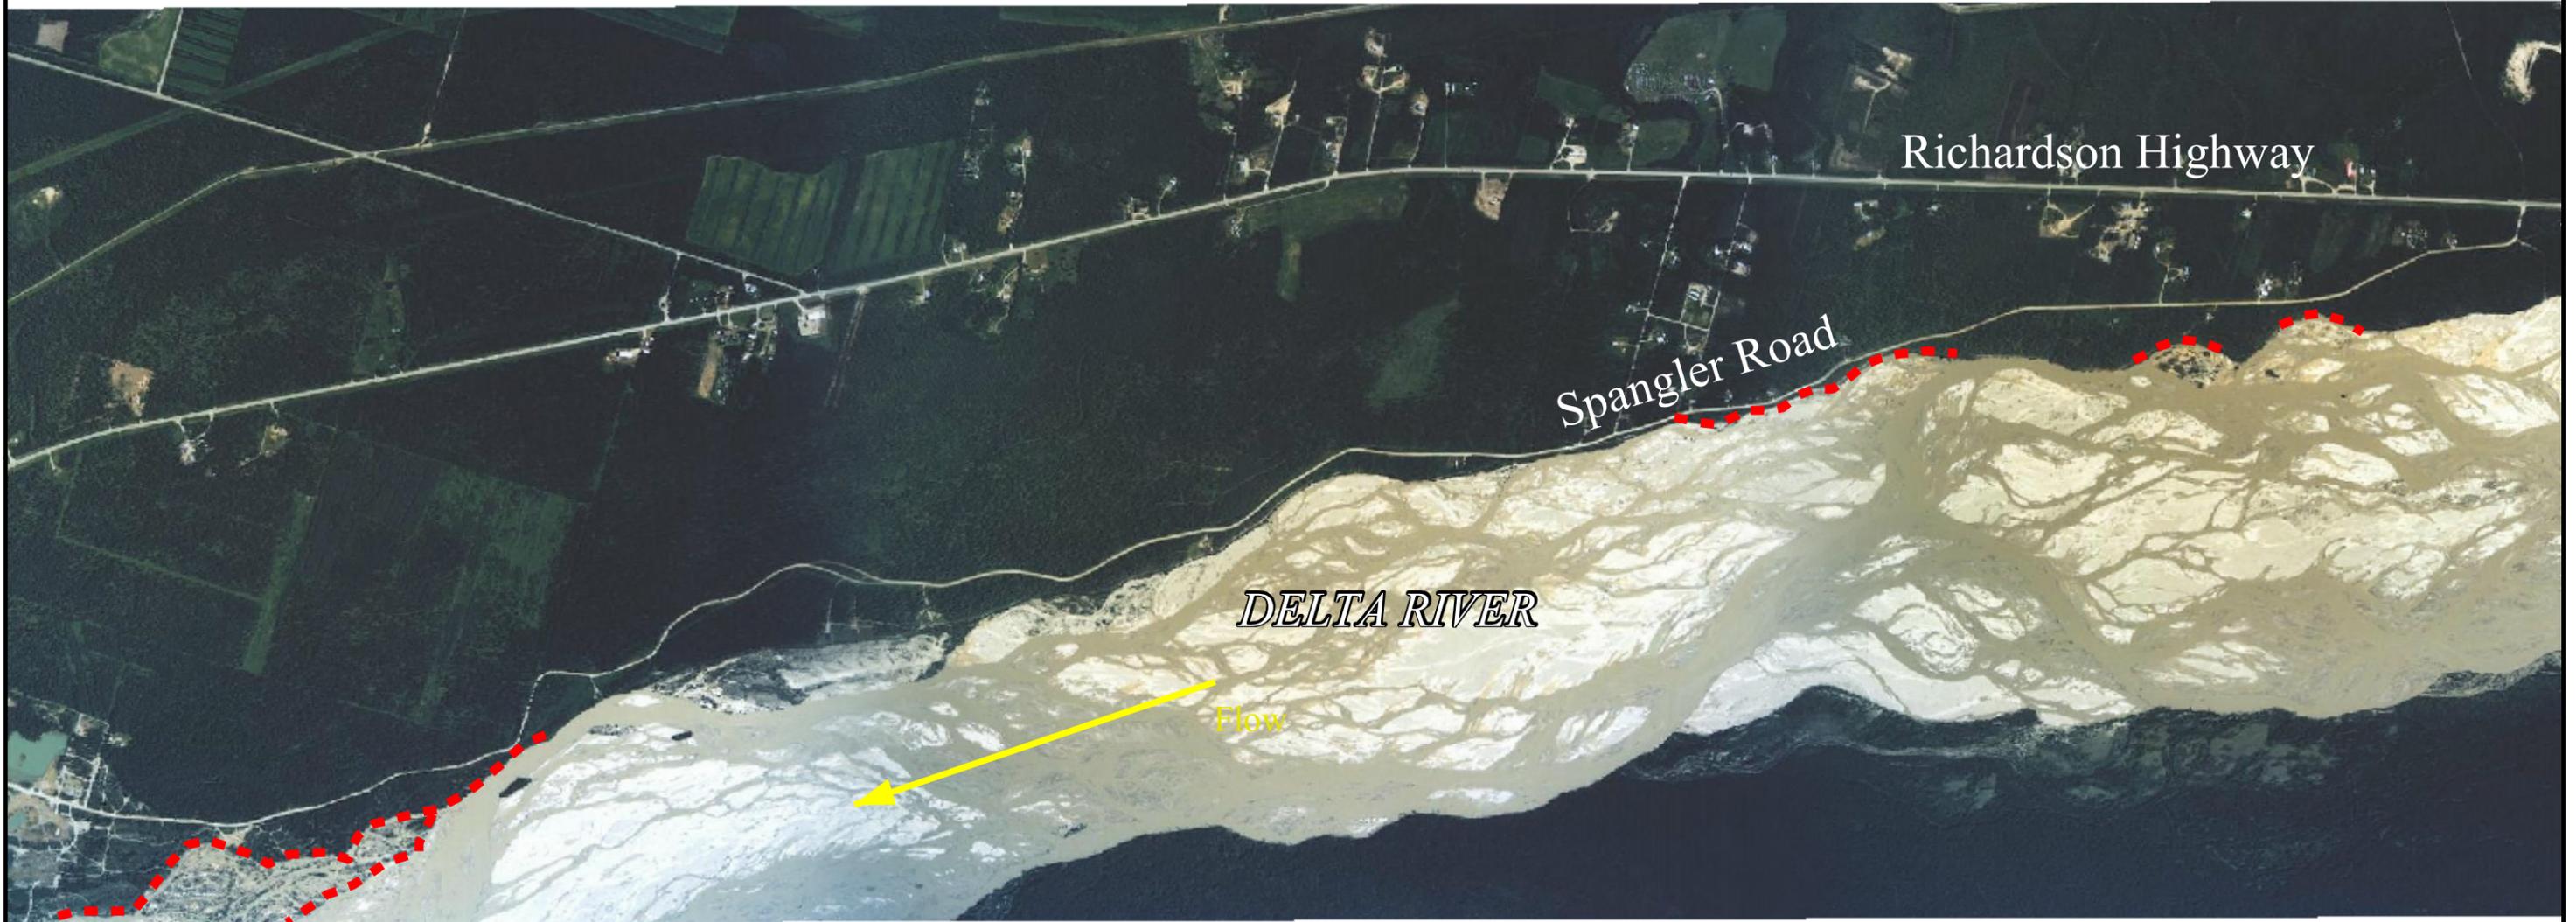
Alaska Baseline Erosion
Big Delta, Alaska

NOTE: The extent of erosion shown on this figure is based on interviews with the community. This data has not been field verified. This figure is only intended to show areas of erosion, not rates or severity of erosion
