U.S. Army Corps
of Engineers
Alaska District

ALASKA BASELINE EROSION ASSESSMENT

Erosion Information Paper - Circle, Alaska

Current as of February 20, 2008

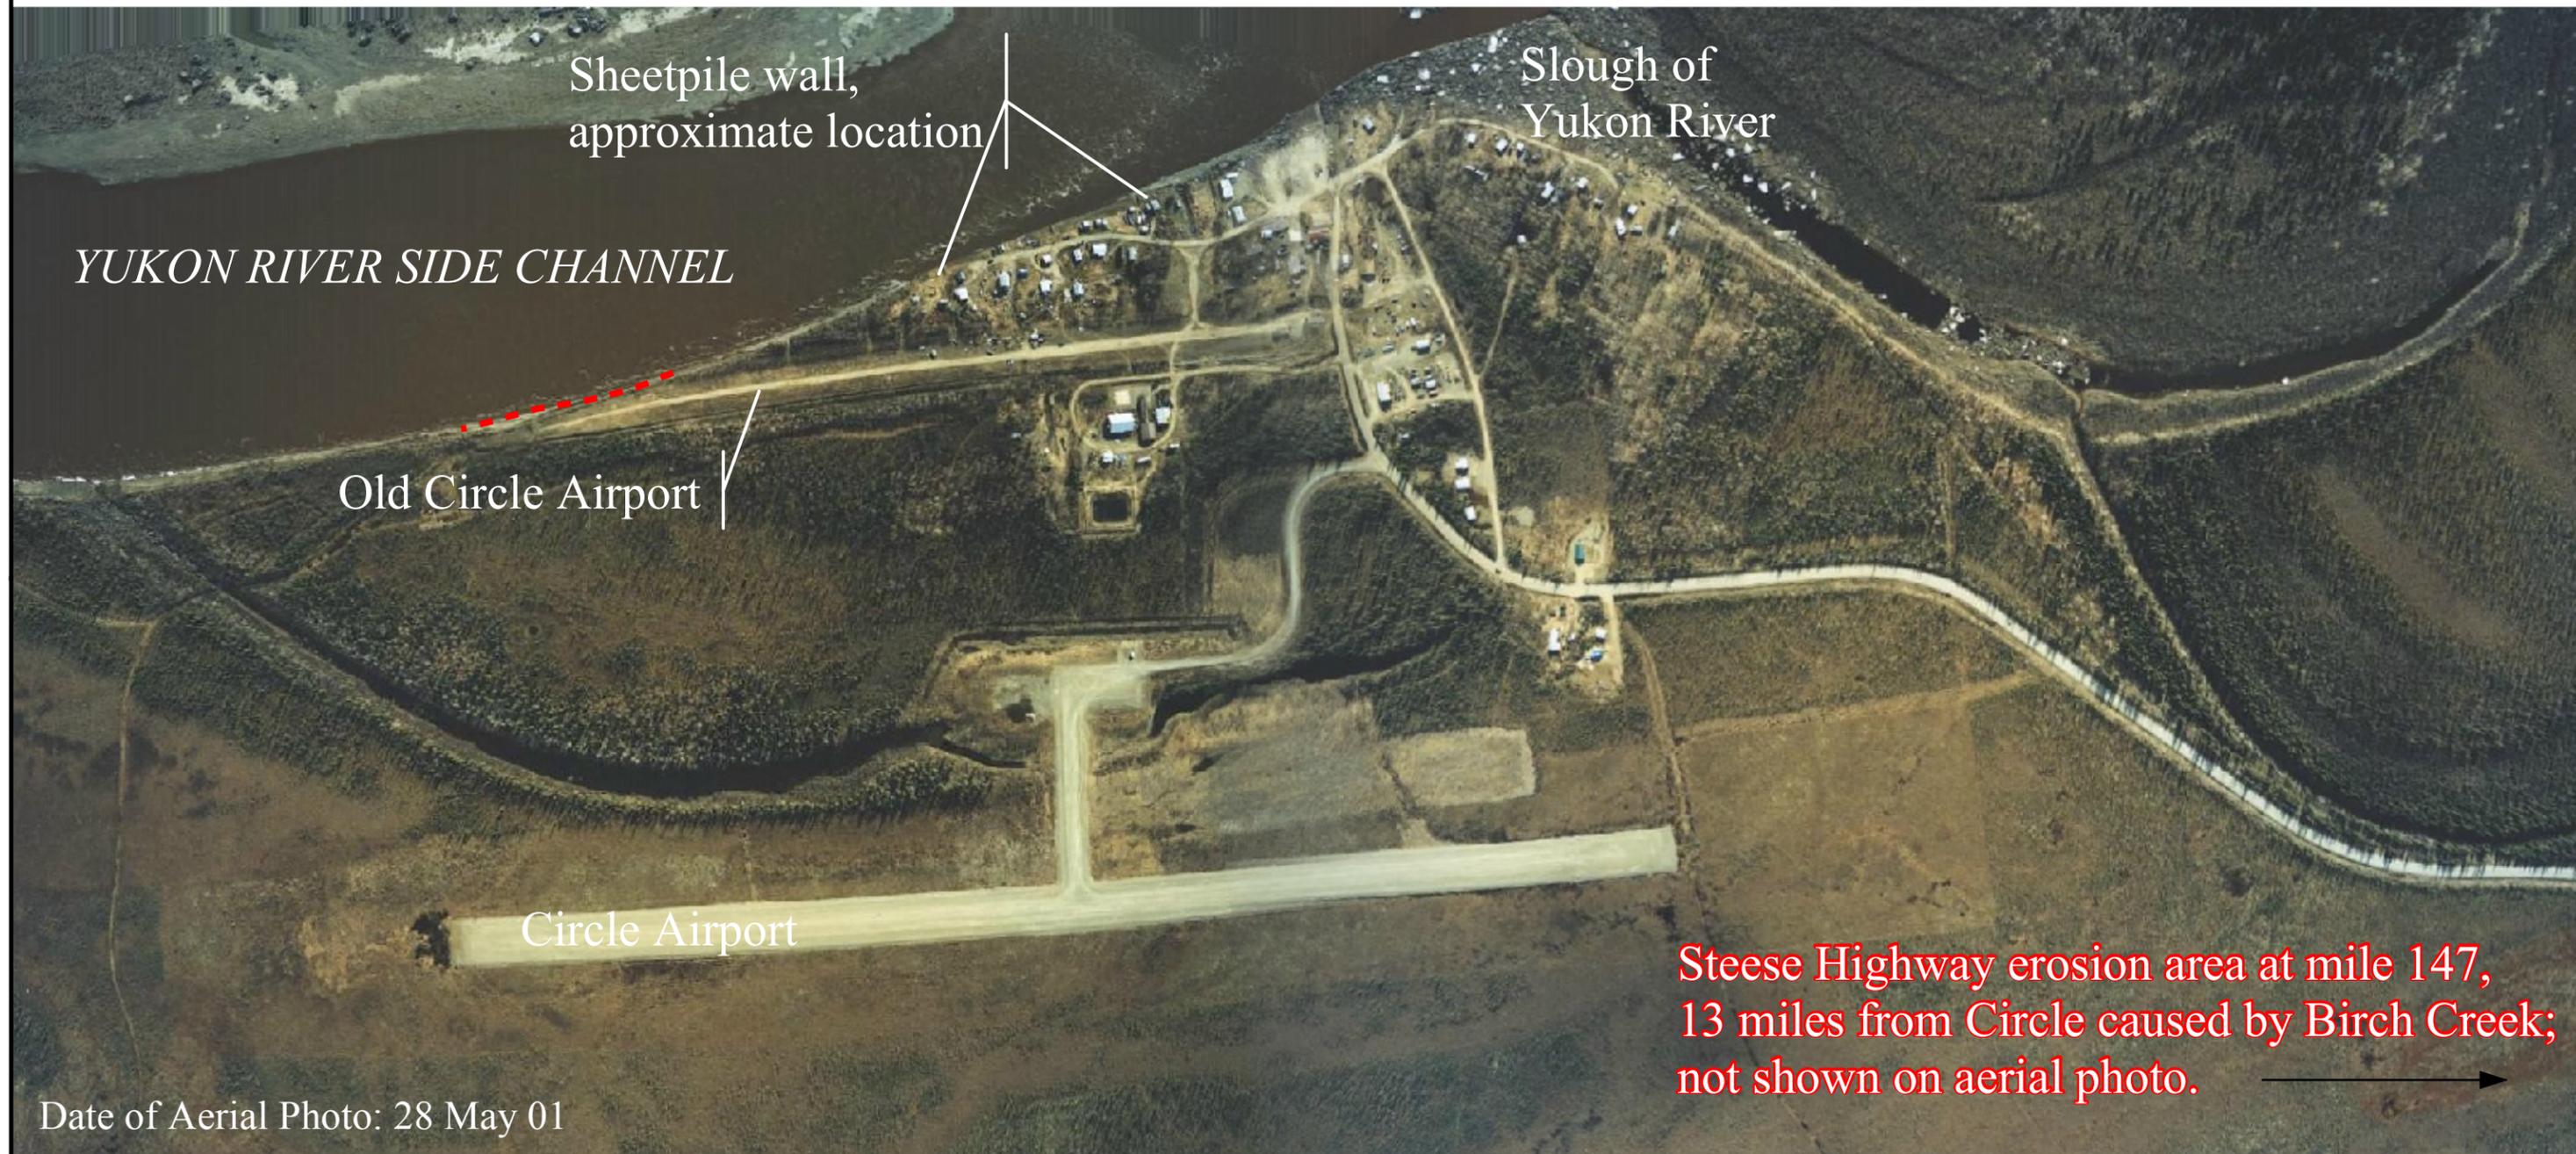
NOTE: The extent of erosion shown on this figure is based on interviews with the community. This data has not been field verified. This figure is only intended to show areas of erosion, not rates or severity of erosion
