GEOTECHNICAL INVESTIGATION AND SITE CONDITIONS REPORT

KENAI RIVER BLUFF EROSION

KENAI, ALASKA

February, 2007

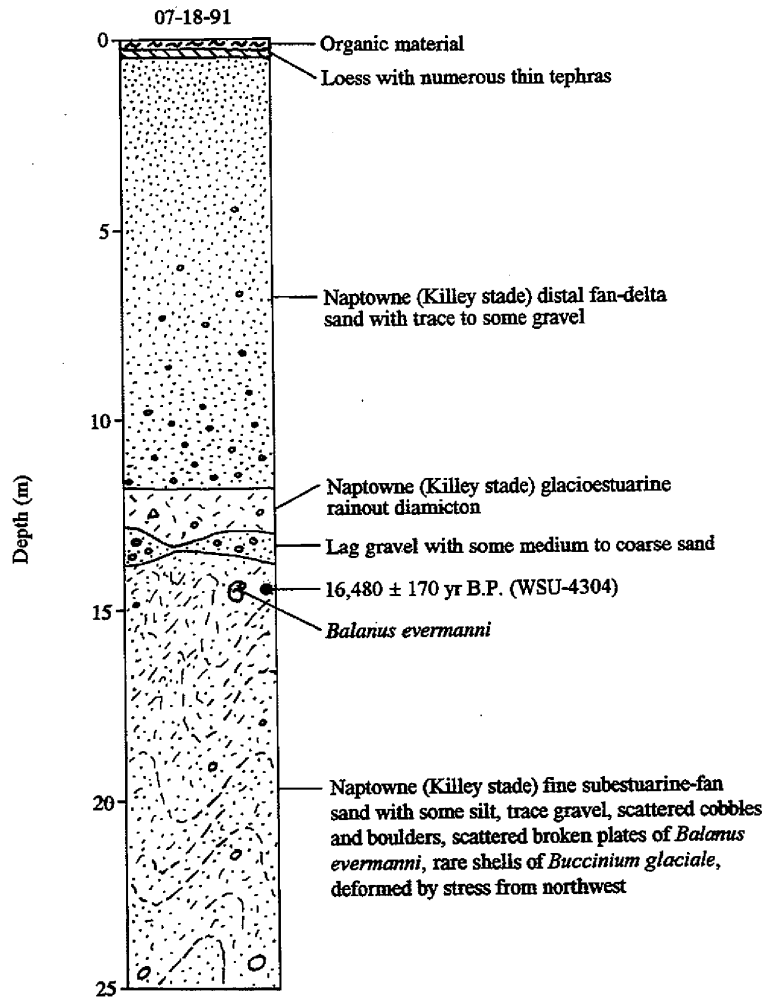
FIGURE 3

Soils exposed along the bluff at Kenai consisted of marine, glacial, and alluvial deposits that have been altered by glacial action and erosion (Figure 3). The surficial soils and features in the area around Kenai have been created by several major Pleistocene glacial events. These included the deposition of marine sandy clays of the Bootlegger Cove Formation (Reger, 1997) in glacioestuarine waters approximately 16,500 years ago. A Killey-age tidewater glacier then passed over the site from the northwest. It apparently floated over the site as the effects of the glacial override did not penetrate deeply into the marine clay. Submarine-fan deposits were spread over the clay. Folding and displacement of the marine sediments occurred when the glacier grounded.

a. Stratigraphy exposed near project site (60°33'07"N, 151°14'17"W), Kenai C-4 SE Quadrangle.

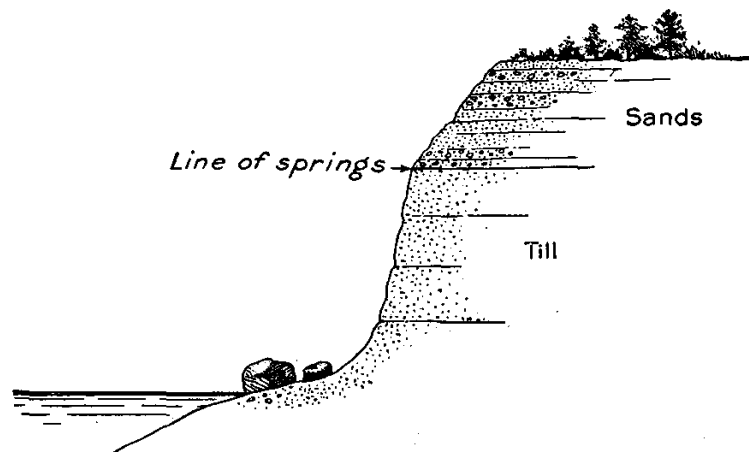
b. Diagrammatic sketch showing relations of stratified sands and till at Kenai.

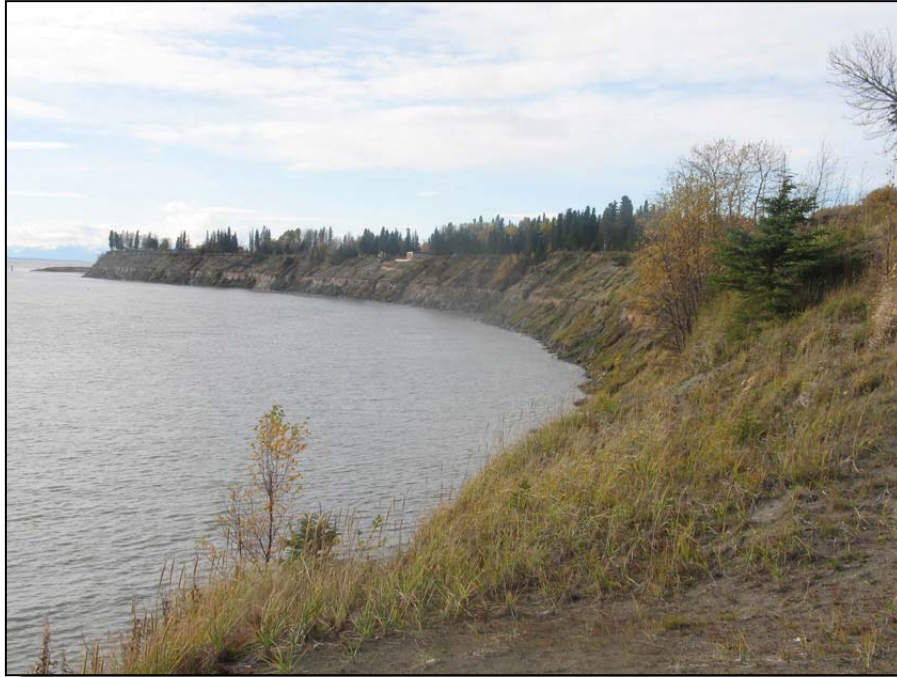
a. Tide flats at high tide along the eastern part of the project.
High tides made it difficult to access drills along the beach. October, 2006.

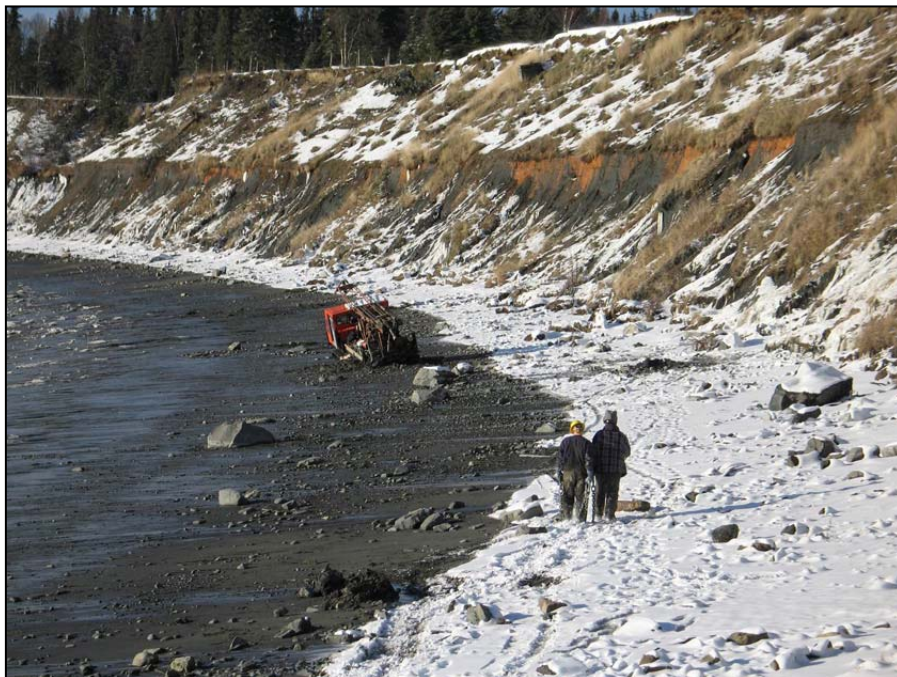
b. Drill stuck in mud near Senior Center.
The soft mud made it difficult to use tracked equipment on tide flats. November, 2006.

The tide flats located at the base of the bluff lie on a marine platform cut into the glacial till. The platform slopes gently toward the river for a horizontal distance of about 100 to 200 feet. The platform was covered with what appeared to be a thin veneer of boulders, cobbles, gravel and sand apparently washed down from the bluff above. Under this veneer of soil, the clays had become soft in many places making travel on the tide flats treacherous for vehicles or personnel (Figure 6b).

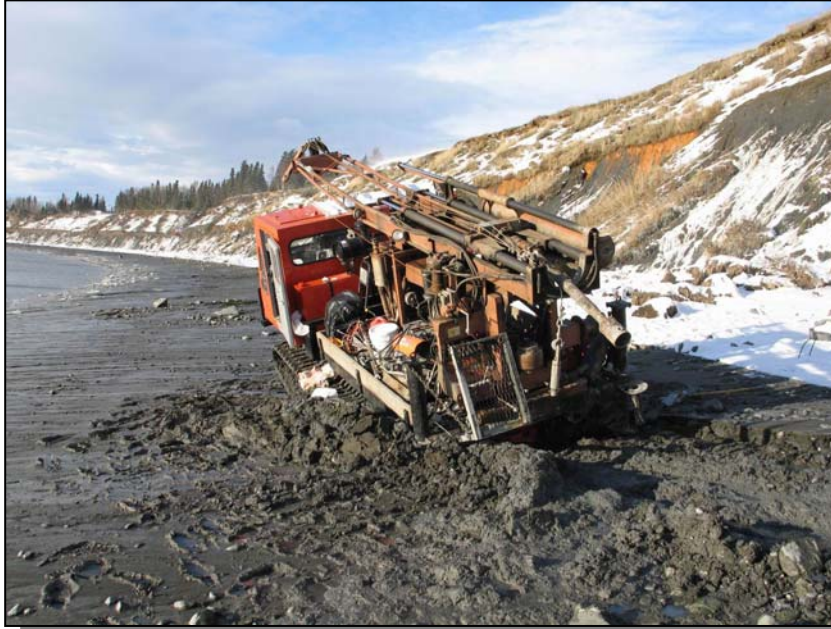
13. Contractors should also be prepared to deal with the soft, quick conditions of the soils along the tide flats (see Figure 20).
14. Within three months of the 1964 Great Alaska Earthquake, the bluff had receded as much as 20 feet within the project area. This was attributed to regional subsidence, rapid removal of sloughed debris along the toe, and undercutting by waves and the river.

a. Nodwell stuck in mud near Test Boring AP-627 at low tide. November 10, 2006.

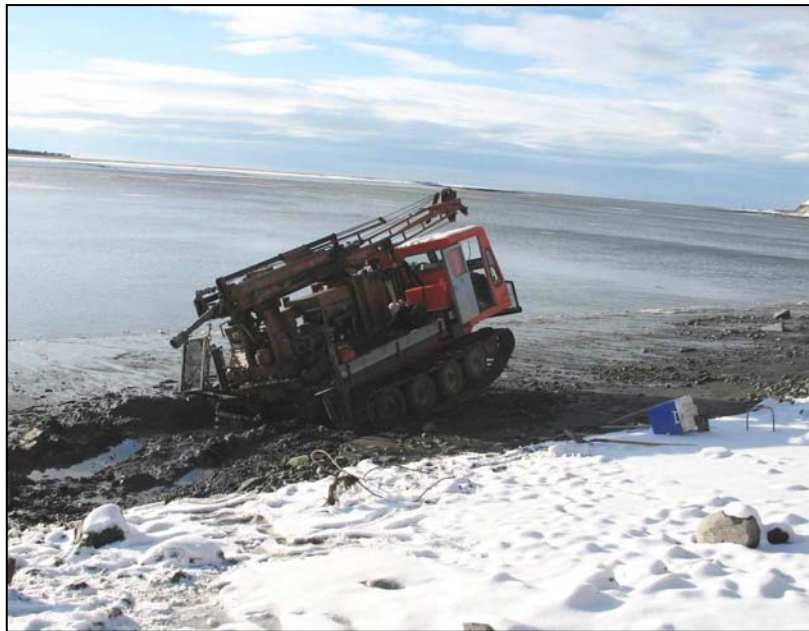
b. The Nodwell has sunk into unfrozen mud below the high tide line (edge of snow covered area). The surface of the mud was frozen under the snow covered area. November 10, 2006.
