# FACT SHEET

## Moose Creek Dam

### *Interim Risk Reduction Measures*

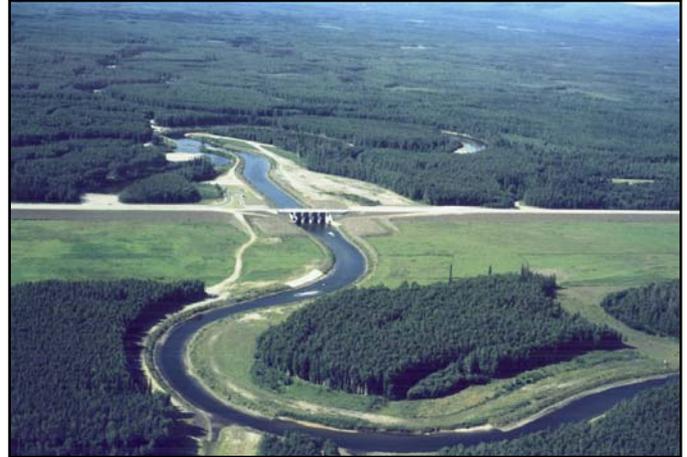
Located 17 miles east of Fairbanks, Moose Creek Dam manages seasonal flood flows to protect local citizens and their property.
