**KLUTINA RIVER AT
COPPER CENTER**

FLOOD CONTROL
 KLUTINA RIVER
 ALASKA
 REVISED 1993

KLUTINA RIVER at COPPER CENTER, ALASKA

Condition of Improvement 30 September 2009

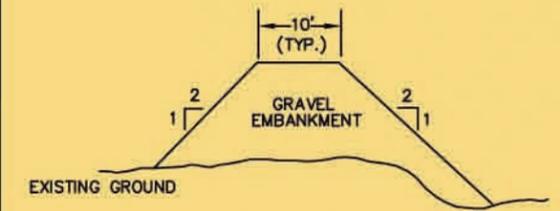
TYPICAL SECTION
NOT TO SCALE

EXISTING PROJECT:	<u>LENGTH</u>	<u>HEIGHT</u>	<u>WIDTH</u>
• Levee	4100 ft	10 ft	10 ft
		avg	at top

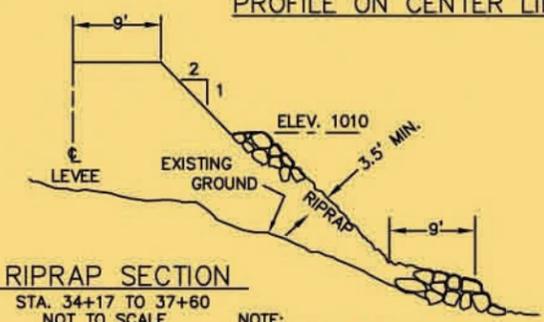
RIPRAP SECTION
STA. 34+17 TO 37+60
NOT TO SCALE

NOTE: REMAINDER OF RIPRAP AREA IDENTICAL EXCEPT FOR TOP ELEVATION.

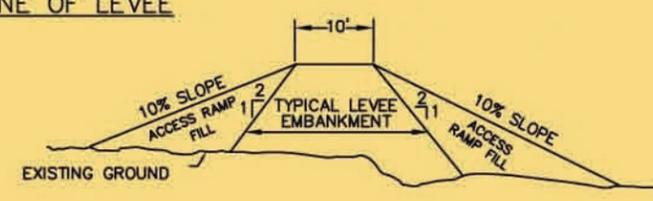
TYPICAL ACCESS RAMP
NOT TO SCALE

NOTES: THIS LOCALITY SHOWN ON U.S.G.S MAP VALDEZ D-4.
 ELEVATION BASED ON MEAN SEA LEVEL (0.0 FT.).
 ADDITIONAL ACCESS RAMPS WITH BARRICADES HAVE BEEN INSTALLED BY THE STATE OF ALASKA.
