GOLD CREEK

FLOOD CONTROL
GOLD CREEK
ALASKA

GOLD CREEK, ALASKA
(CWIS NO. 06630)

Condition of Improvement 30 September 2007

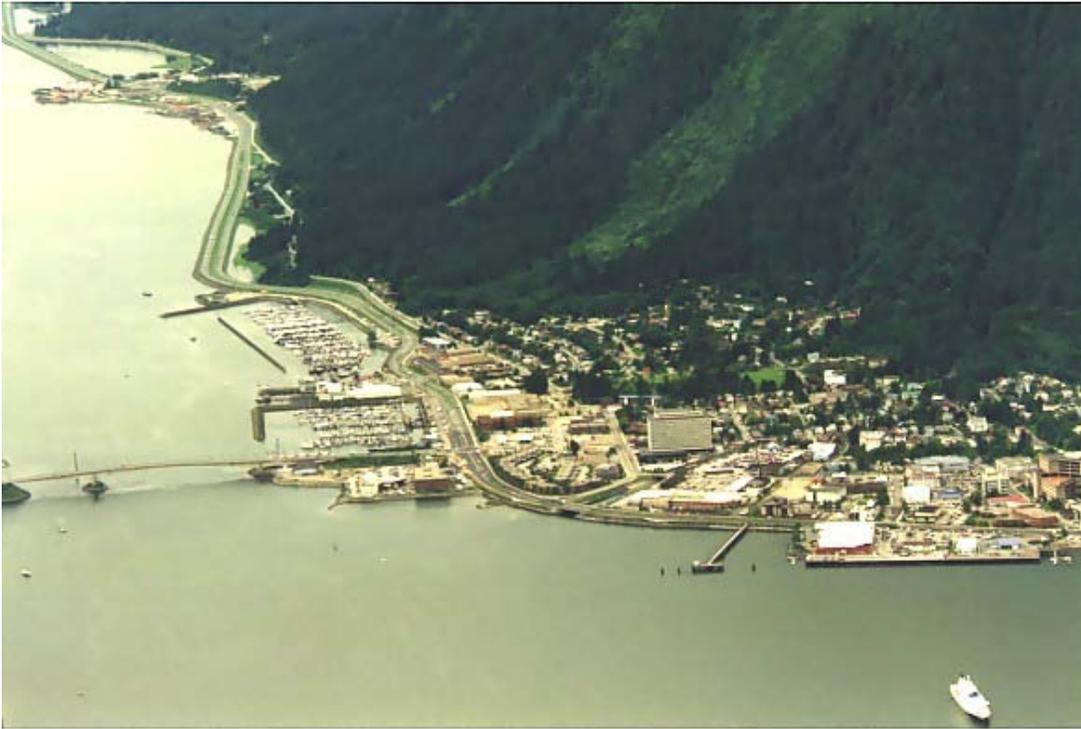
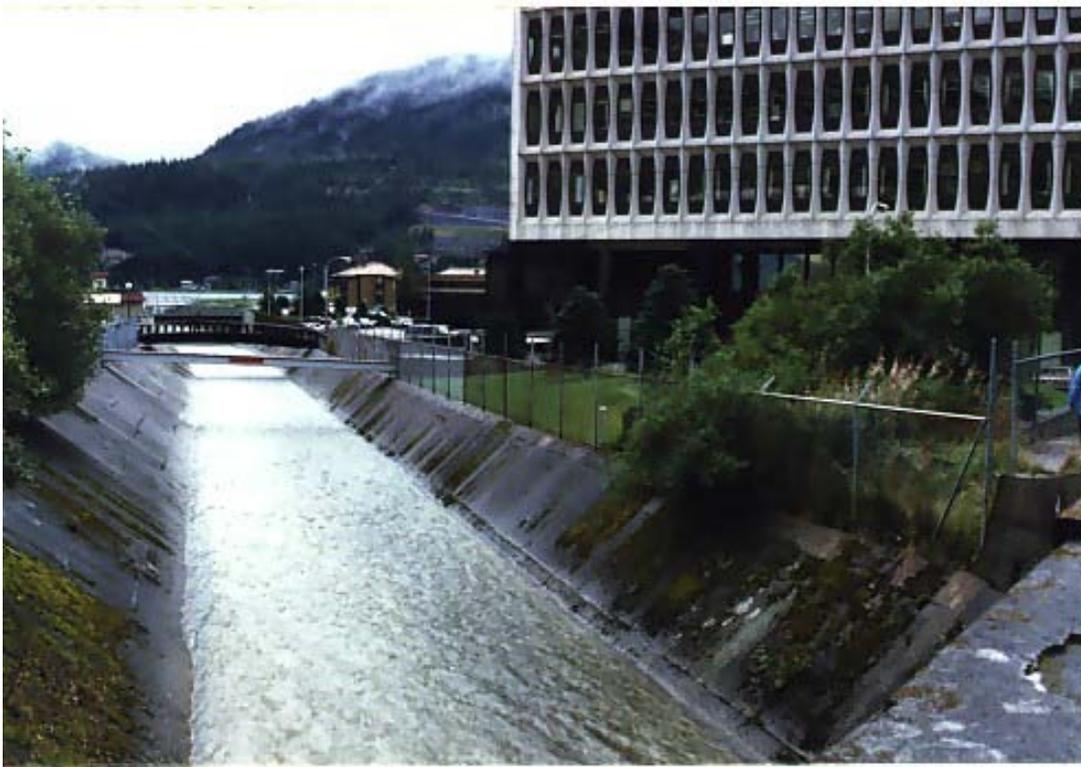
Gold Creek, Juneau, Alaska

Gold Creek Bank Stabilization through downtown Juneau, Alaska 2007.
