**SITKA ALASKA  
CRESCENT BAY BASIN  
AND  
WESTERN CHANNEL**

**SITKA HARBOR, ALASKA**  
 (Western Channel, Crescent Bay Basin, Channel Rock Breakwaters)  
 (CWIS NOS. 72845, 16840, 10322, 55030, 13787)

Condition of Improvement 30 September 2011

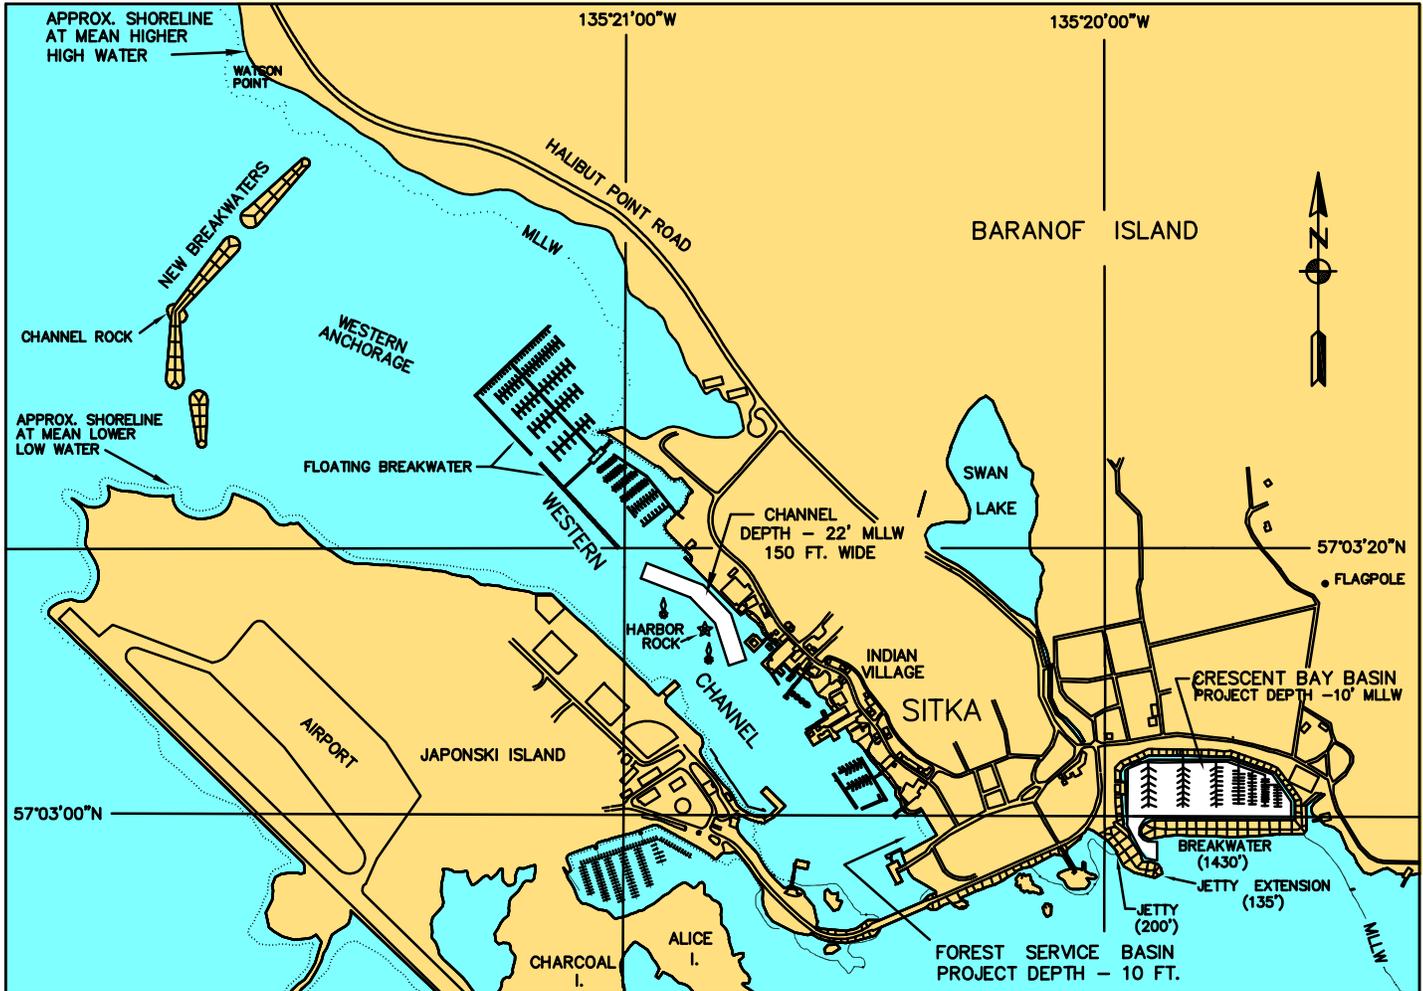
1. ELEVATIONS AND DEPTHS ARE IN FEET AND REFER TO MEAN LOWER LOW WATER (MLLW = 0.0').
2. THIS LOCALITY IS SHOWN ON USC & GS CHART NOS. 17320, 17324, 17326, 17327.

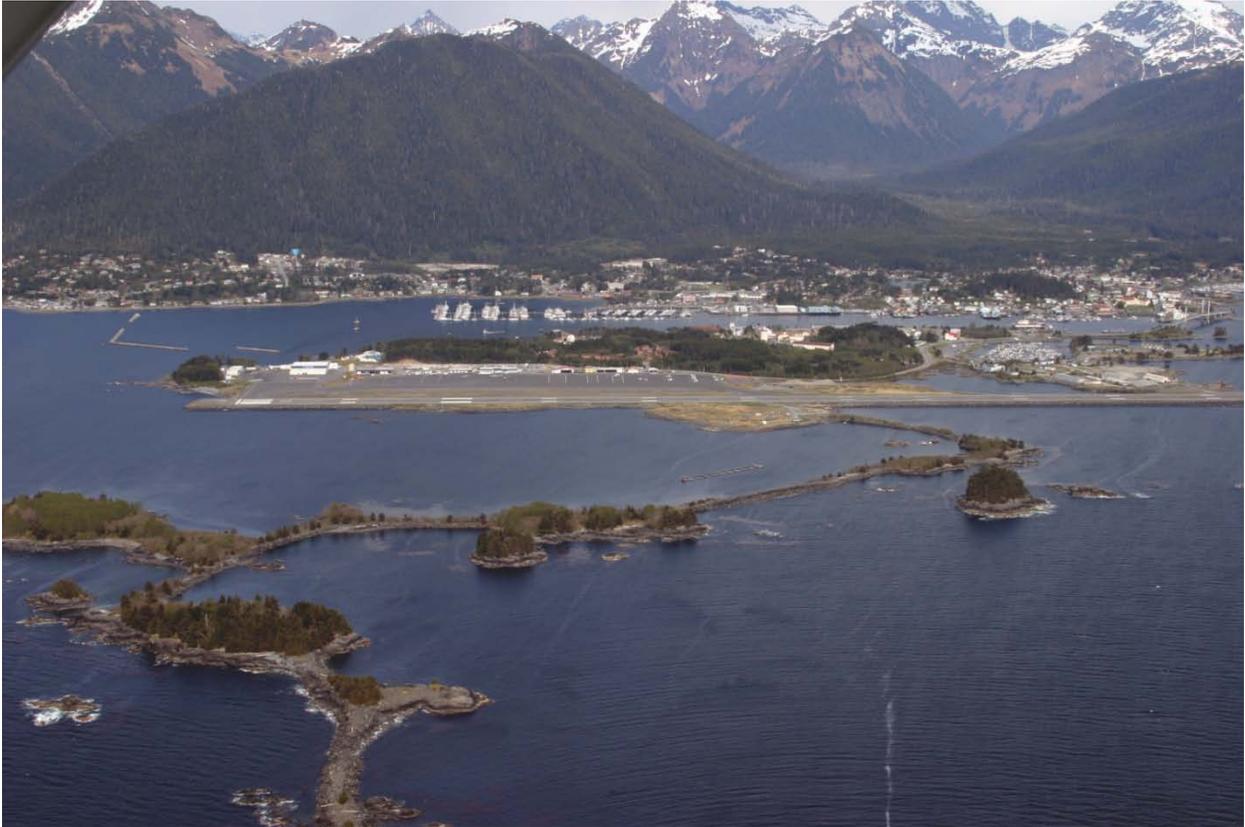
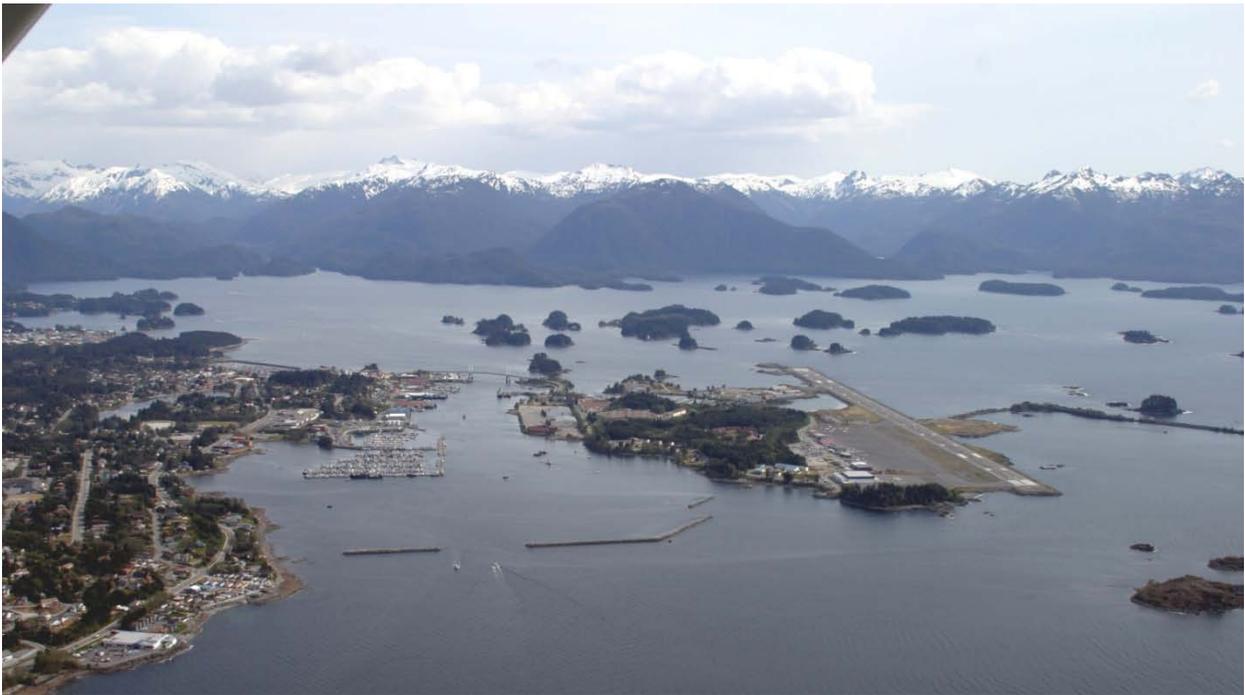
Sitka Channel Breakwater aerial oblique photographs taken in 2003.

- 2003 - Vertical and oblique aerial photography is taken in May.
- 2005 - The most recent condition survey of all three federal projects including the Forest Service Basin are conducted in May.
