Lowell Creek Flood Diversion Feasibility Study Appendix B – Geotechnical Appendix (Draft) Seward, Alaska

September 2020

SUBJECT: Geotechnical Appendix, Lowell Creek Flood Diversion, Seward Alaska

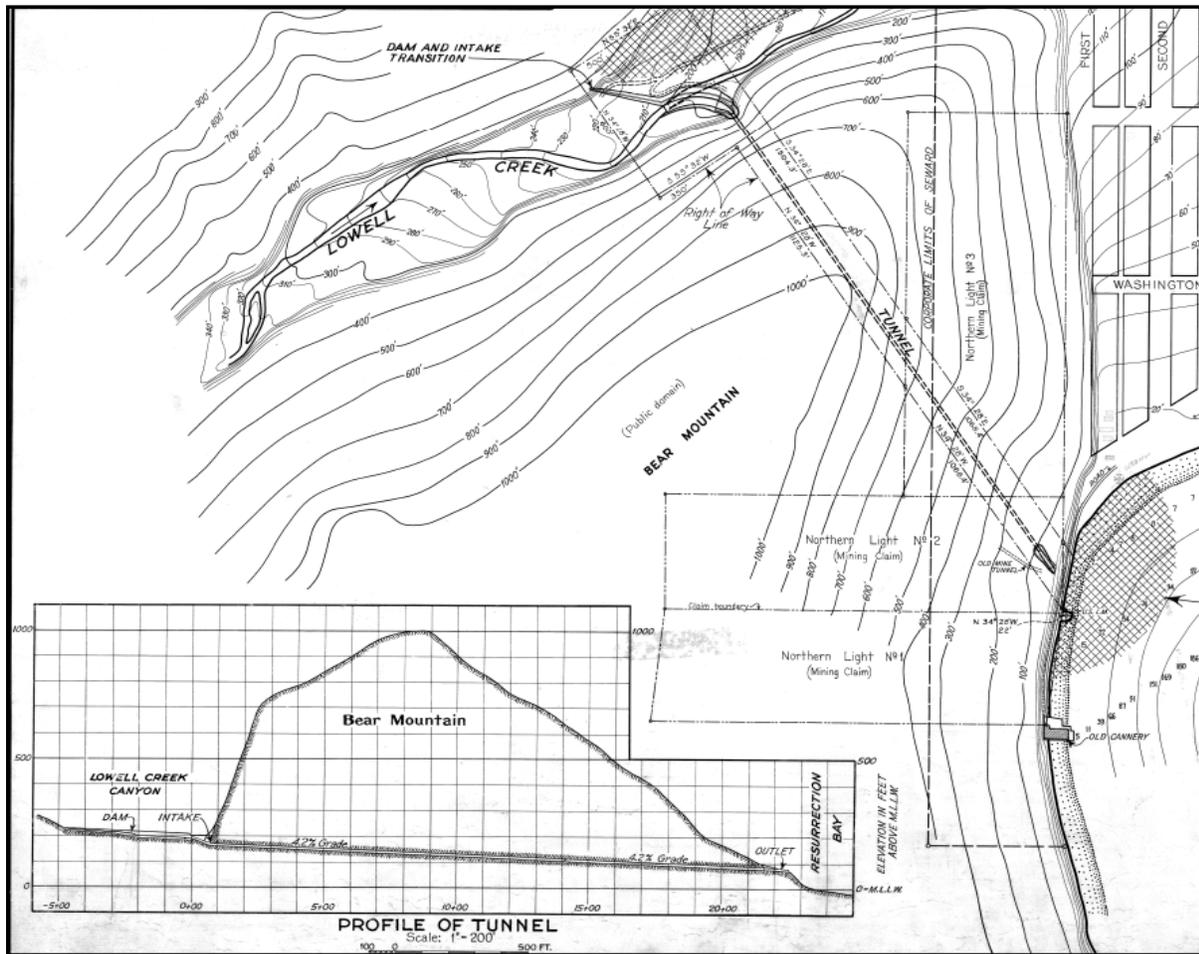
Figure B1. Project Overview

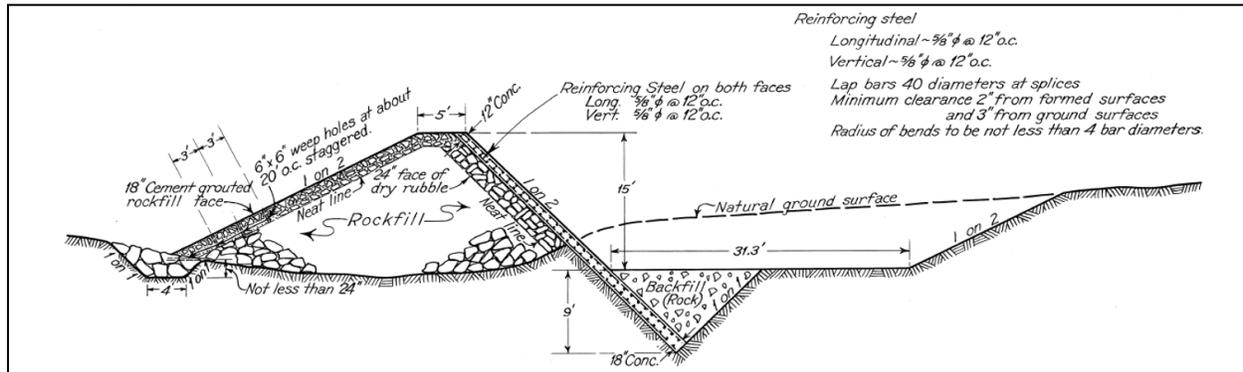
The diversion dam consists of a 450 foot long rock-filled embankment with a crest elevation that varies from 203.2 to 225.7 feet NAVD88 and a maximum height of 25 feet as measured from tunnel entrance end of invert to the spillway crest. The dam is designed to divert water into the tunnel and is not intended to impound water for long periods. The upstream slope at two horizontal to one vertical (2H:1V) is lined with a reinforced concrete slab. The downstream slope at two horizontal to one vertical (2H:1V) is lined with a cement grouted rock fill. The rock fill for the embankment was specified to range in size from one-half cubic feet to 27 cubic feet, of which not less than 25 percent of the stones shall be five cubic feet or more in volume. Rock chips and spalls were specified to be included only to the extent necessary to fill the voids between the larger stones. Rock slabs having an average thickness less than 25 percent the average width were not allowed. The left abutment of the dam is constructed against the canyon wall, with the rock cut to a four horizontal to one vertical (4H:1V) slope and a concrete slab attached with dowels against the rock face. The right abutment of the dam is tied into the tunnel entrance, which is cast into the rock of Bear Mountain. A 12 inch drain pipe was also installed for use during maintenance operations; however, debris

Figure B2. Typical Embankment Cross-Sections C-C

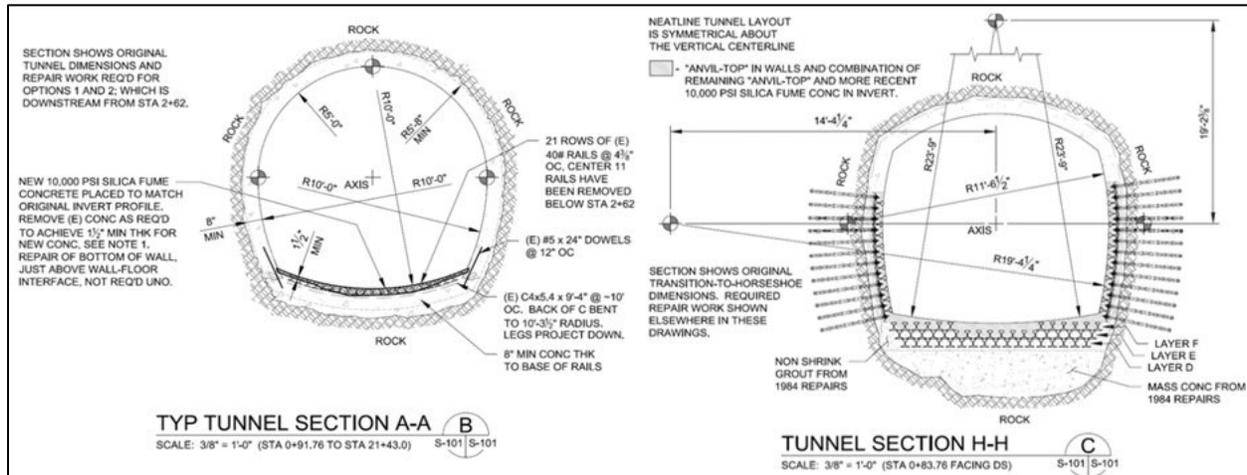
The tunnel consists of a ten foot diameter concrete lined horseshoe-shaped tunnel through Bear Mountain, which is 2,089 feet long with an average grade of 4.2 percent. It is designed with a sharp drop at the intake transition; this accelerates the water to approximately 43 feet per second and facilitates debris transportation through the tunnel. The tunnel was constructed with drill and blast techniques. The bedrock was supported with timbers and lagging until placement of the tunnel concrete liner. It is believed the timber supports were left in place during liner construction, and contact grouting within the timber holes was seems to have not been performed after the liner was emplaced. The crown of the tunnel is assumed to have not been fully contact grouted and voids are still present within this section, reducing the liner's overall structural integrity. The tunnel was designed to be lined with concrete throughout the length of the tunnel, and was originally armored with 40-pound railroad rails welded to the channel cross ties embedded in the invert. Sheet 2 of the 1945 original drawings has details that can be found in the Hydraulics and Hydrology Appendix. The outside curve side of the tunnel is also rail lined at the intake. Spaces between rails have been filled with concrete during subsequent tunnel repairs. The tunnel capacity, assuming the spillway crest is filled to full capacity, has been calculated at 2,800 cubic feet per second.

Figure B3. Typical Tunnel Cross-Sections

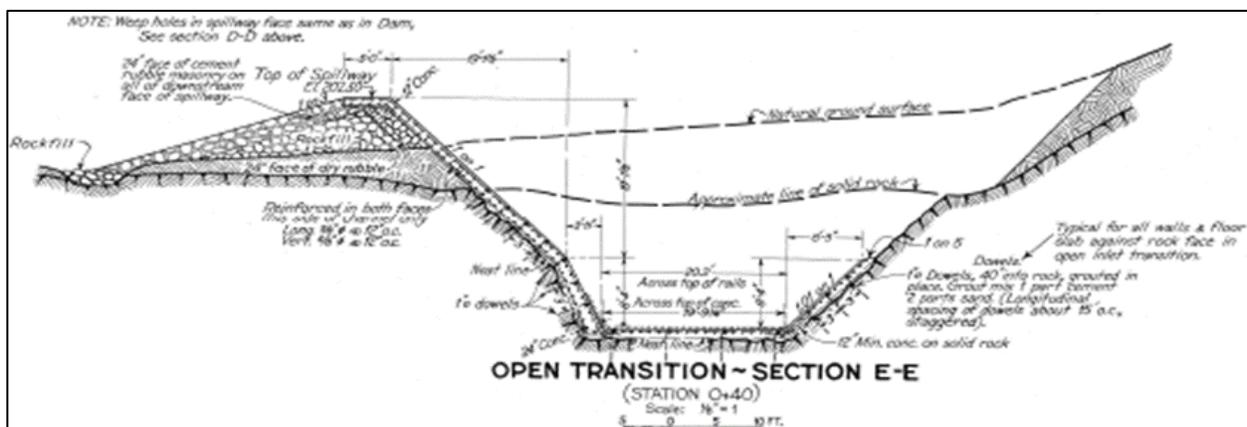
The emergency spillway is an uncontrolled weir with a discharge capacity of 1,700 cubic feet per second. The downstream side of the dam is sloped at three horizontal to one vertical (3H:1V) at the spillway, and is protected by the same grouted rock fill as the main embankment. The spillway is a 40 foot long section of the dam with a crest elevation of 199.0 feet NAVD88. Additional details can be found in the Hydraulics and Hydrology Appendix.

Figure B4. Typical Embankment Spillway Cross-Sections

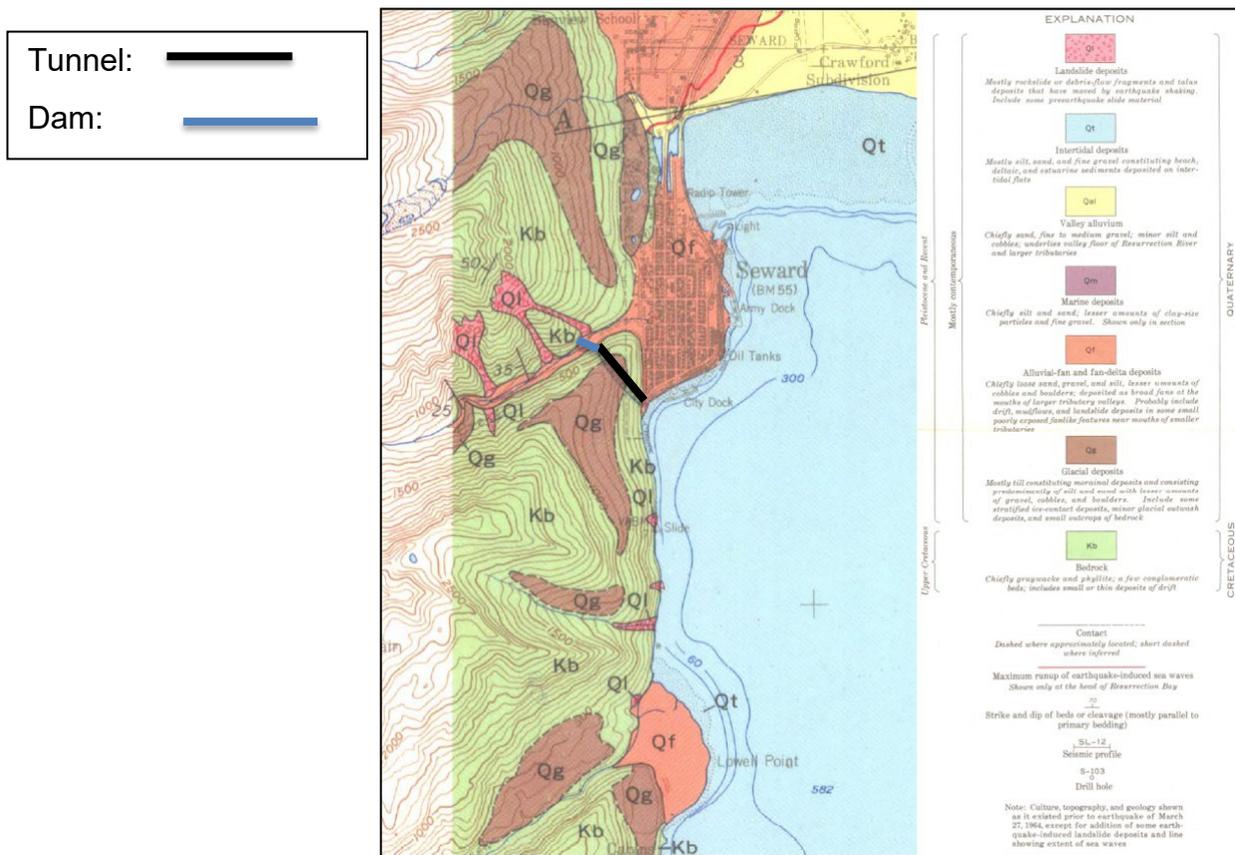
Seward is located on the Kenai Peninsula at the north end of Resurrection Bay. The Kenai Mountains are composed primarily of sedimentary rocks that show a wide range of character and varying degrees of metamorphism. The main composition of these mountains is predominantly argillite, slate, and greywacke. The material was originally deposited as impure sand and mud. With time and pressure the sediments were transformed into shale and sandstone with a certain fine-grained content. The rock has been further altered during folding of the mountains due to plate tectonics. The common geologic structure now appears as hard shale, argillite, greywacke, and impure quartzite, although locally metamorphism has proceeded far enough to convert the rock to slate or schist. Surface weathering in this area is significant with temperature fluctuation (freeze/thaw cycle) and high rain quantities noted for the surrounding geographic regime. With these factors the rock structure within this drainage basin produces great quantities of trap rock or shingle, which has a very flat angle of repose and is readily transported by water action. Figure B5 provides a geologic map for the project vicinity, indicating the major rock formations present. The City of Seward was built on the alluvial fan delta (Qf unit) made from sediments deposited by Lowell Creek. The location of some major landslide deposits within the upper Lowell Creek drainage basis are shown in Figure B5.

Figure B5. Geologic Map (Lemke, 1967)

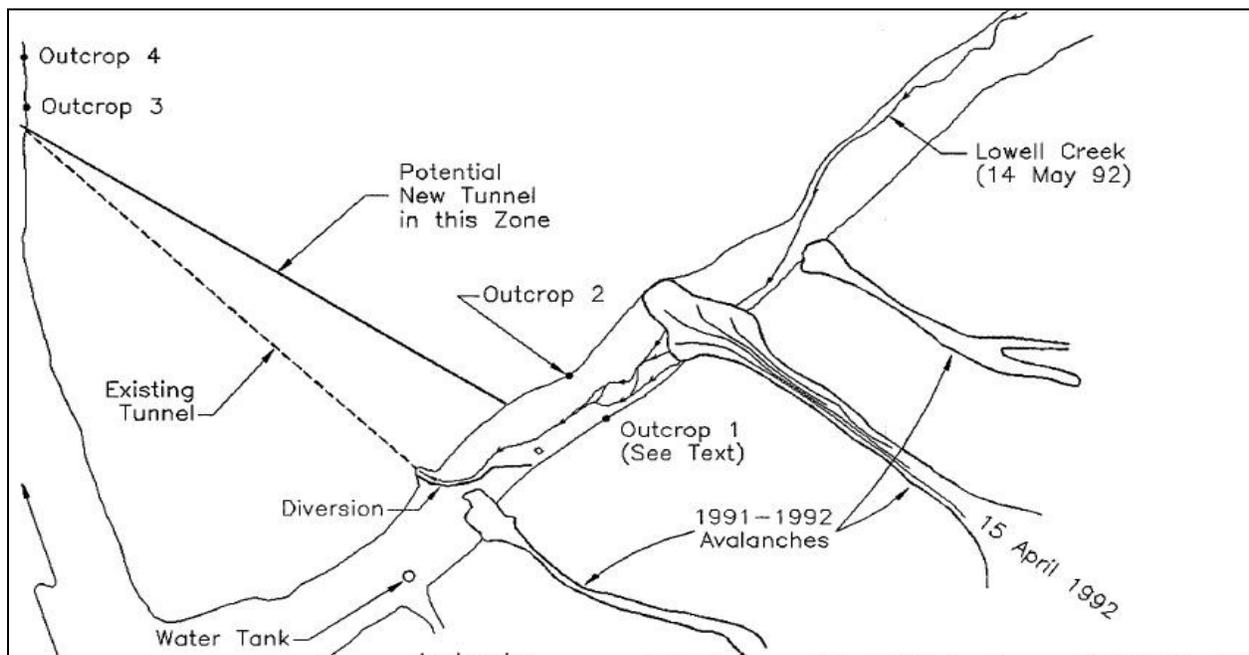
Figure B6. Bedrock outcrop map upstream from Lowell Creek Tunnel entrance

Bedrock outcrops 1 and 2 identified in Figure B6 are located just upstream of the existing tunnel entrance. Outcrop 1 consists of thin to thickly bedded graywacke bearing N10-13°E 72°W. The rock is hard and moderately jointed. Thick vegetation hides most rock on the left bank. Outcrop 2 is actually in two locations: the downstream portion is an outcrop of interbedded graywacke and shale bearing N-S 85°W, while the upstream portion is a fissile shale outcrop bearing N10°W 80°W (See Figure B7).

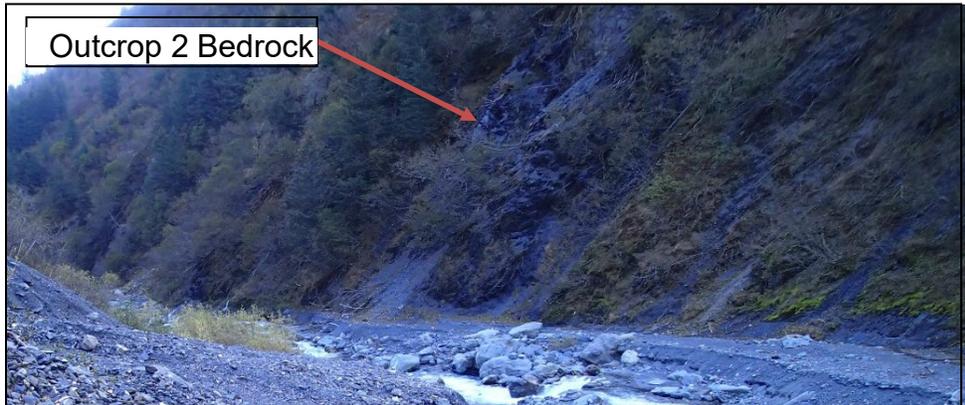
Figure B7 Bedrock Outcrop 2 photo facing downstream

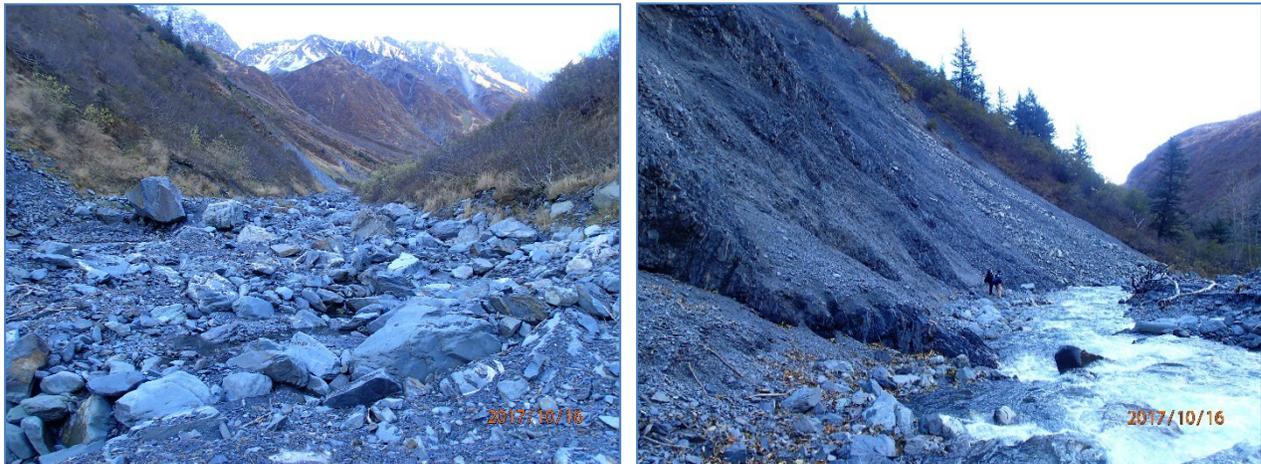
Figure B8 Lowell Canyon. Left photo 1.25 miles upstream from facility, lateral moraine and Right photo $\frac{3}{4}$ mile upstream from facility, landslide on right side of photo shifted channel left.

Creek valley contain 1991 slide scars. The volumes of these slides are unknown. The upper valley has very steep, essentially un-vegetated side slopes consisting of thick lateral moraines. These moraines continue upstream to remnant snowfields, where loose lateral and ablation moraines cover the valley. This material is very permeable and subject to continuous mass movement. During a site visit in October 2017, the team met with Matthew Balazs, a PhD candidate from University of Alaska, Fairbanks, who was investigating a lateral moraine located about 1.25 miles upstream of the project. This moraine was estimated to cover an area of approximately one million square feet, estimated from satellite imagery. The height of the moraine is unknown; however, if the average thickness of the deposit were 30 feet, the volume material in the moraine would be approximately one million cubic yards. See Figure B8 for photos of canyon deposits.

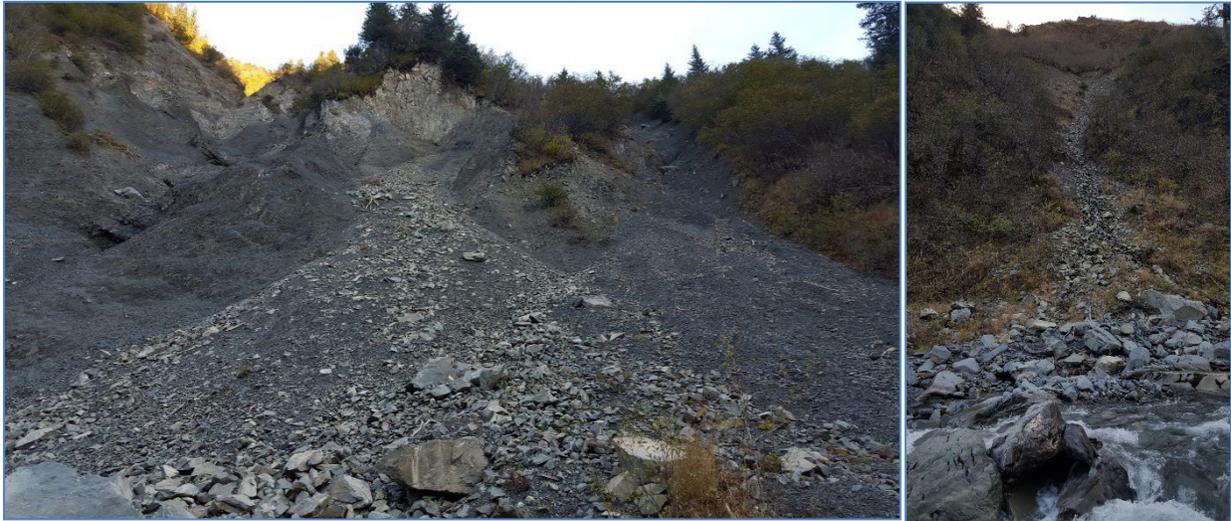
Figure B9 Lowell Canyon weathered rock face and slope failures upstream from diversion facility.

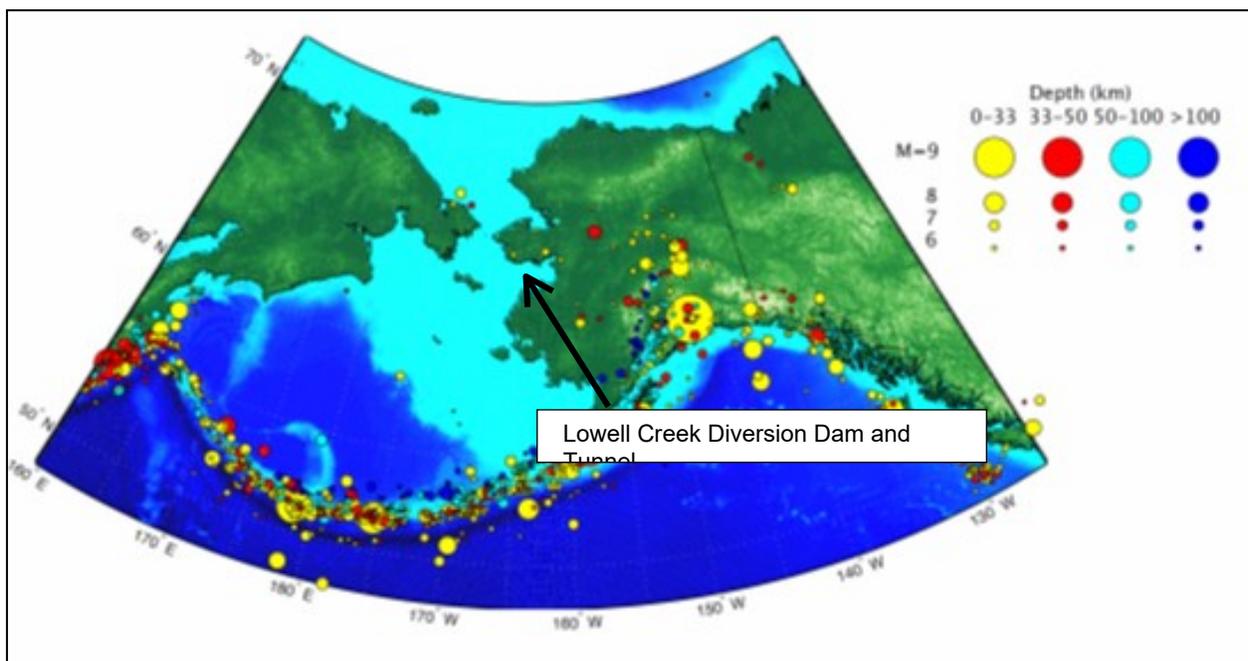
Figure B10. Alaska Earthquakes with $M_w \geq 5.5$ from 1900 to 2004 (Wesson et al. 2007)

Most of the seismicity in Alaska is associated with the Alaska-Aleutian megathrust fault which runs along the Aleutian arc as illustrated in Figures B10 and B11. The fault is where the northwestward-moving Pacific Plate is subducted beneath the North American Plate (Wesson et al, 2007). The Alaska-Aleutian subduction zone is the source for the 1938 M8.3 Alaska Peninsula earthquake, 1946 M7.8 Unimak earthquake, 1957 M8.6 Fox Islands earthquake, 1964 M9.2 Prince William Sound earthquake, and the 1965 M8.7 Rat Islands earthquake (Koehler et al, 2012). The 1964 Prince William Sound M_w 9.2 event is the second largest earthquake in the world ever recorded. Other significant sources of seismicity include the Denali fault in south-central Alaska and a series of northwest-striking right-lateral strike-slip faults that run along the panhandle of southeast Alaska. These faults form the north-northeast boundary of the Pacific Plate at depth (Wesson et al, 2007). The 2002 Denali fault M_w 7.9 event is the largest earthquake to occur on land in the U.S. since the 1906 San Francisco earthquake. The

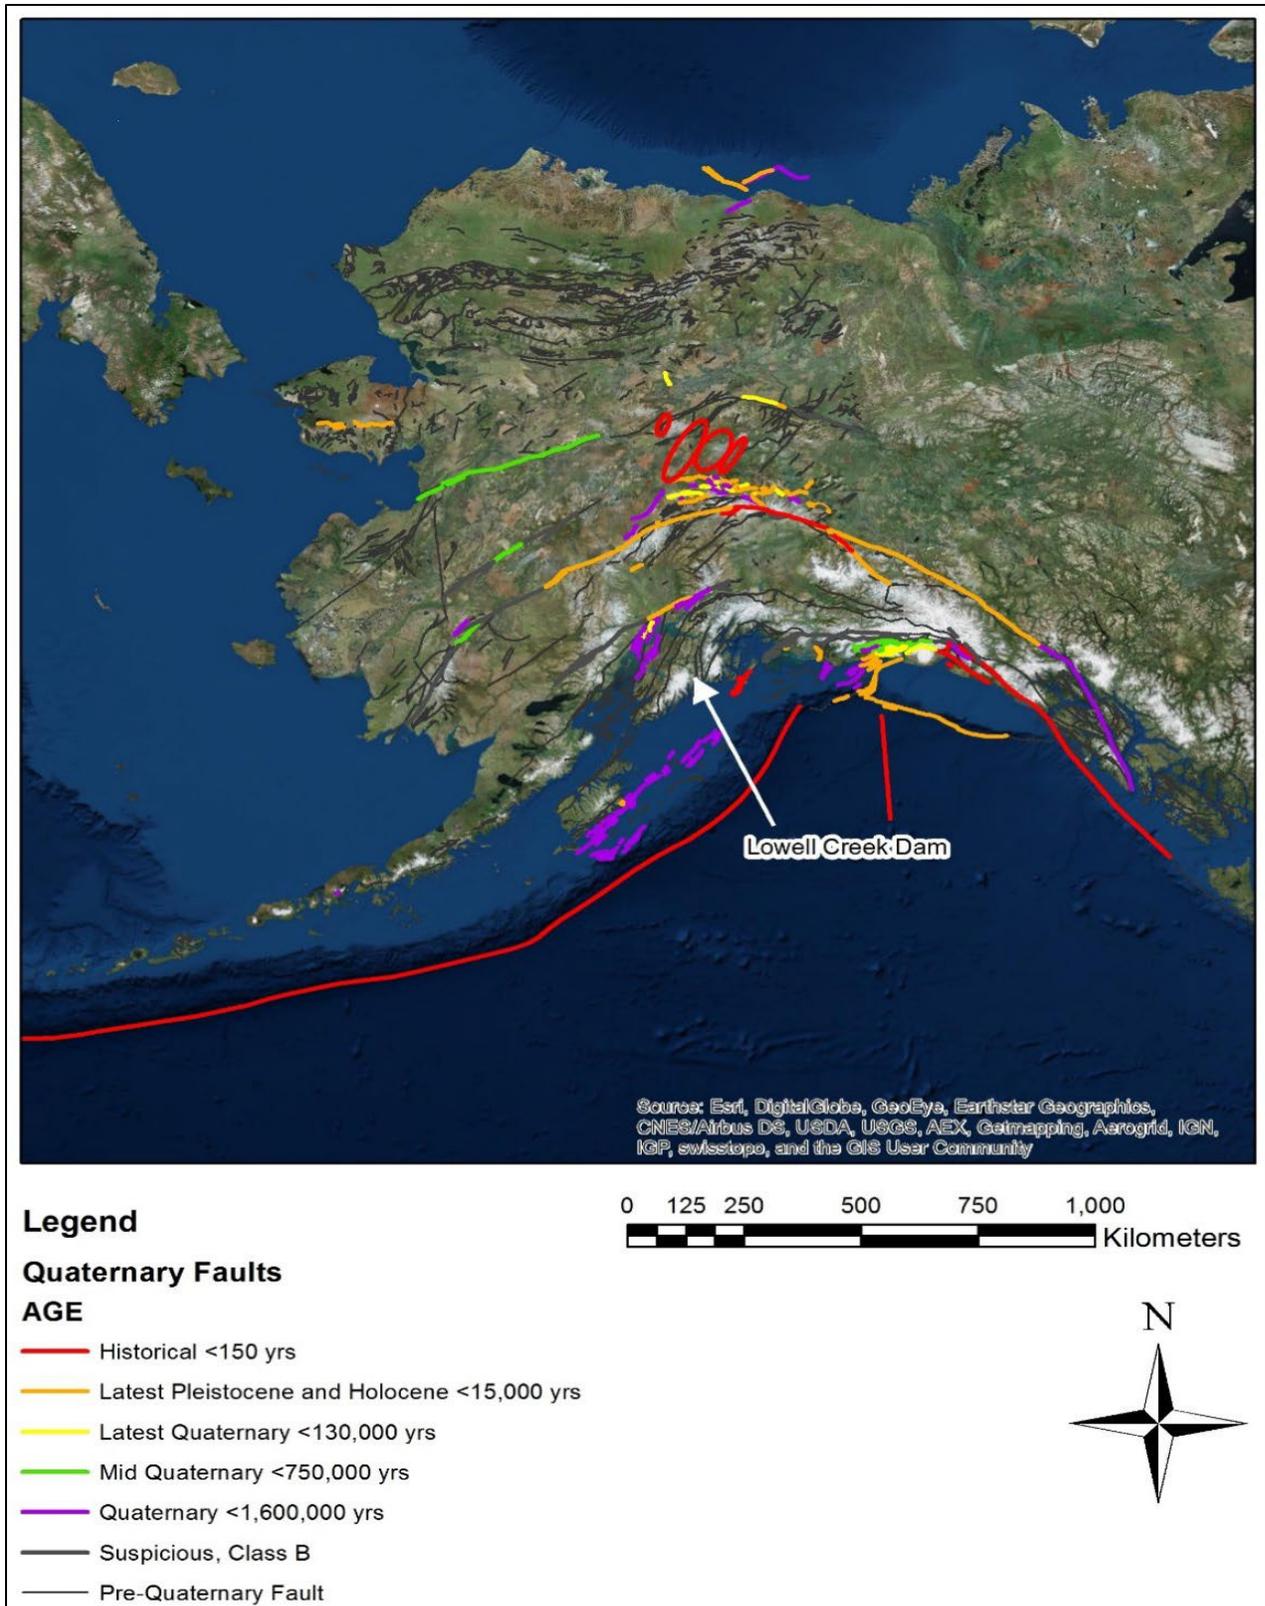
Figures B11 and B12 show the location of active and suspected active faults of various ages in Alaska and in the vicinity of the project site, as obtained from a database of Alaska faults and folds compiled by Kohler et al (2012). The age of fault movement ranges from known events in historical time (last 150 years) to Quaternary faults which have been recognized at the ground surface and have evidence of movement in the past 1.6 million years. Fault sources within 450 kilometers of the dam are presented in Kohler et al (2012). The majority of Quaternary faults and folds in Alaska remain poorly characterized and information on the location, style of deformation, and slip rates for most faults is limited.

Figure B11. Location of Fault Sources in Alaska (Koehler, R.D. et al, 2012 and 2013)

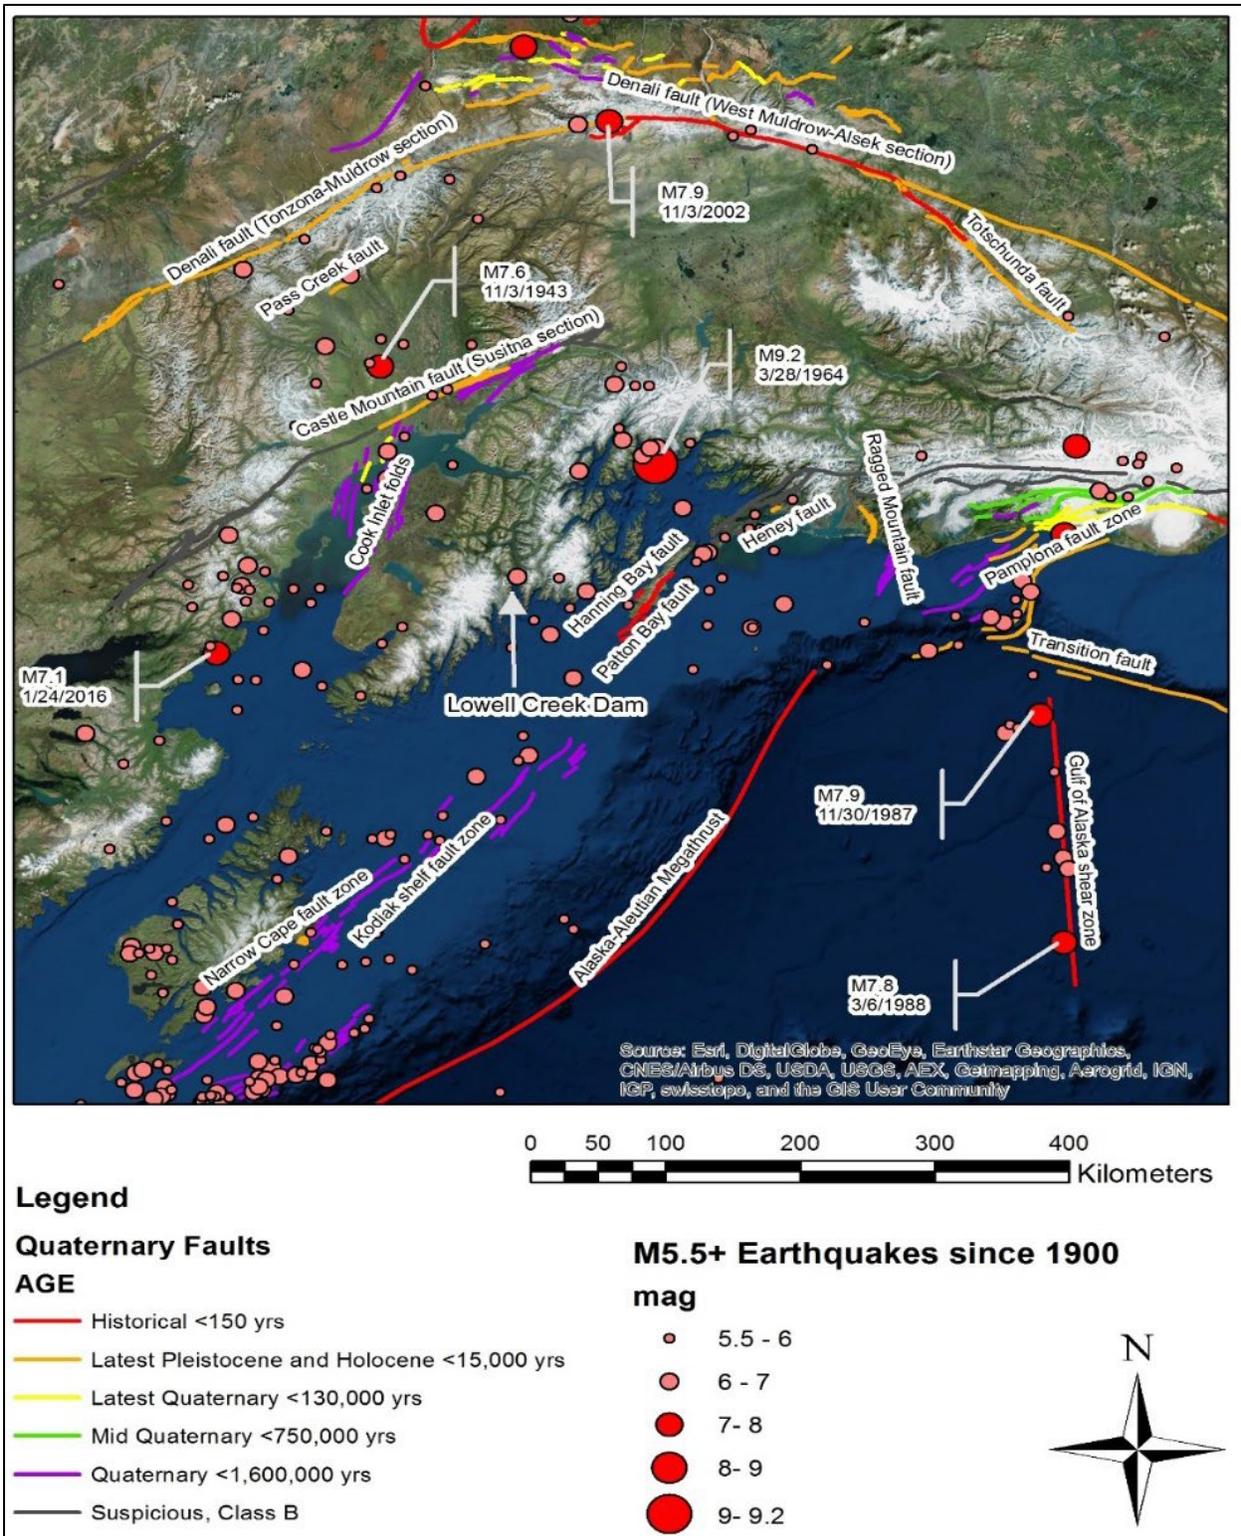
Figure B12. Faulting in the Dam Vicinity (Koehler, R.D. et al, 2012 and 2013) and M5.5+ earthquakes since 1900 (USGS 2017)

The Aleutian arc is the most active seismic feature in the state and extends approximately 3,000 kilometers from the Gulf of Alaska in the east to the Kamchatka Peninsula in the west (see Figure B12, USGS, 2017). Nearly all of the plate boundary along the subduction zone has ruptured during the last century (Wesson et al, 2007). The Pacific Plate is moving northwest at a rate of approximately 60 millimeters per year at the eastern edge of the arc to approximately 76 millimeters per year near the western terminus. Motion along the eastern Aleutian arc, which is closest to the project, is characterized by arc-perpendicular convergence and Pacific Plate subduction (USGS, 2017). Most of the seismicity here results from thrust faulting along the interface between the North American Plate and the subducting Pacific Plate. The closest megathrust earthquake to the dam was the 27 March 1964 M9.2 Prince William Sound earthquake. The rupture length for this event was approximately 700 kilometer long extending from Prince William Sound to the southern end of Kodiak Island. Damage was reported in Kenai, Moose Pass, and Kodiak, with the largest property damage occurring in Anchorage as a result of shaking from the main shock and subsequent landslides (USGS 2017).

Other faults close to the project include the Cook Inlet folds, the Castle Mountain fault, and the Kodiak Shelf fault zone as shown in Figure B12 and Table B1. The Cook Inlet basin lies on a northeast-trending forearc located between the Chugach and Kenai Mountains to the southeast, and the Alaska Range and Aleutian volcanic arc to the northwest. Deformation of the Cook Inlet basin started between Eocene and early Oligocene time. Deformation in the upper Cook Inlet is transpressional and resulted in a series of folds, faults, and eroded horst blocks (Haeussler & Saltus, 2011).

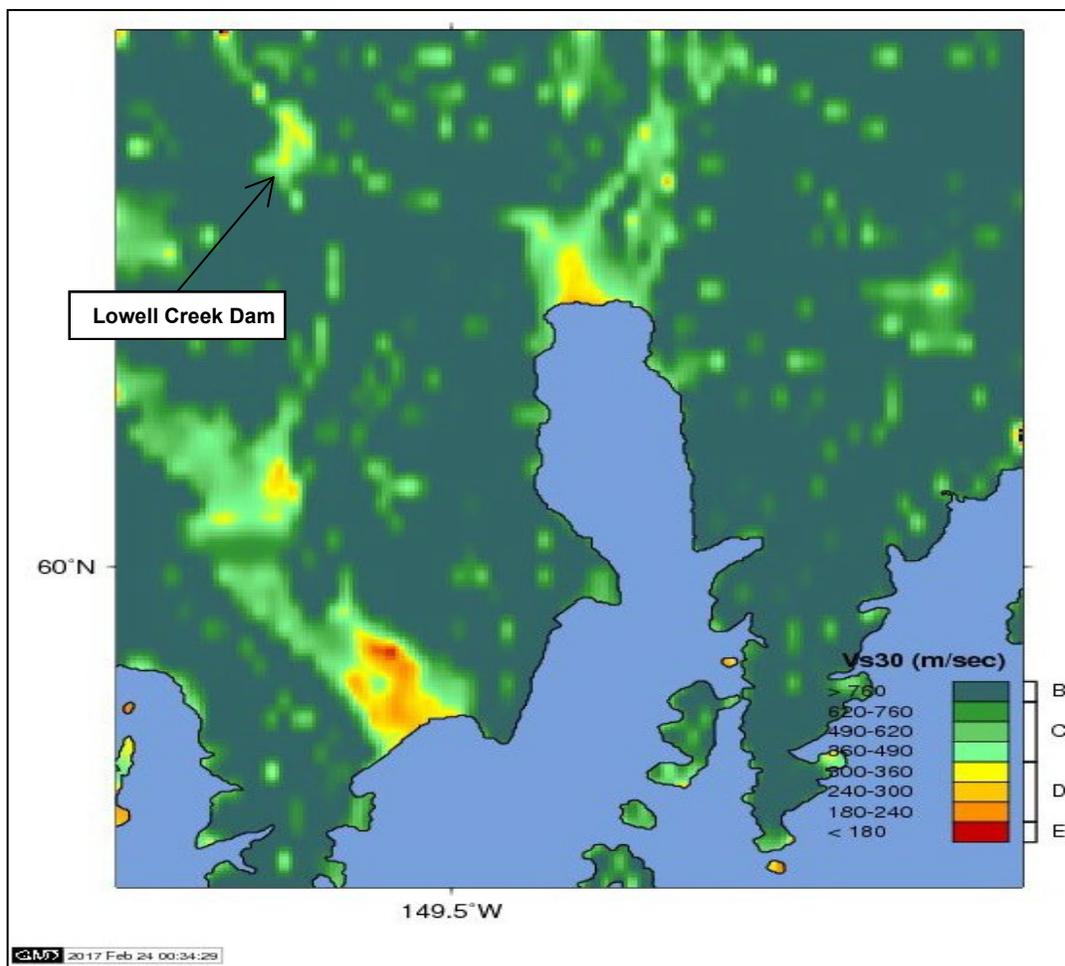
Directly acquired shear wave velocity data is not available for the site. Wald and Allen (2007) developed an indirect methodology to derive maps of v_s^{30} based on topographic slopes. Based on the topography at the dam site, the v_s^{30} is estimated to be approximately the B and C boundary (760 meters per-second) shown on the reference scale in Figure B13. The use of downhole vertical shear velocity profiling and or alternative geophysical surveys conducted from the surface will further refined the material's v_s^{30} value, to provide accurate information for design purposes.

Figure B13. v_s^{30} based on high-resolution topographic data (Allen and Wald, 2007).

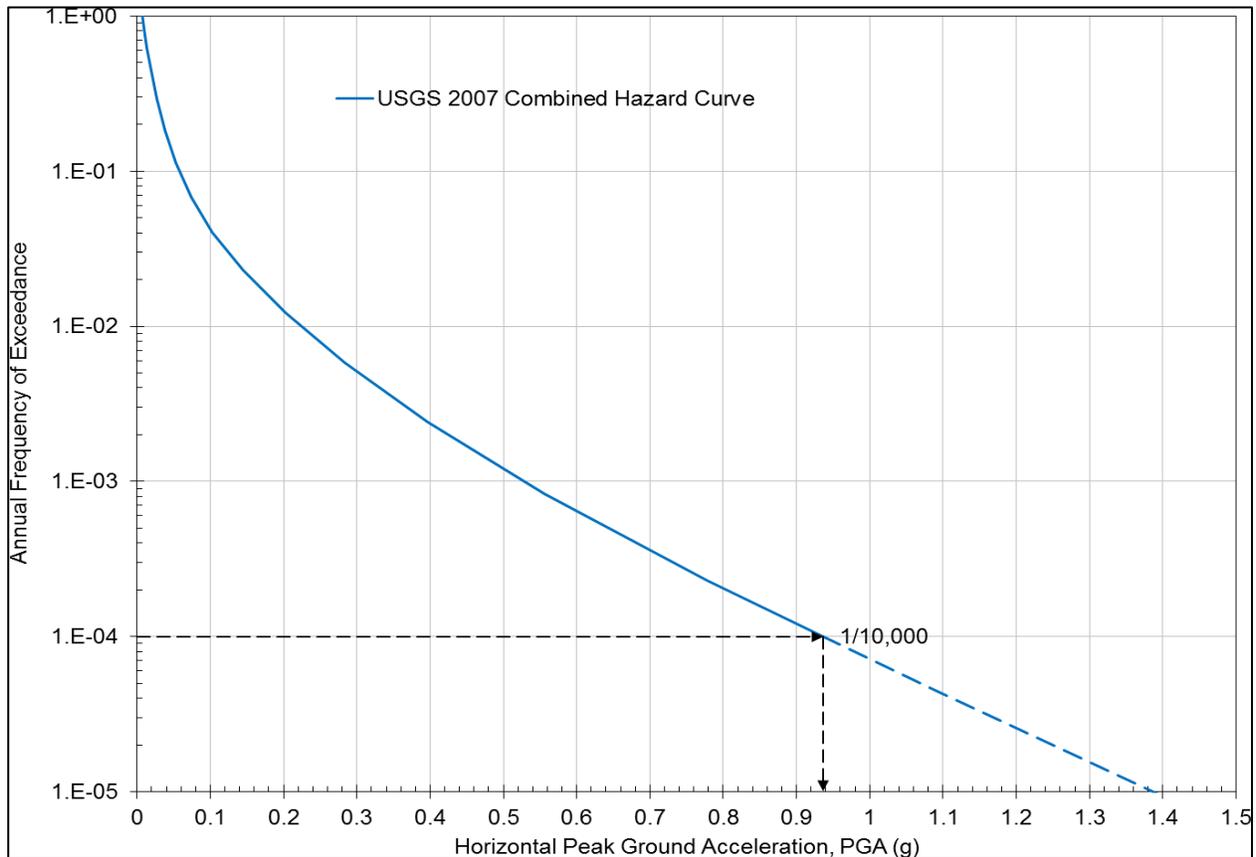
Figure B14. Seismic Hazard Curve for peak horizontal ground acceleration (Wesson et al, 2007)

Time-independent probabilistic seismic hazard maps of Alaska and the Aleutians were developed by the USGS in 2007. The 2008 and 2014 updates to the National Seismic Hazard Map do not include Alaska. The 2007 seismic source model for Alaska considers uncharacterized and unrecognized fault sources, active faults with known parameters, and the Alaska-Aleutian megathrust associated with the subduction of the Pacific Plate. There is considerable uncertainty for annual exceedance probabilities (AEP) less than 1/10,000. The extrapolation of the mean hazard curve to remote annual exceedance probabilities (i.e., less than 1/10,000 AEP) is shown as a dashed line in Figure B14. The peak horizontal ground acceleration corresponding to selected common values of return periods were interpolated from this mean hazard curve and are shown in Table B2.

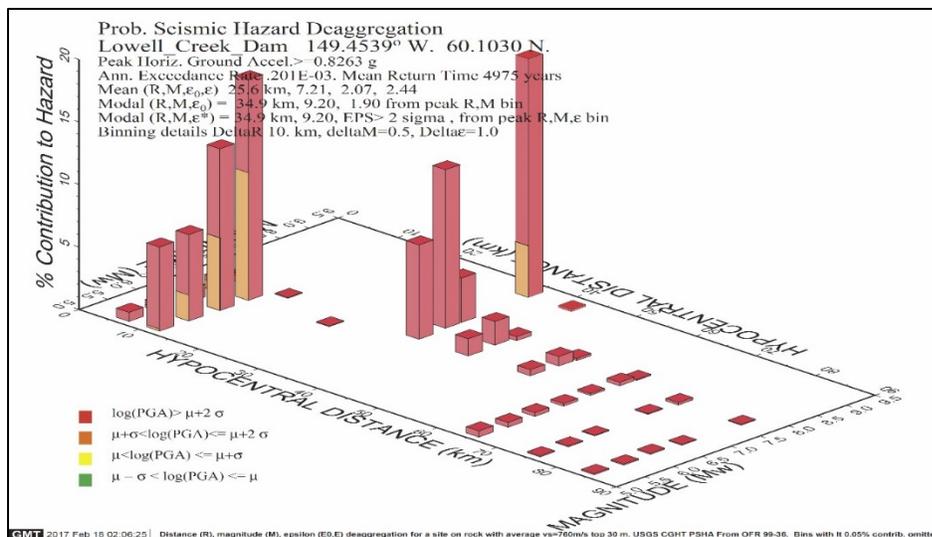
The USGS has not published a web application to perform the seismic hazard deaggregation using the most recent Alaska probabilistic seismic hazard analysis (Wesson et al, 2007). The deaggregated seismic hazard for the peak horizontal ground acceleration is shown in Figure B15 using the 1998 USGS NSHMP Hazard Maps for Alaska. Deaggregation corresponding to only the B and C boundary (at 760 meters per-second, Figure B13) v³⁰ site class is available. The deaggregation suggests that the primary contributors to the seismic hazard at the site include an Mw 6.2 earthquake from shallow random sources at a distance of 11.4 kilometer, an Mw 7.6 earthquake from the subduction zone at a distance of 38.6 kilometers, and an Mw 9 earthquake from the subduction zone at a distance of approximately 38 kilometers. An updated evaluation of significant seismic hazard sources and associated ground motions would be provided in a current probabilistic seismic hazard analysis supporting the project design phase.

Figure B15. Probabilistic Seismic Hazard Deaggregation for peak horizontal ground acceleration with 1% probability of exceedance in 50 years (1/4,975 AEP) (USGS 1998)

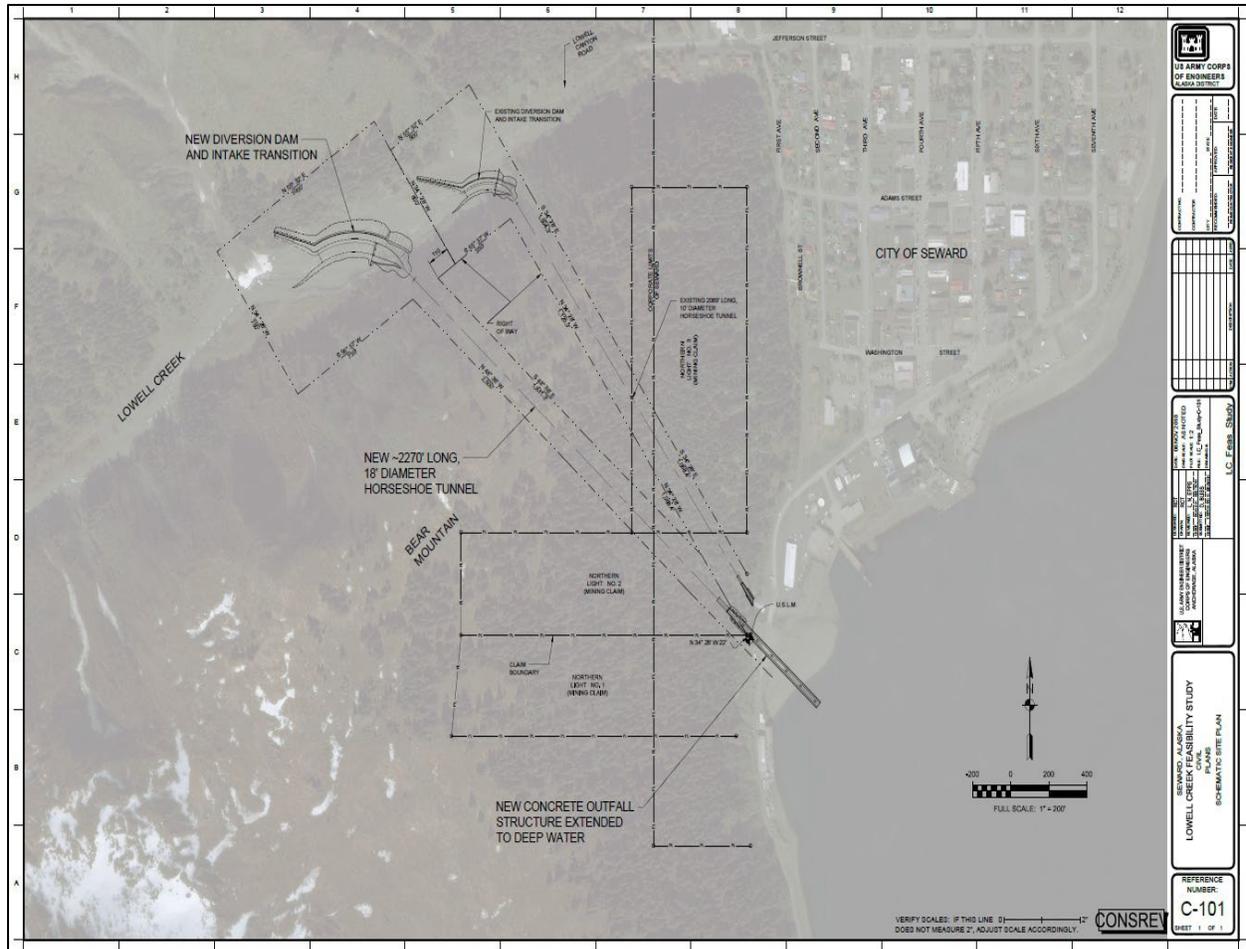
This alternative focuses on eliminating elements that contribute to the risk from Lowell Creek. This alternative adds a new eighteen foot tunnel and diversion dam upstream of the existing facility (S1 & S8), and this design would have an effect on the risks associated with flows up to 8,400 cubic feet per-second (probable maximum flood). Figure B16 show a general proposed location and layout for this alternative. This alternative also incorporates measures from Alternative 2 and the same site investigation requirements stated in Section 4.2.

Figure B16. Alternative 4 Conceptual Drawing

A geotechnical investigation including a geophysical survey and borings conducted to bedrock with associated soil and rock materials testing is required at the proposed dam location. Analysis of groundwater flow will be extended to the proposed dam location. Field geologic mapping and borings with rock coring will be required through Bear Mountain, at and above the proposed tunnel location. Field geologic mapping and borings with soil sampling and rock coring will also be needed around the inlet and outfall locations, as tunnel portals and the surrounding slopes often present the most challenging excavation and rock support conditions for a tunneling project. Core sampling within the original tunnel liner and surrounding rock mass will still be required, as the original tunnel will still function as an overflow diversion structure.
