# Lowell Creek Flood Diversion Seward, Alaska Appendix B: Geotechnical

Appendix B: Geotechnical

Integrated Feasibility Report and Environmental Assessment

Lowell Creek Flood Diversion

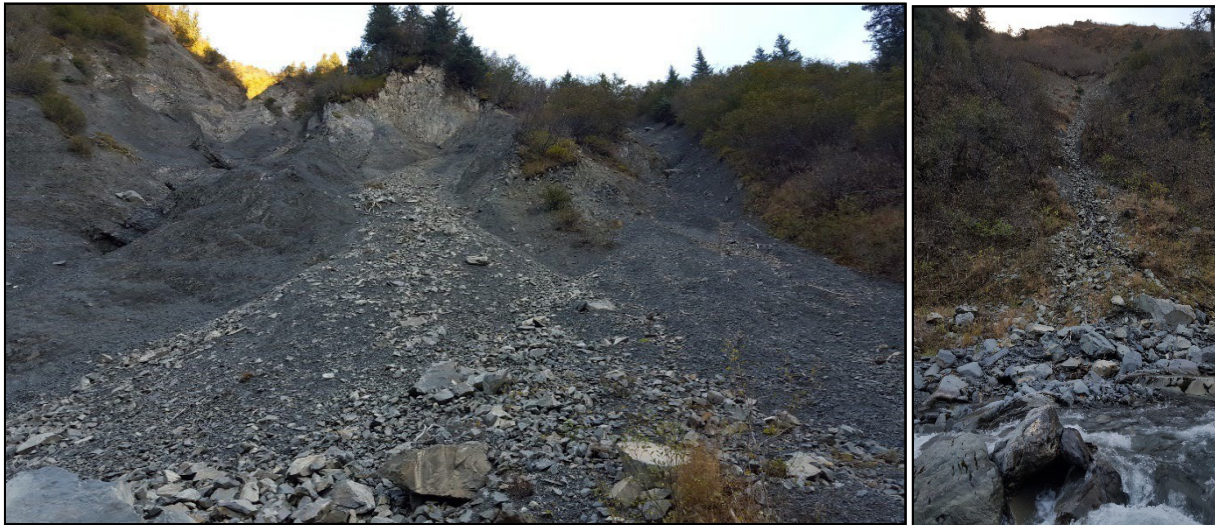
Figure 9. Lowell Canyon Weathered Rock Face and Slope Failures Upstream from Diversion Facility.

Figure 9 presents photos of weathered rock faces and slope failures upstream of the diversion facility. Large amounts of material can come down the slides or come from

over-steepened glacial deposits during intense rainfall, temporarily blocking the stream. The subsequent breaching of the slide material and release of impounded water can result in a much greater flood peak than would otherwise have occurred due to rainfall alone. In addition, the 1988 study evaluated the potential for surge-release floods in Lowell Canyon to be high. The assignment of potential for debris-laden surge-release floods was based on known past events and the assignment of potential for landslides or avalanches was based on the work by Lemke (1967), field reconnaissance in October 1986, and analysis of historical aerial photographs (Jones and Zenone 1988).

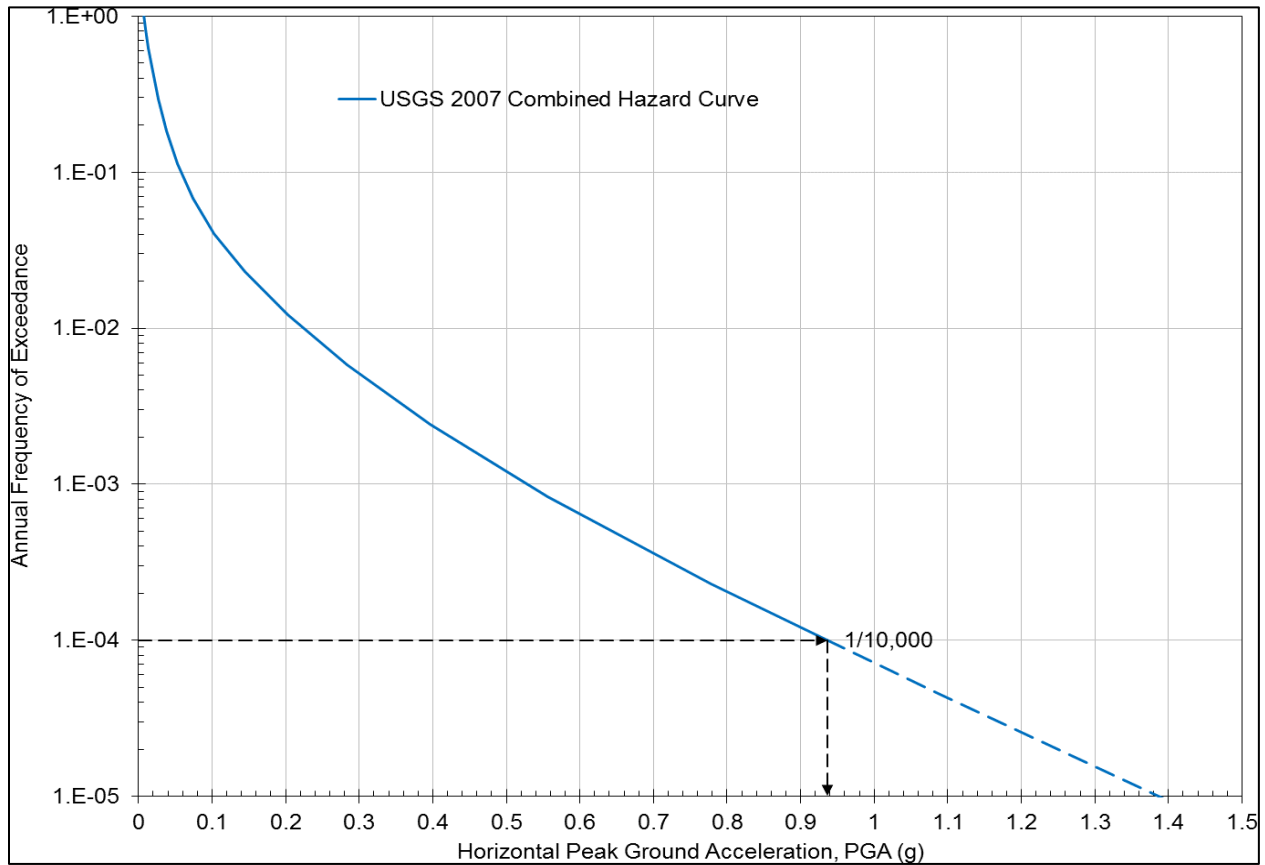
Figure 14. Seismic Hazard Curve for PGA (Wesson et al. 2007).

For the purposes of this risk assessment, a probabilistic return period and corresponding ground motion value were selected by the risk assessment team, as this was sufficient for determining the potential failure mode and consequences. A site-specific PSHA may need to be performed during the design phase for a more accurate characterization of seismic ground motions applicable to the TSP. The mean seismic hazard curve for the peak horizontal ground acceleration (PGA) shown in Figure 14 is based on a regional PSHA for Alaska (Wesson et al. 2007). This analysis provides a general estimation of the seismic hazard rate and frequency for the region around the City of Seward, Alaska.

Time-independent probabilistic seismic hazard maps of Alaska and the Aleutians were developed by the USGS in 2007. The 2008 and 2014 updates to the National Seismic Hazard Map do not include Alaska. The 2007 seismic source model for Alaska considers uncharacterized and unrecognized fault sources, active faults with known parameters, and the Alaska-Aleutian megathrust associated with the subduction of the Pacific Plate. There is considerable uncertainty for annual exceedance probabilities (AEP) less than 1/10,000. The extrapolation of the mean hazard curve to remote annual exceedance probabilities (i.e., less than 1/10,000 AEP) is shown as a dashed line in Figure 14. The PGA corresponding to selected common values of return periods were interpolated from this mean hazard curve and are shown in Table 2.
