ALASKA BASELINE EROSION ASSESSMENT

U.S. Army Corps of Engineers Alaska District

Erosion Information Paper - Gambell, Alaska

Current as of February 15, 2008

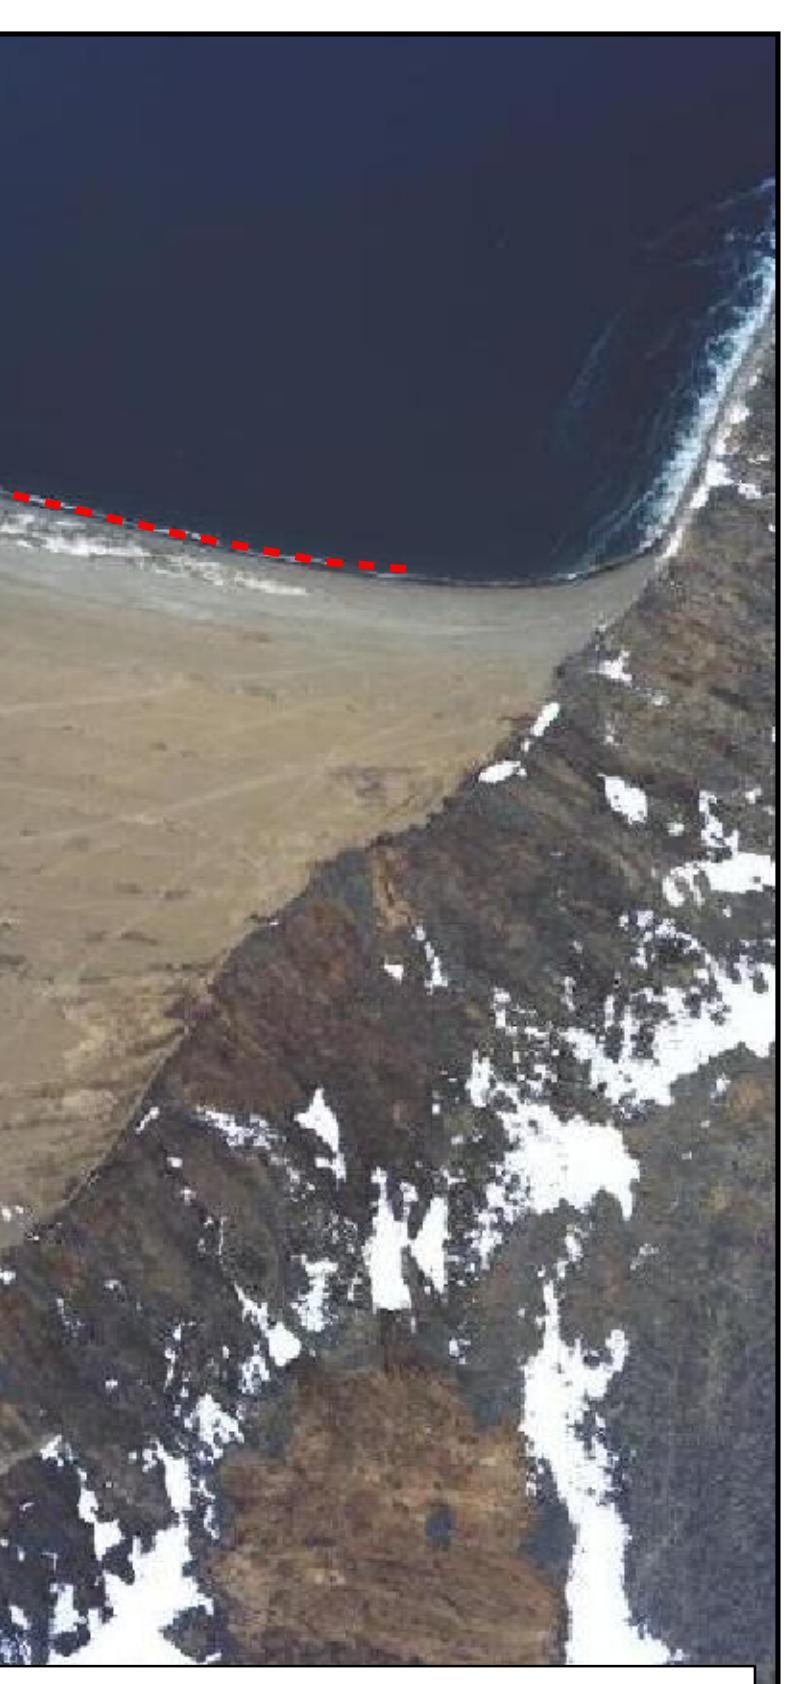
Linear Extent of Erosion

Erosion occurs along airport off aerial photo coverage

not rates or severity of erosion

NOTE: The extent of erosion shown on this figure is based on interviews with the community. This data has not been field verified. This figure is only intended to show areas of erosion,

The one area, not show on the diagram, is the small strip of land that facilitates the airport runway between the Bering Sea and Troutman Lake. Fall storms can generate 30-40 foot waves that surges over the runway and into Troutman Lake. The potential danger to community members is to be cut off due to flooding from the Emergency Evacuation Road and the possibility of damaging the runway. The community does not agree with the R&M study suggesting 33-65 years before erosion could impact the runway. Erosion of the beach gravel at the waterline is a constant concern, especially to the runway.
