# Juneau Harris Harbor

# Condition of Improvements 31 December 2019 Harris Harbor Juneau, Alaska (CWIS No. 072797)

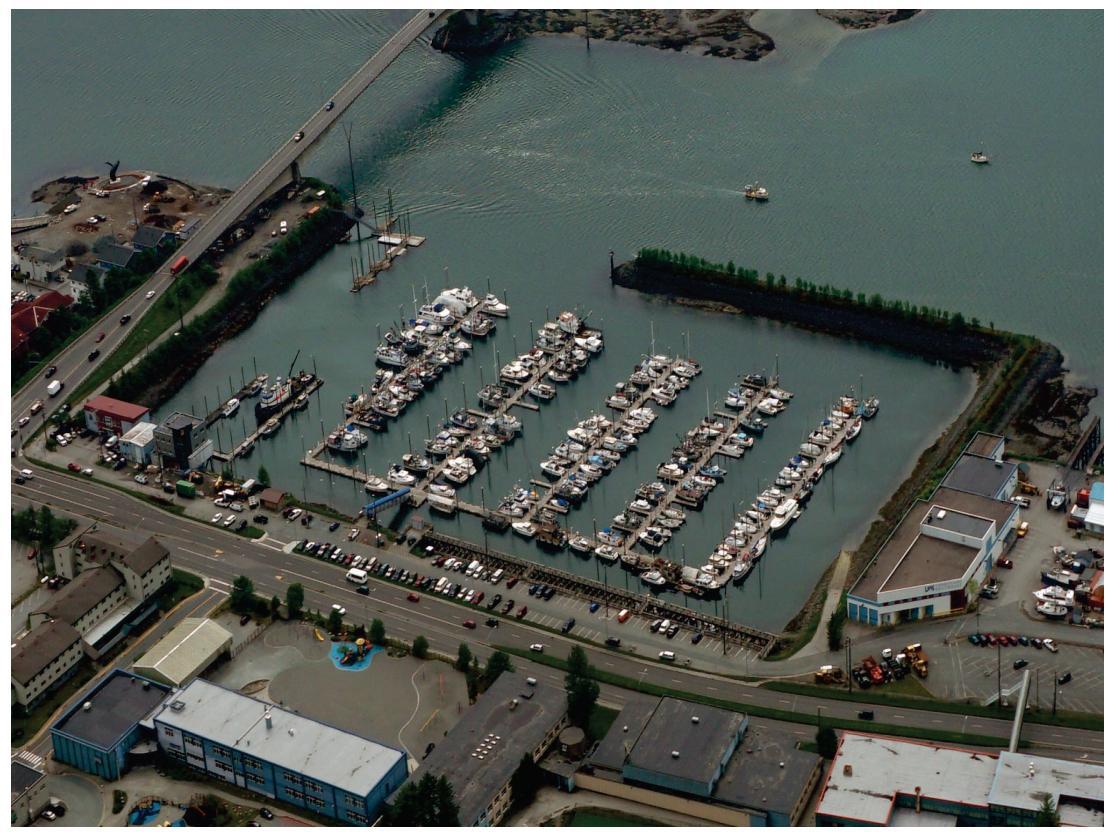
Oblique of Harris Harbor, June 2017

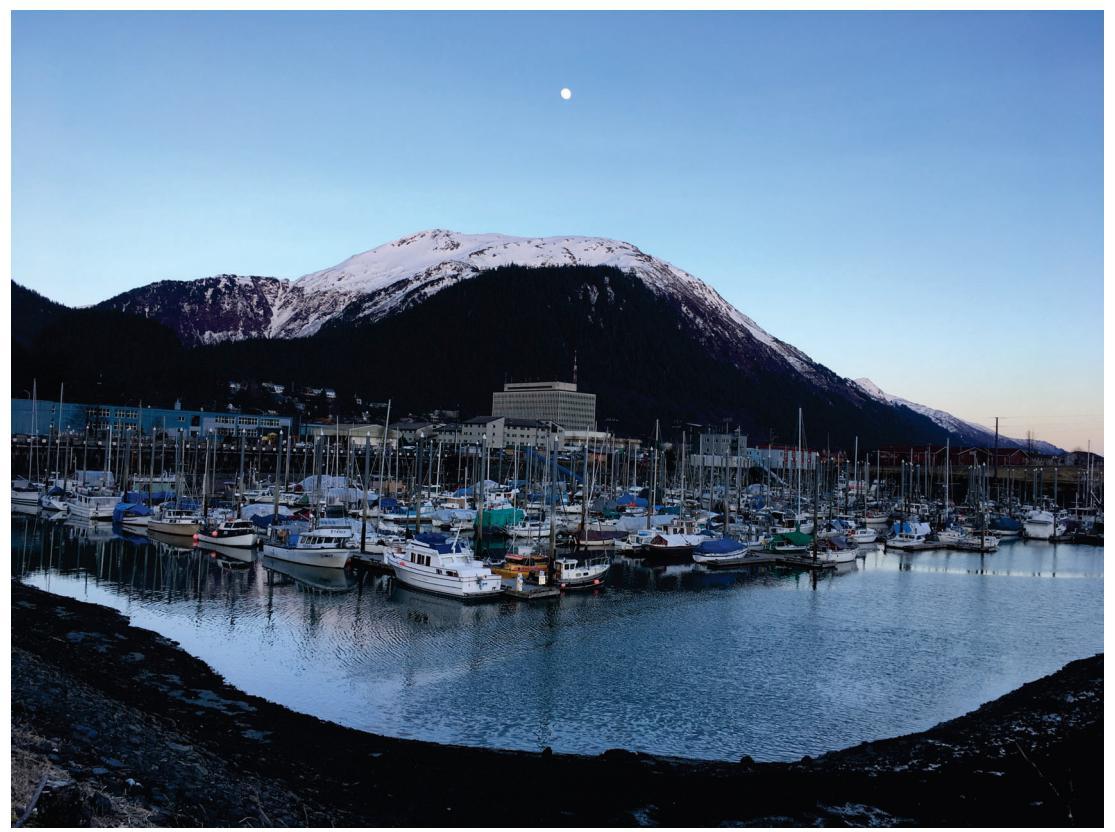
Harris Harbor, March 2019

**Controlling Depth** In March 2019, a depth of -8.6 feet MLLW controls in the northeast corner of Harris Harbor in an area accessible only by small craft and a depth of -5.9 feet MLLW controls the ADF&G float at the south end of the harbor. There is shoaling in a majority of the southern half of the harbor to include the transient float.
