Bethel Harbor

Condition of Improvements
30 December 2014
Bethel Harbor, Alaska
(CWIS No. 024100)

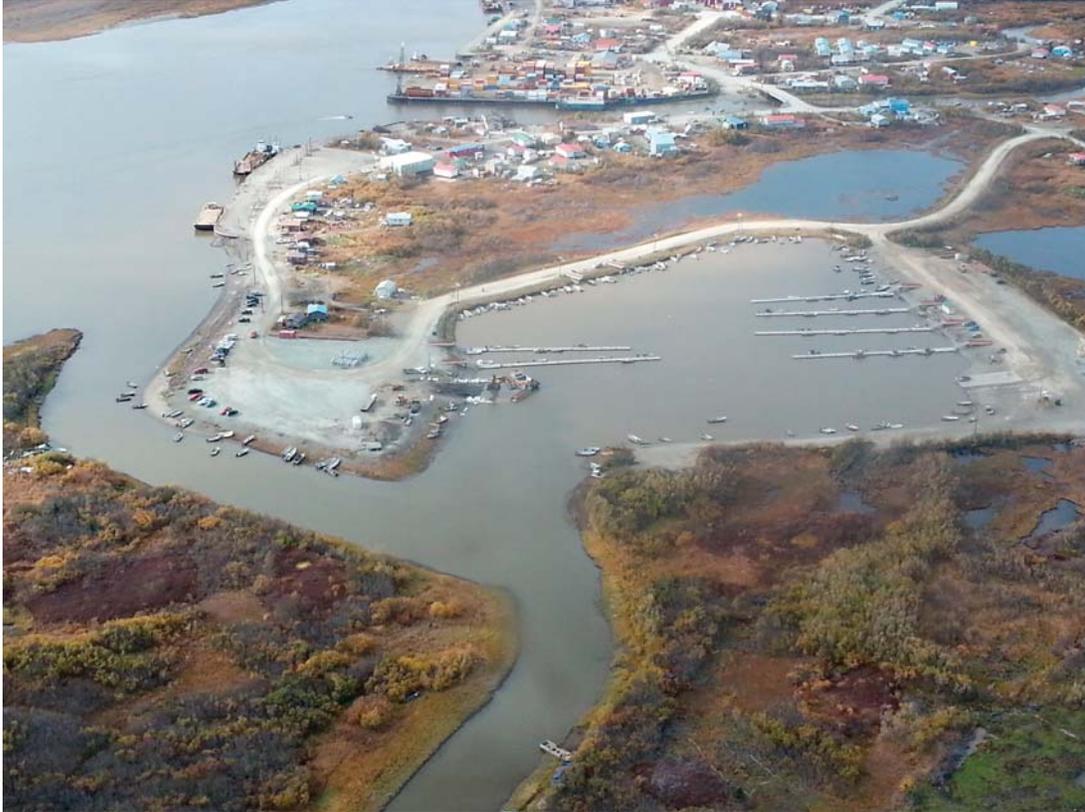
Oblique of Bethel Harbor, September 2013.

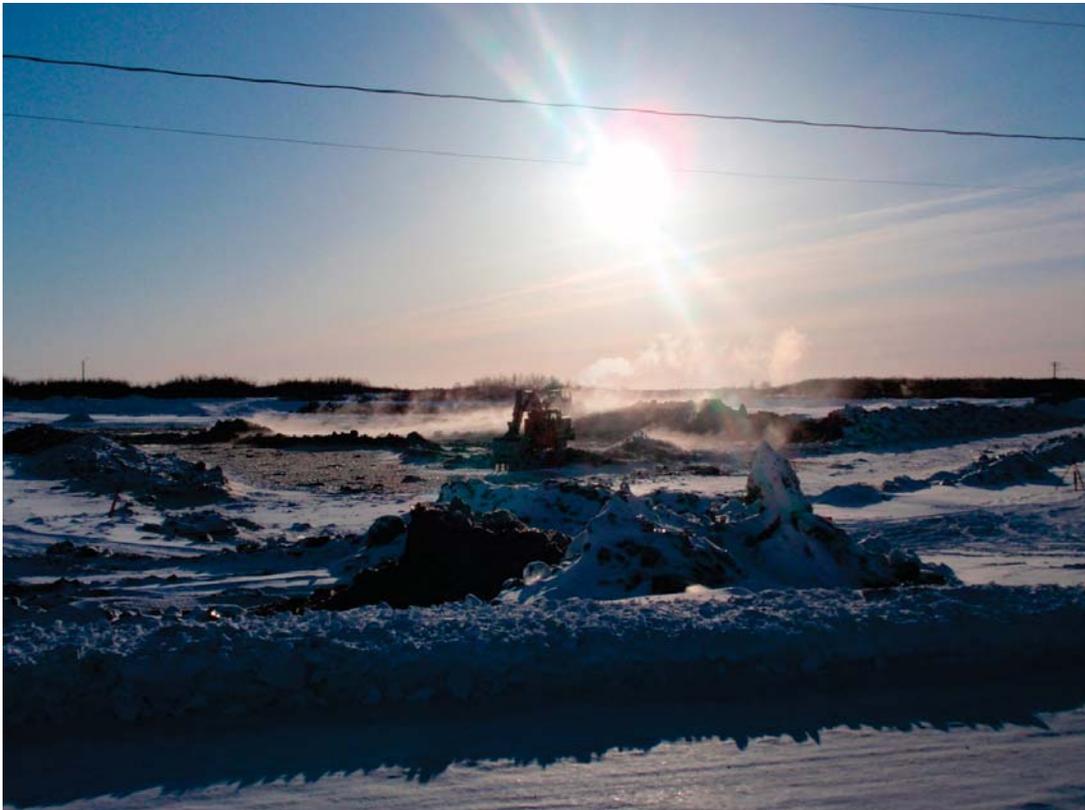
Dredged material is stockpiled for transfer to the upland disposal area, 2013.

This area was used to dispose of material from the 1992, 1997, and 2013 maintenance dredging events. The harbor sediment is hauled by truck to the disposal area. A background sample collected from this area in 1991 had a concentration of 26 mg/kg arsenic.

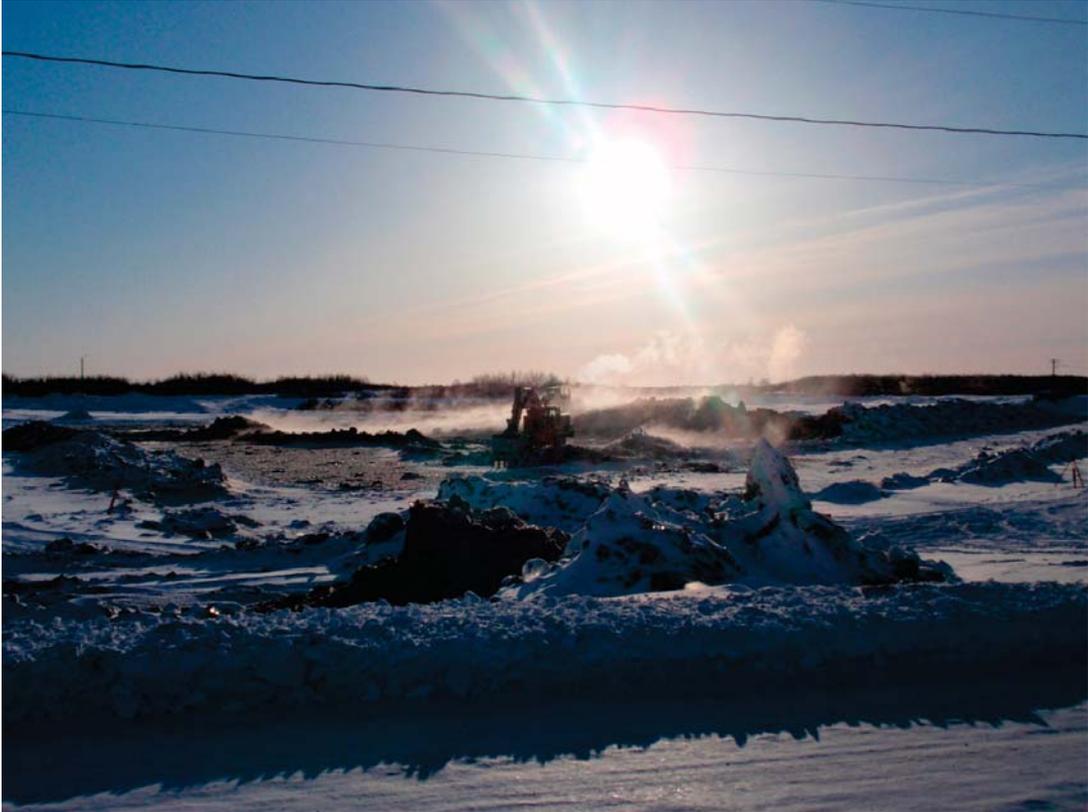
Maintenance dredging of the basin and channel in the winter of 2013.

| 2013 | Annual maintenance dredging removed 17,800 cubic yards from the basin and entrance channel and placed the material in an upland stockpile. A condition survey is completed in late September. |

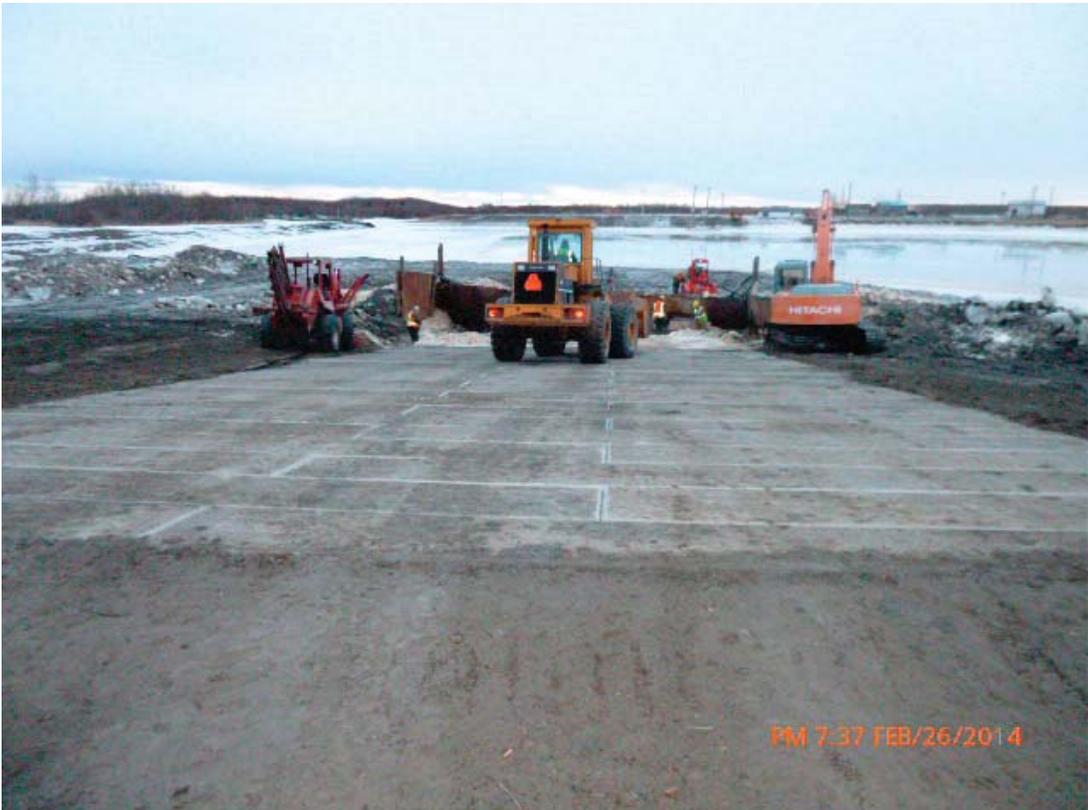
Replacement of the South Ramp, February 2014.
