**CRAIG HARBOR
ALASKA**
REVISED 2003

CRAIG HARBOR, ALASKA
(CWIS NO. 87246)

Condition of Improvement 30 September 2007

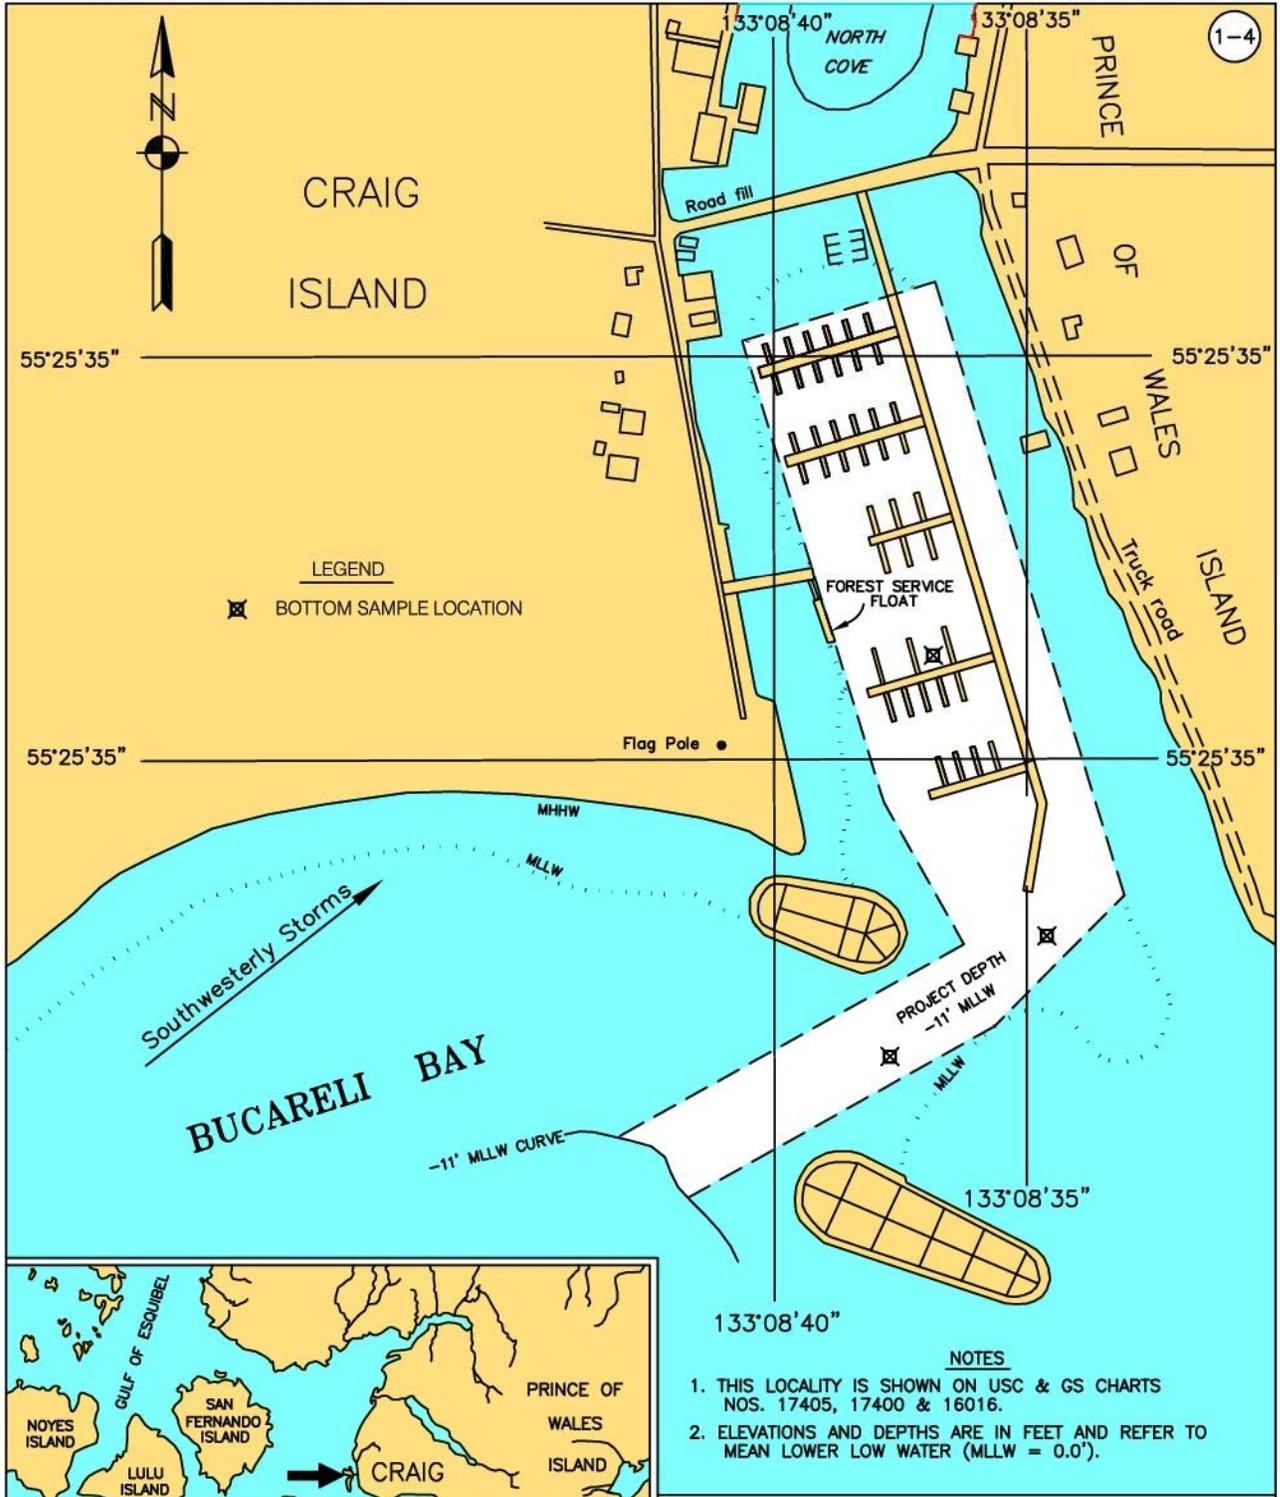
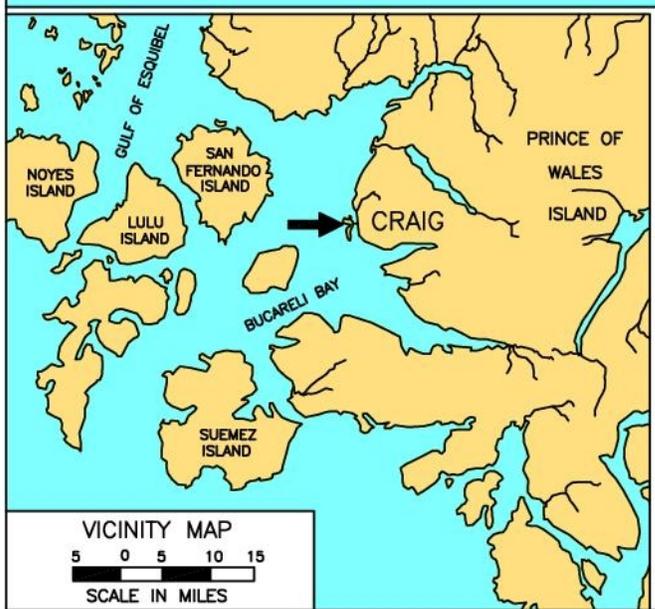
- NOTES**
1. THIS LOCALITY IS SHOWN ON USC & GS CHARTS NOS. 17405, 17400 & 16016.
 2. ELEVATIONS AND DEPTHS ARE IN FEET AND REFER TO MEAN LOWER LOW WATER (MLLW = 0.0').

EXISTING PROJECT:	<u>LENGTH</u>	<u>DEPTH</u>	<u>WIDTH</u>
• Basin	700 ft	-11 ft	225 ft
• Entrance Channel	500 ft	-11 ft	100 ft

CONTROLLING DEPTH: A depth of -9.4 feet MLLW appears to control in the entrance channel.

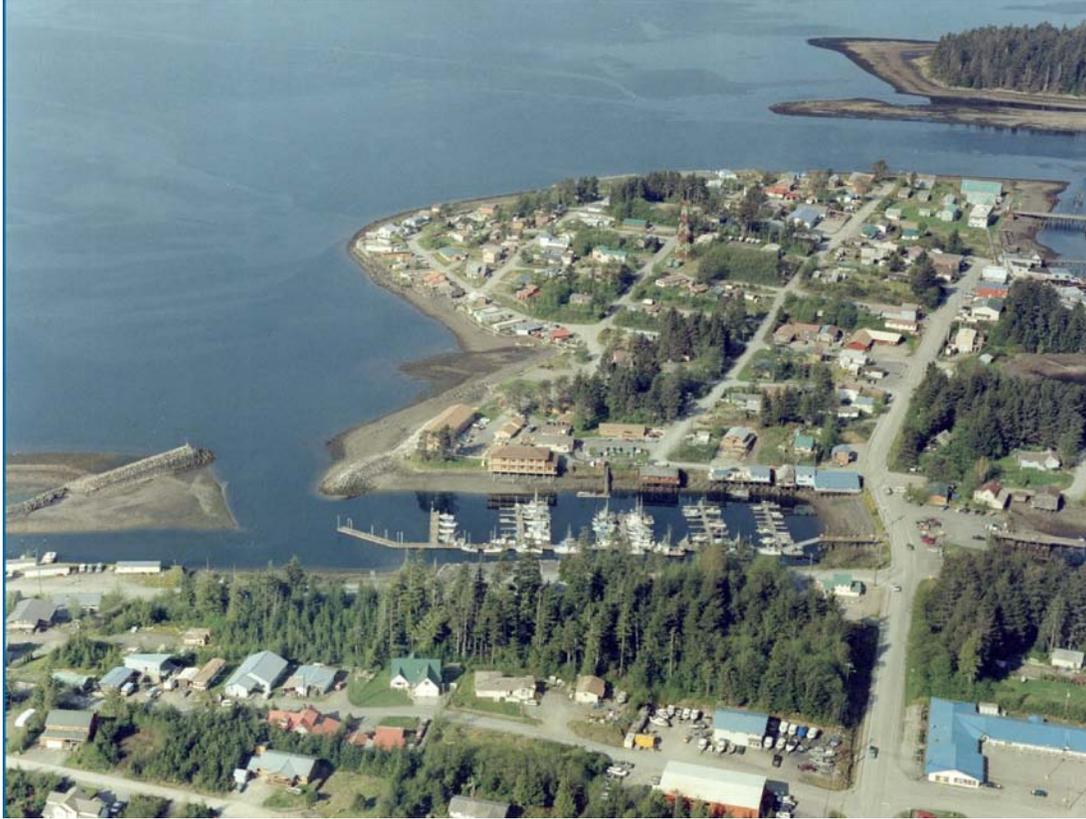
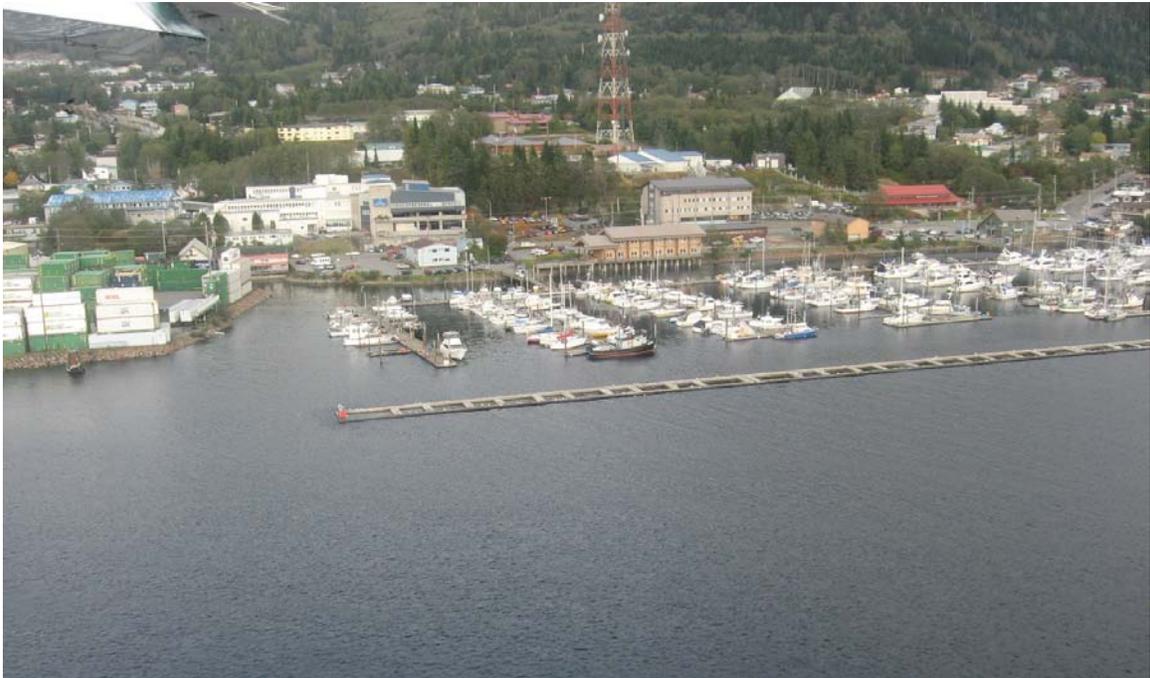
CRAIG HARBOR, CRAIG, ALASKA

Aerial photos of Craig Small Boat Harbor 2005.
