EGEGIK RIVER ALASKA

EGEGIK RIVER, ALASKA
(CWIS NO. 72792)

Condition of Improvement 30 September 1989

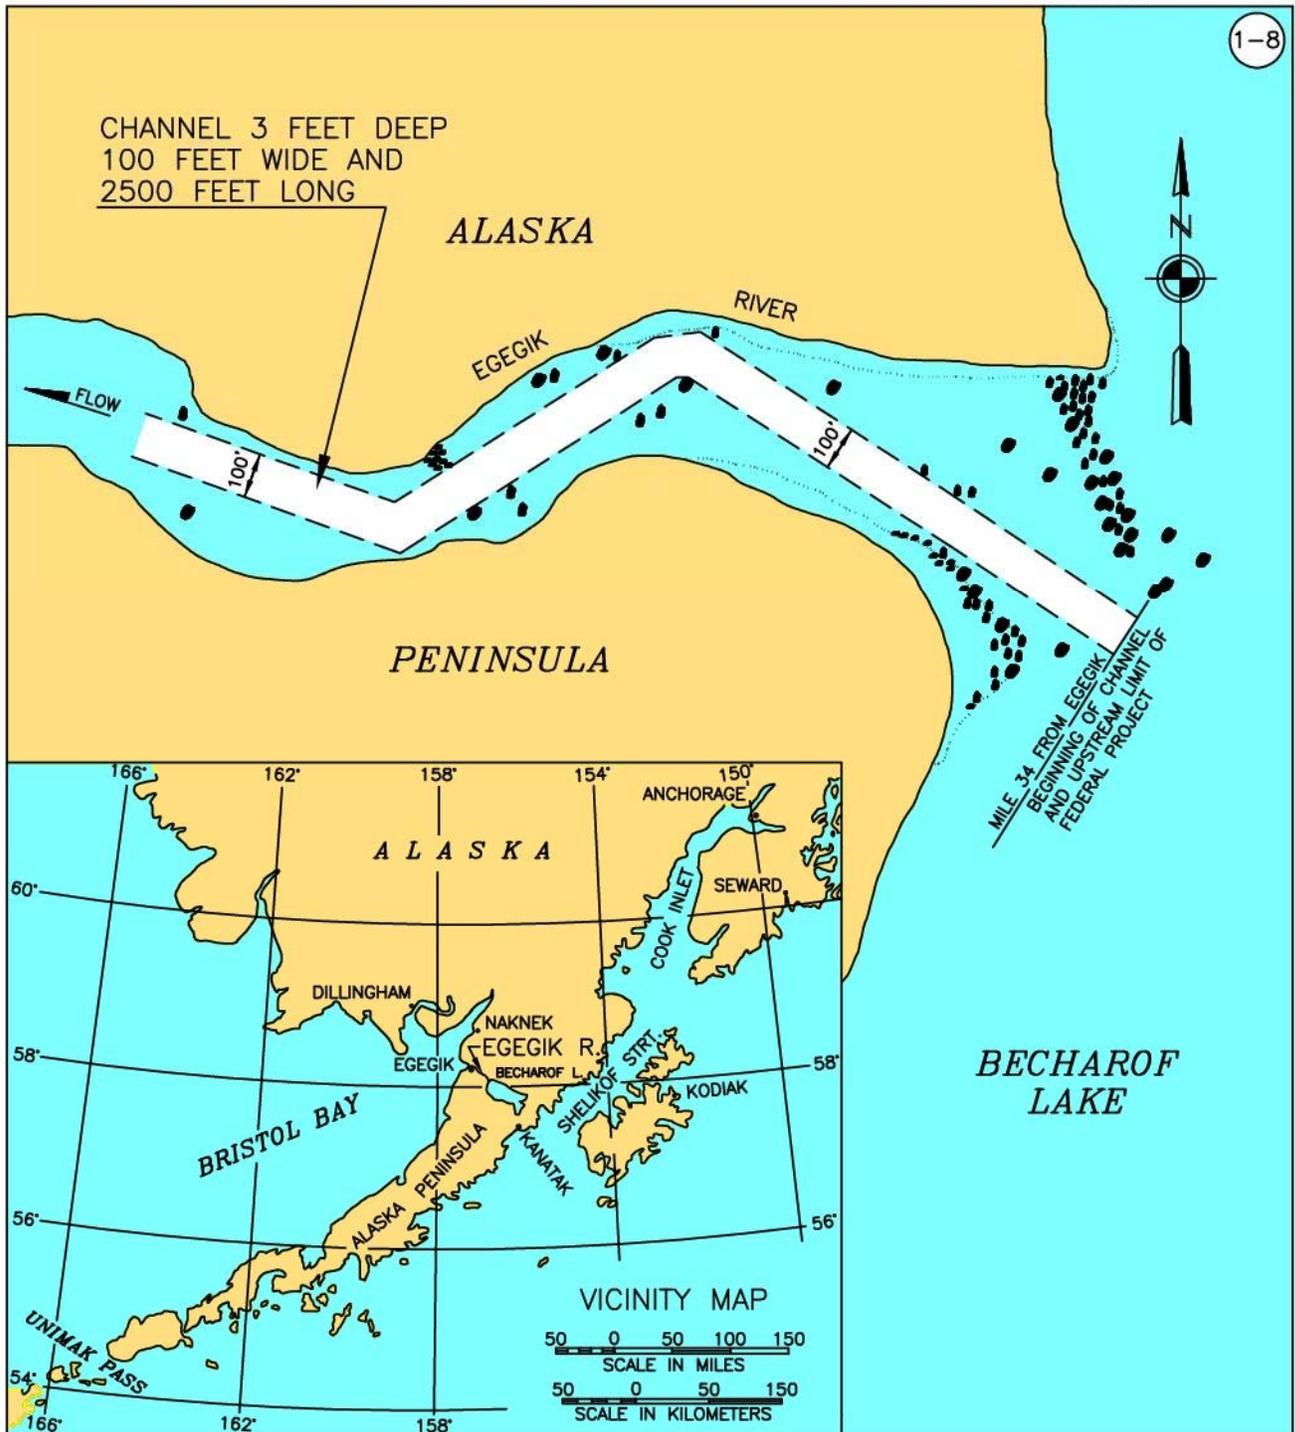
EGEGIK RIVER

1. BOULDER SIZES AND LOCATIONS ARE APPROXIMATE AND ARE SUBMERGED (1) TO (4) FEET BELOW SURFACE; BOULDERS ARE INDICATED WITH THE (●) SYMBOL.
2. ELEVATIONS AND DEPTHS ARE IN FEET AND REFER TO MEAN LOWER LOW WATER (MLLW = 0.0').
3. THIS LOCALITY IS SHOWN ON USC & GS CHART NO. 16323.

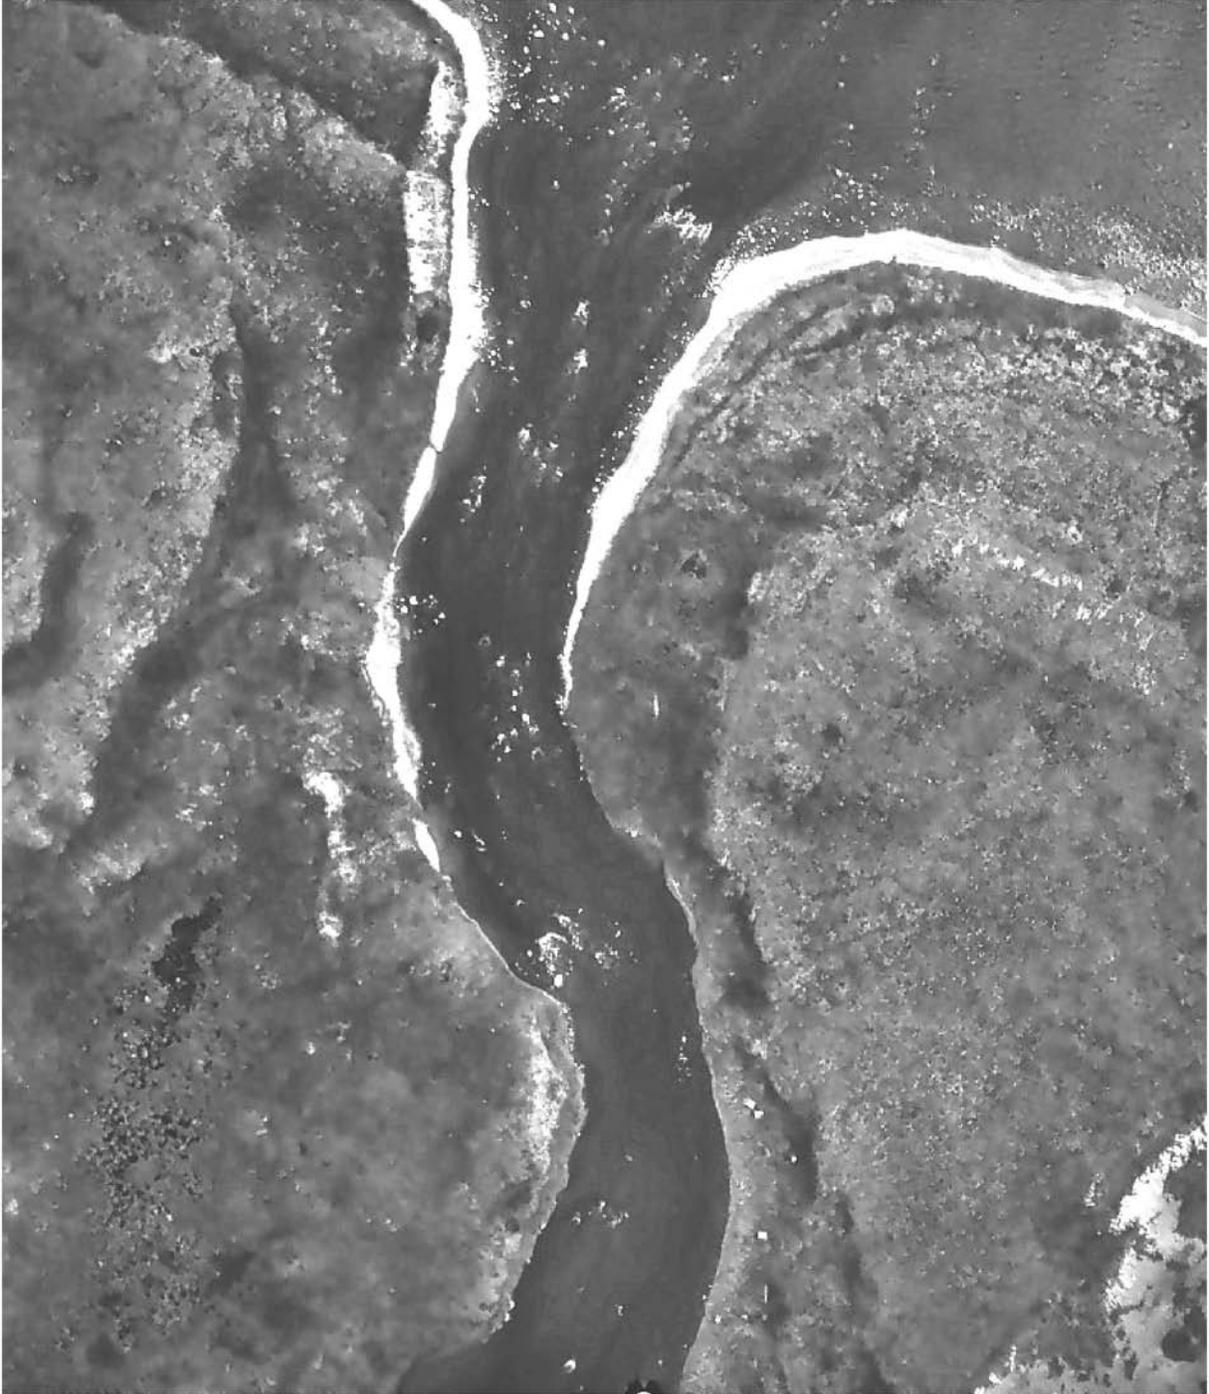
Looking down at the headwaters of the Egegik River. Becharof Lake is at the top, September 1985.
