OLD HARBOR

OLD HARBOR, ALASKA
(CWIS NO. 065017 & 154295)

Condition of Improvement 30 September 2010

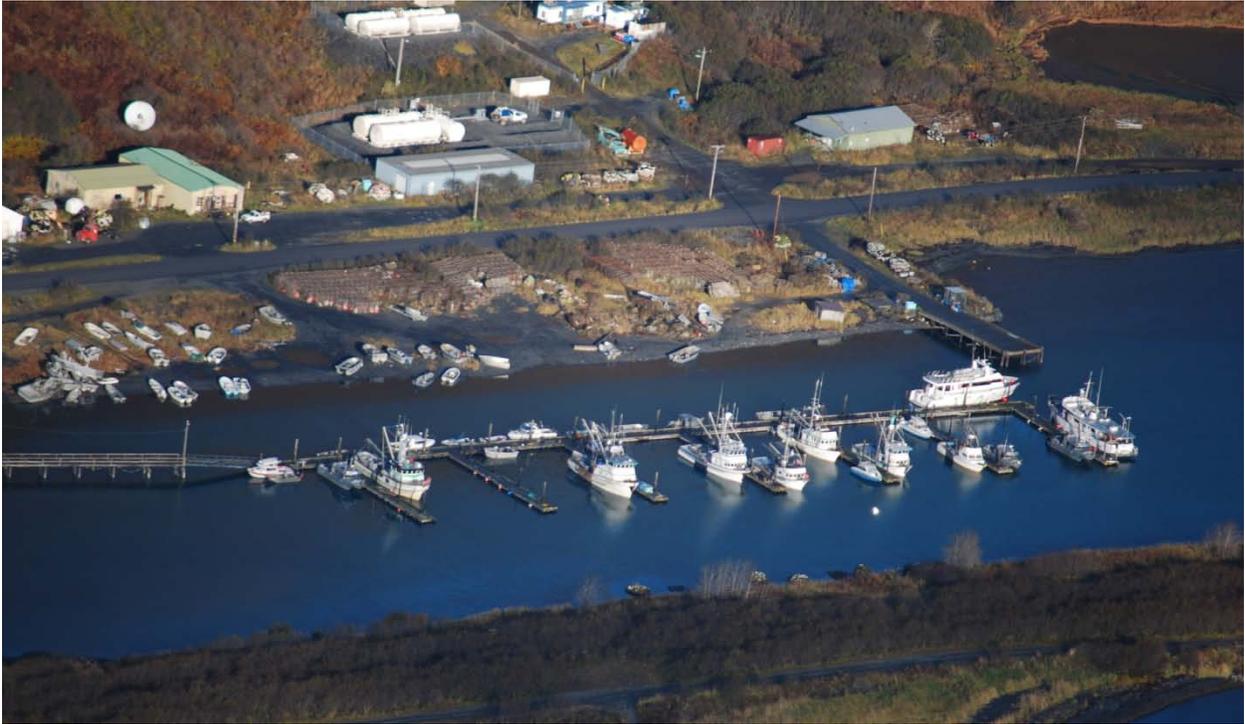
Aerial view of the harbor basin in 2009.

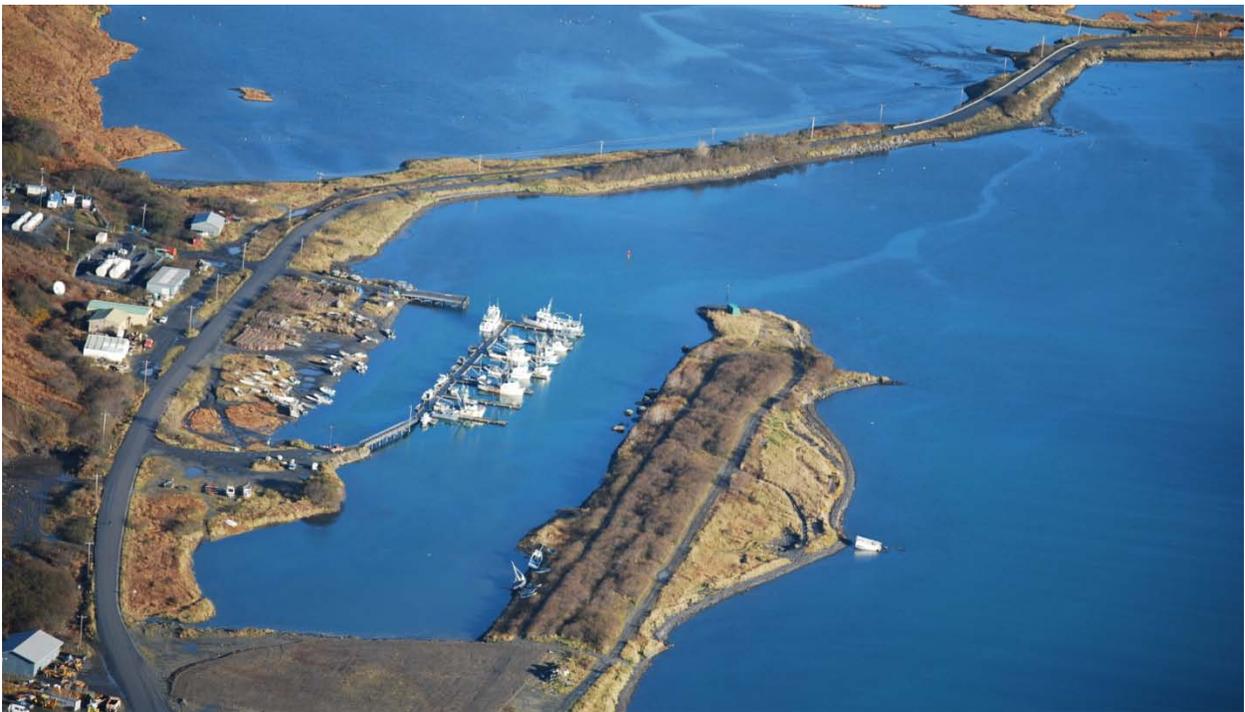
Aerial view of the harbor and entrance channel in 2009.

- 2009 - A tidal datum update study and project condition survey are conducted in August and September.
- 2010 - NOAA officially establishes a tidal datum for the community in June. Tying in the 2009 condition survey to the new datum reveals entrance channel elevations to be approximately -3 ft MLLW; about 5 ft. higher than it was previously. The absence of an accurate tidal datum determination originally, a rise of the ocean floor, and concern that the entrance channel may have never been dredged to its authorized depth originally are likely contributions to the difference.
