Petersburg Harbor

PETERSBURG HARBOR ALASKA

Condition of Improvements
 30 December 2014
Petersburg Harbor, Alaska
 (CWIS No. 072759)

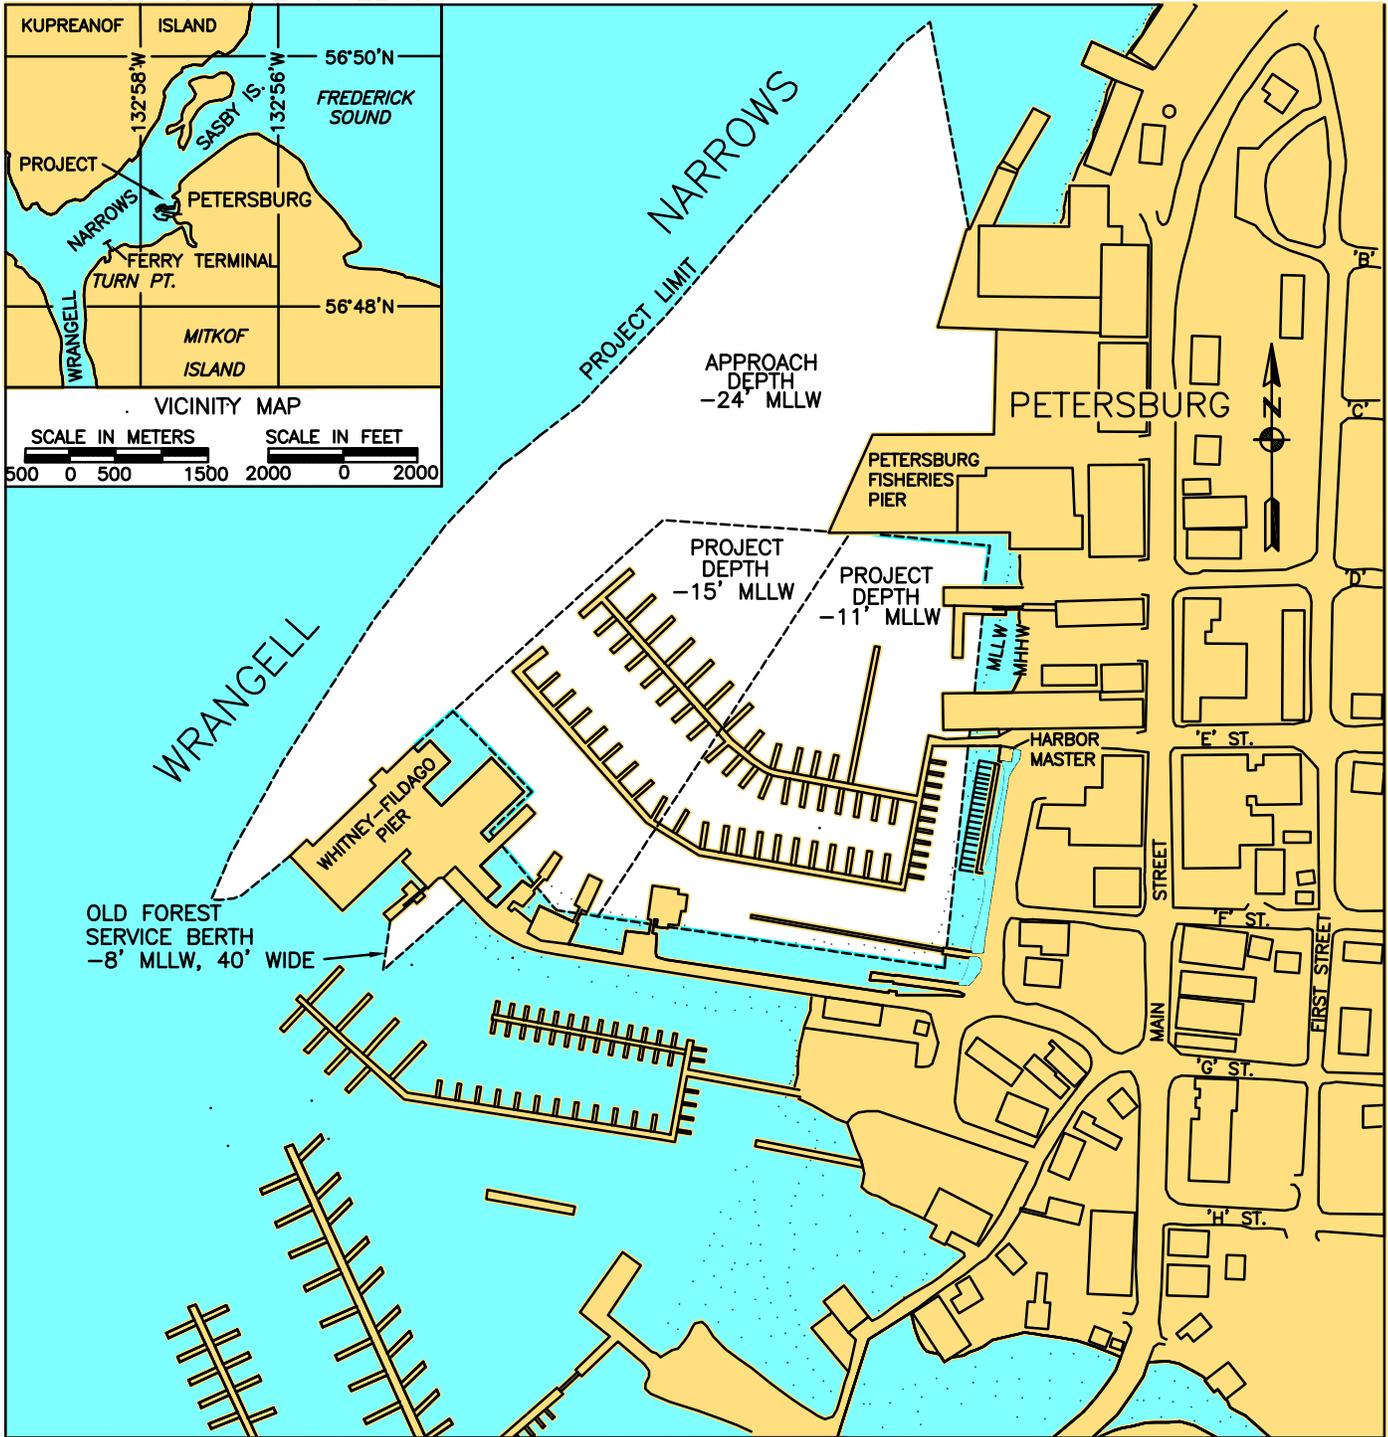
Controlling Depth Shoaling is apparent around the vessel berths in both the -15 and -11 foot areas. Shoaling is also apparent along the entire southern portion of the project limits. -7.4 feet MLLW controls in the vessel berths, May 2008.

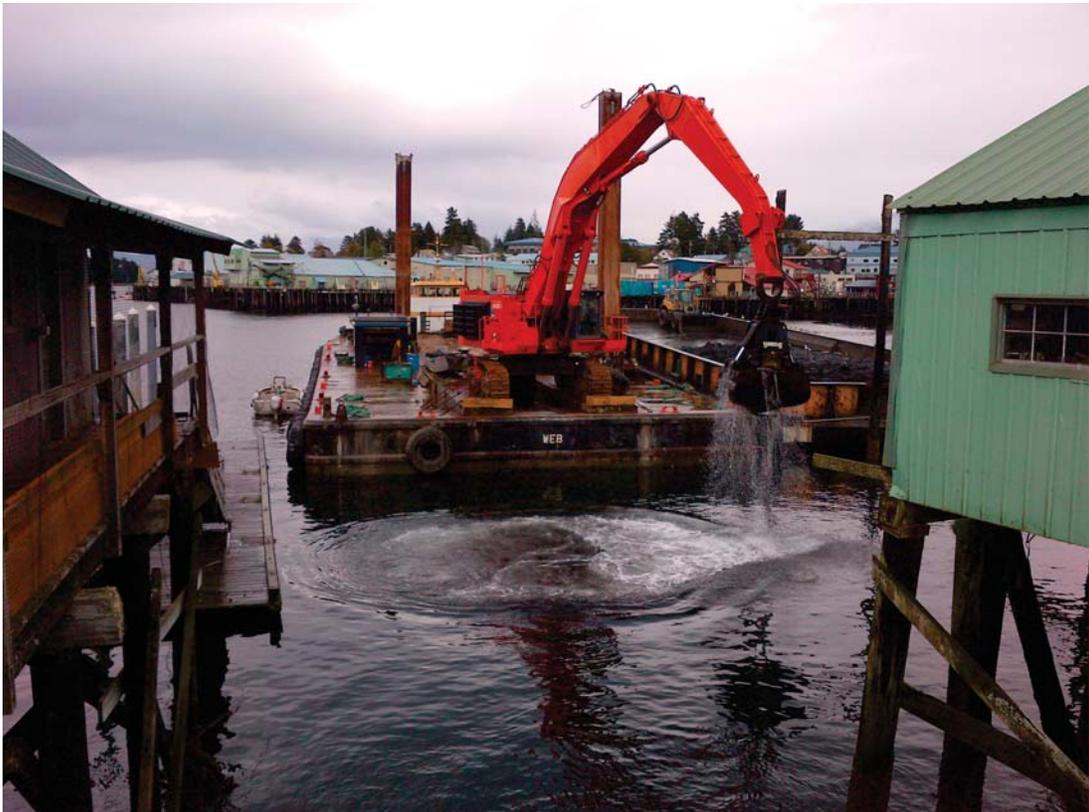
Dredging operations in Petersburg Harbor, 1 October 2013.

2011	A project condition survey was conducted in September.
2012	A contract was awarded to S&S Construction for mechanical dredging of the harbor.
2013	USACE Comprehensive Evaluation of Project Datums (CEPD) Compliance report completed and recorded in April.
