Nome Harbor

Condition of Improvements
31 December 2022
Nome Harbor, Alaska
(CWIS No. 010422, 012270, 072742, 087755)

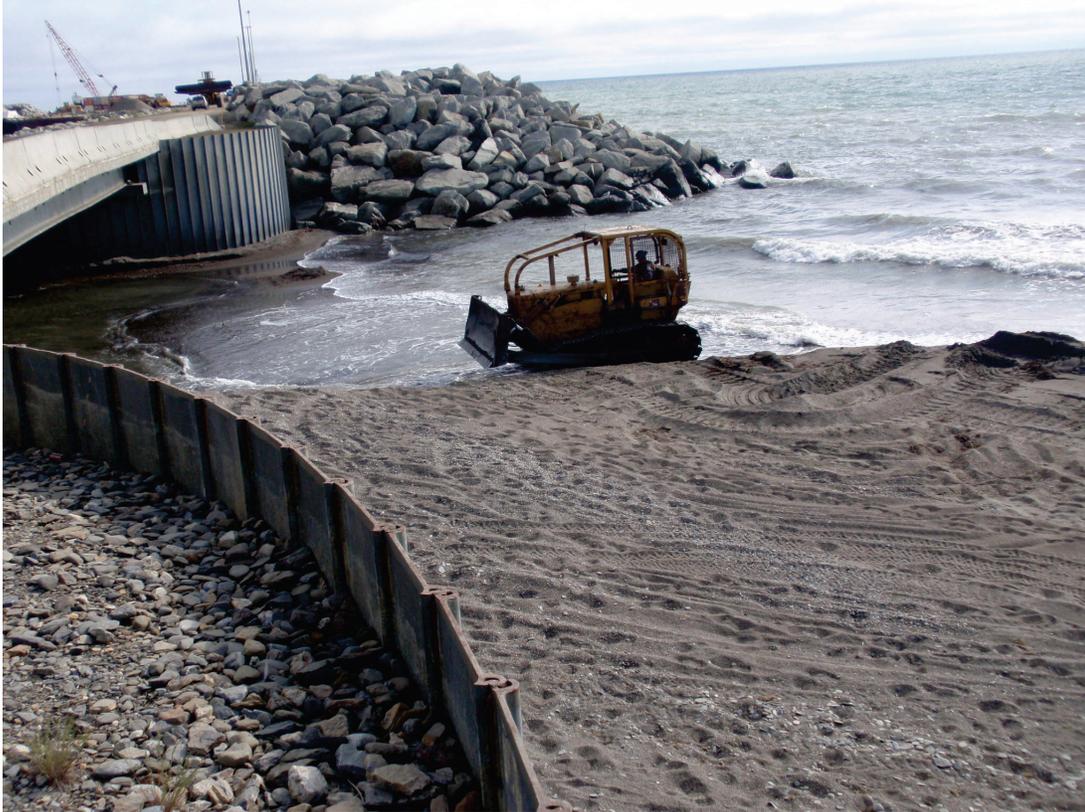
Pushing material under the causeway bridge towards the sediment trap, June 2019

- 2019 The biennial inspection found the causeway bridge in satisfactory condition. The harbor was ice free in mid-May, nearly a month earlier than normal. The shoal under the causeway bridge did not wash out from a winter storm. As a result, the maintenance dredging contract was modified to remove approximately 3,400 cubic yards under the bridge. A small bulldozer pushed the material to the cutterhead pipeline dredge which worked its way into the bank from the east sediment trap. Maintenance dredging was completed in late June removing 31,530 cubic yards. All dredged material was placed in the designated location for beach nourishment. A site visit in August finds the causeway breach shoaled.

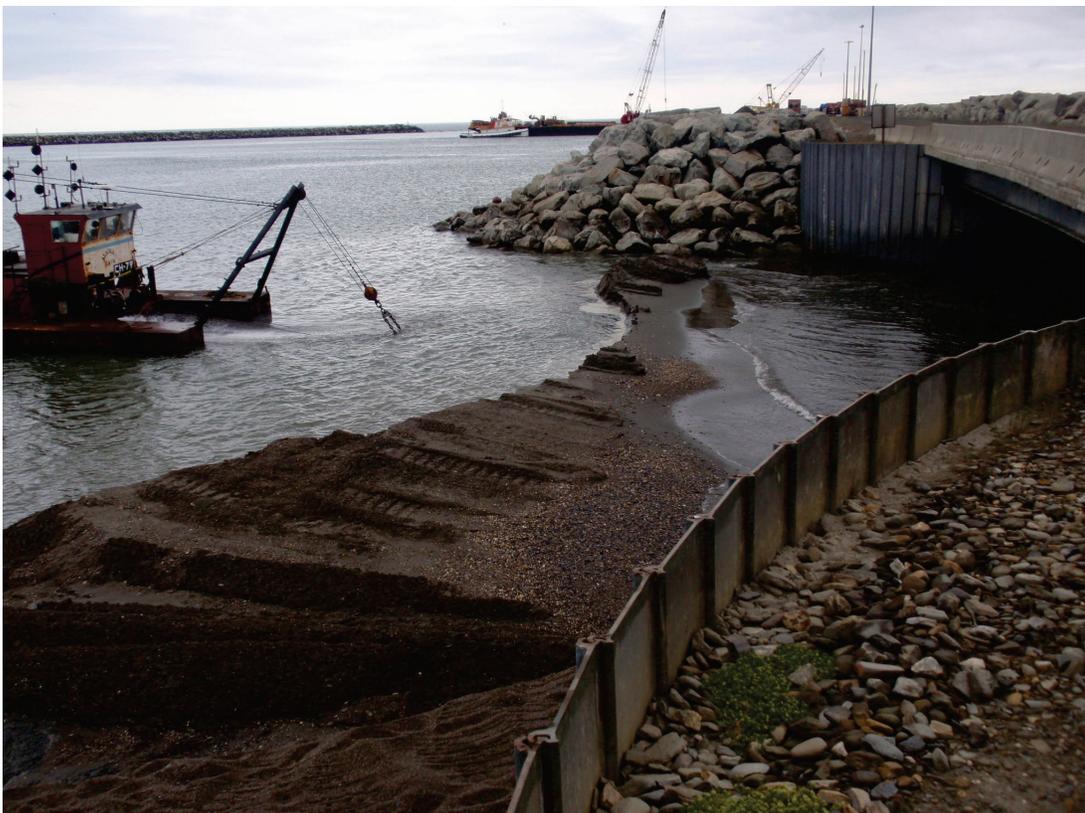
Dredging shoaled material near the sediment trap and causeway breach, June 2019
