ALASKA BASELINE EROSION ASSESSMENT

Erosion Information Paper - Ivanof Bay, Alaska

Current as of March 4, 2008

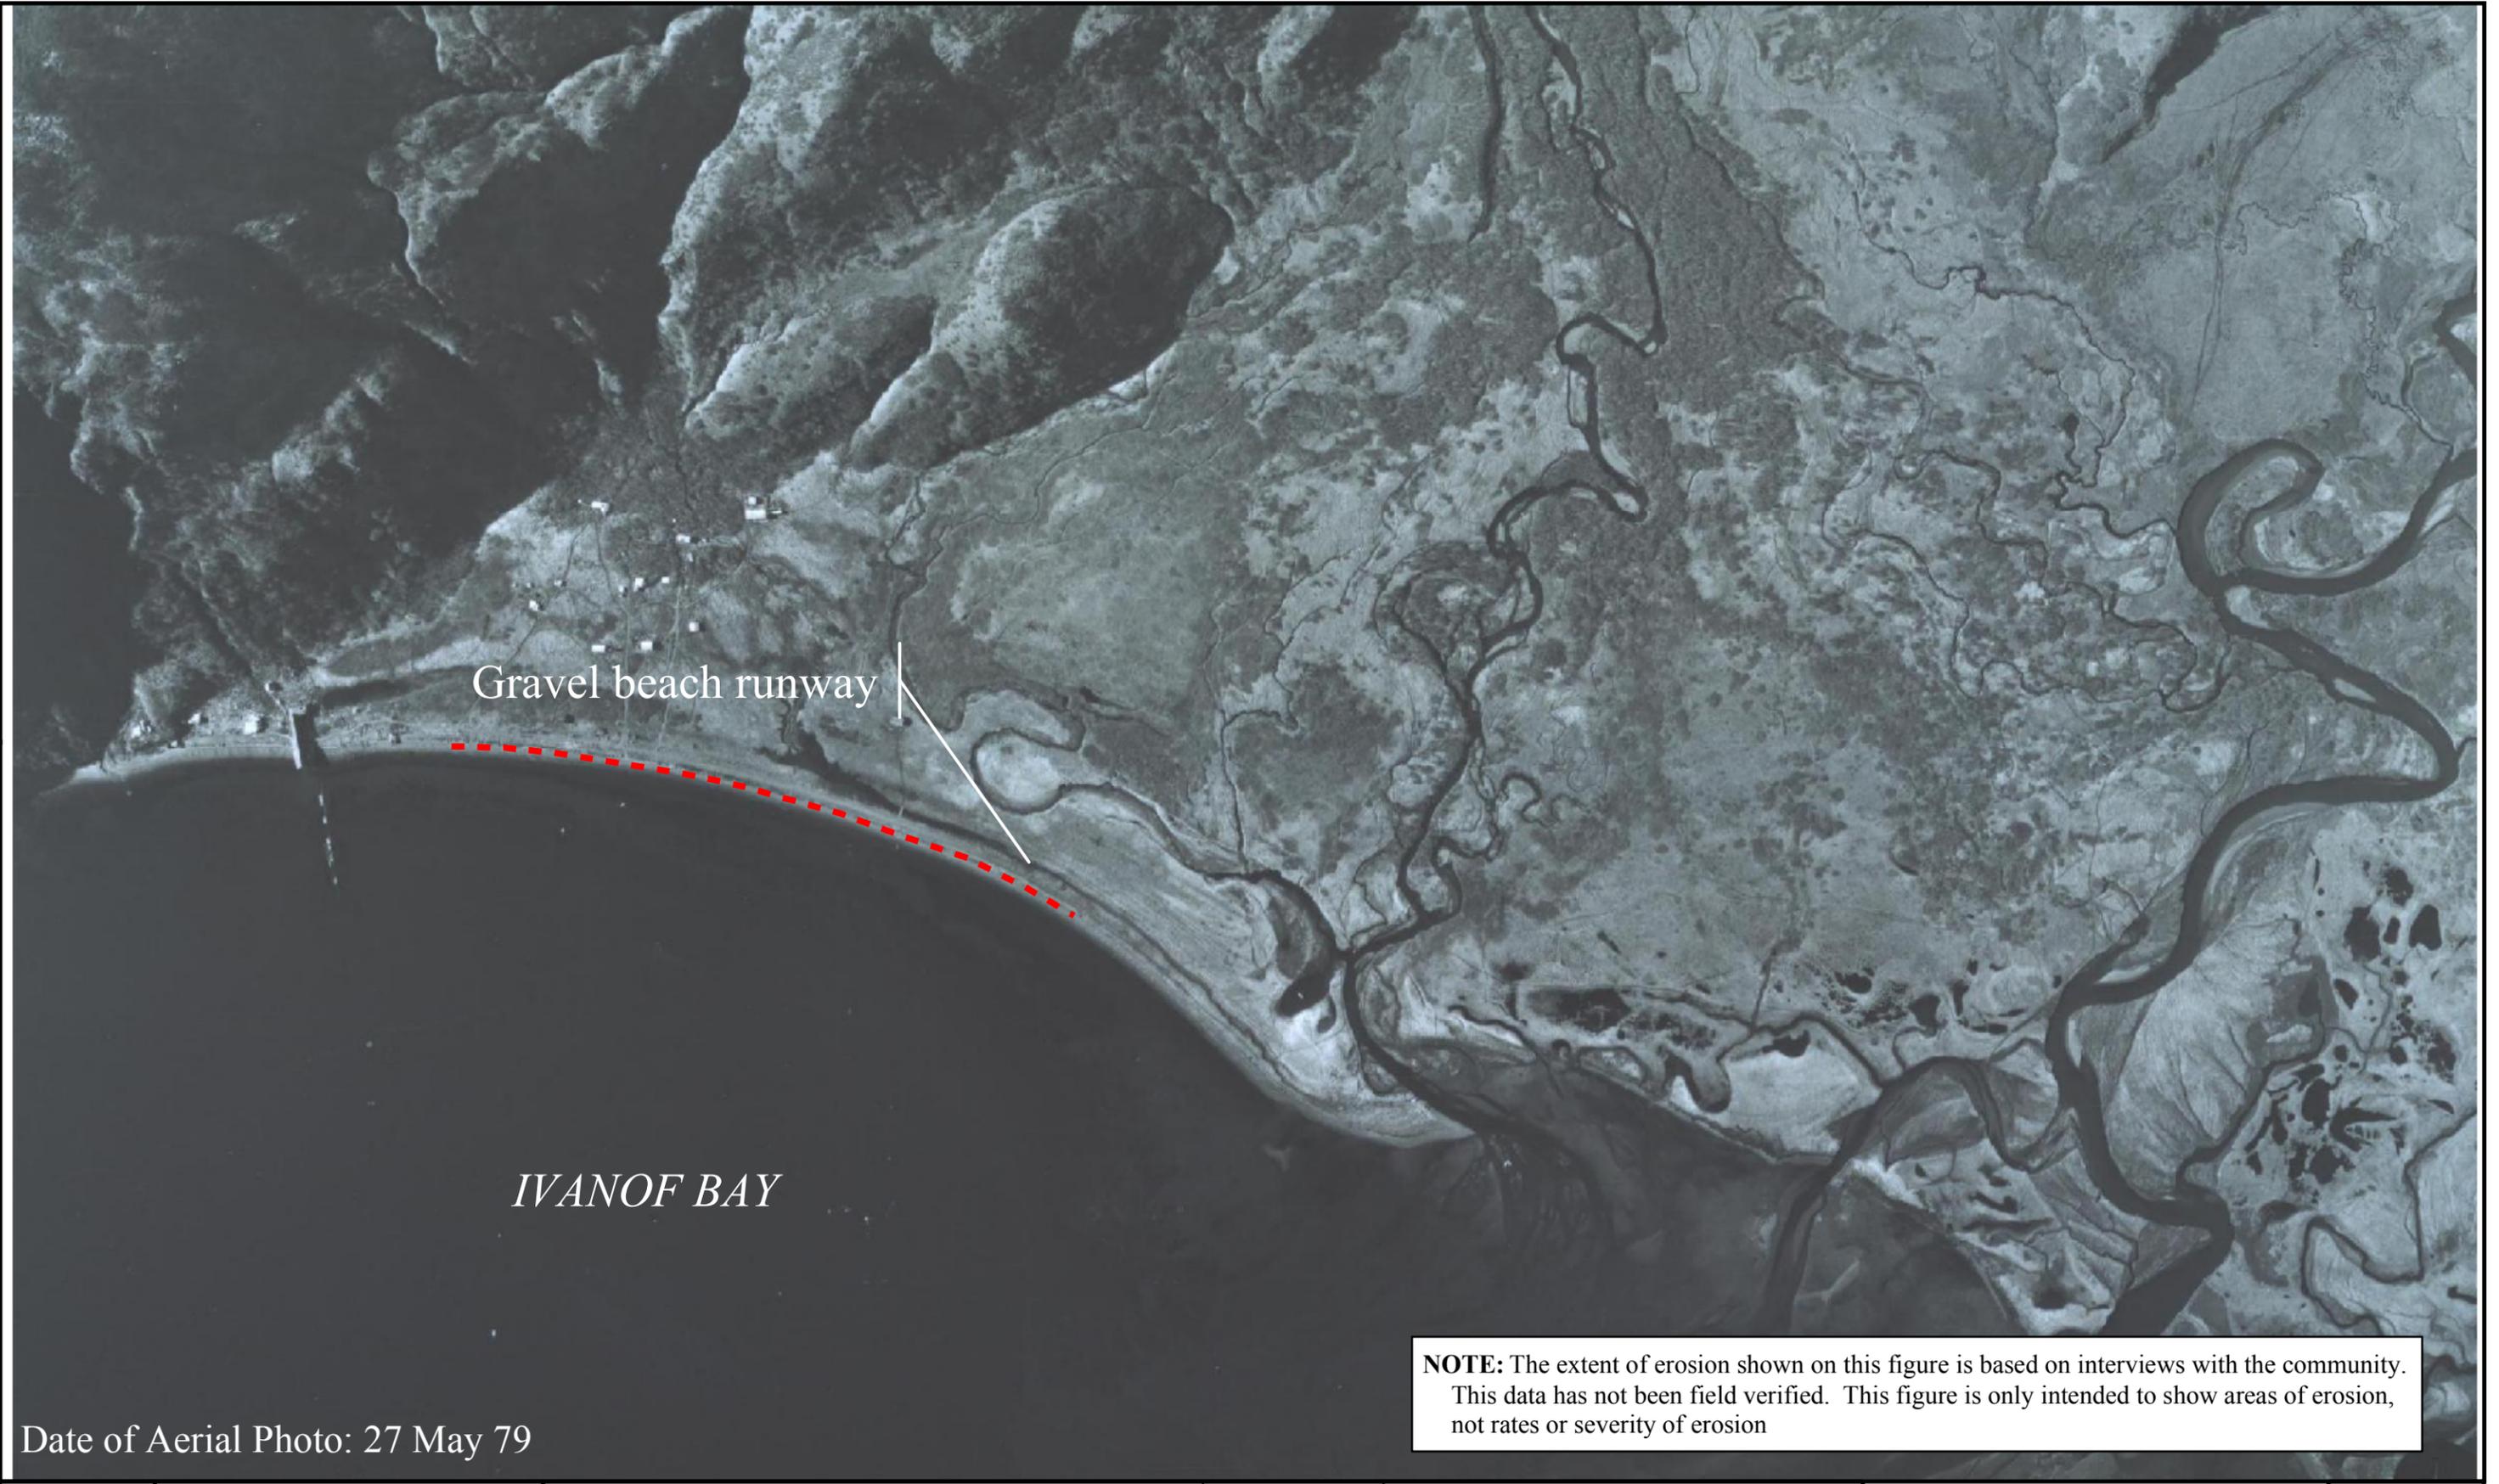
Date of Aerial Photo: 27 May 79

No photos were provided by community or other sources. The attached diagram shows the linear extent of erosion.

- - - - Linear Extent of Erosion
