U.S. Army Corps
of Engineers
Alaska District

ALASKA BASELINE EROSION ASSESSMENT

Erosion Information Paper – Port Lions, Alaska

Current as of March 18, 2008

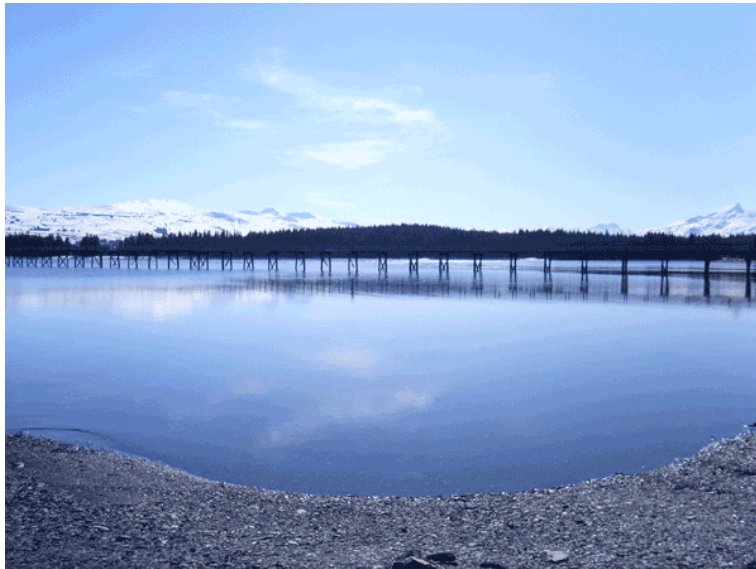
Photo 1: Port Lions causeway across Settler Cove. Photo courtesy of Native Village of Port Lions, No photo date available.

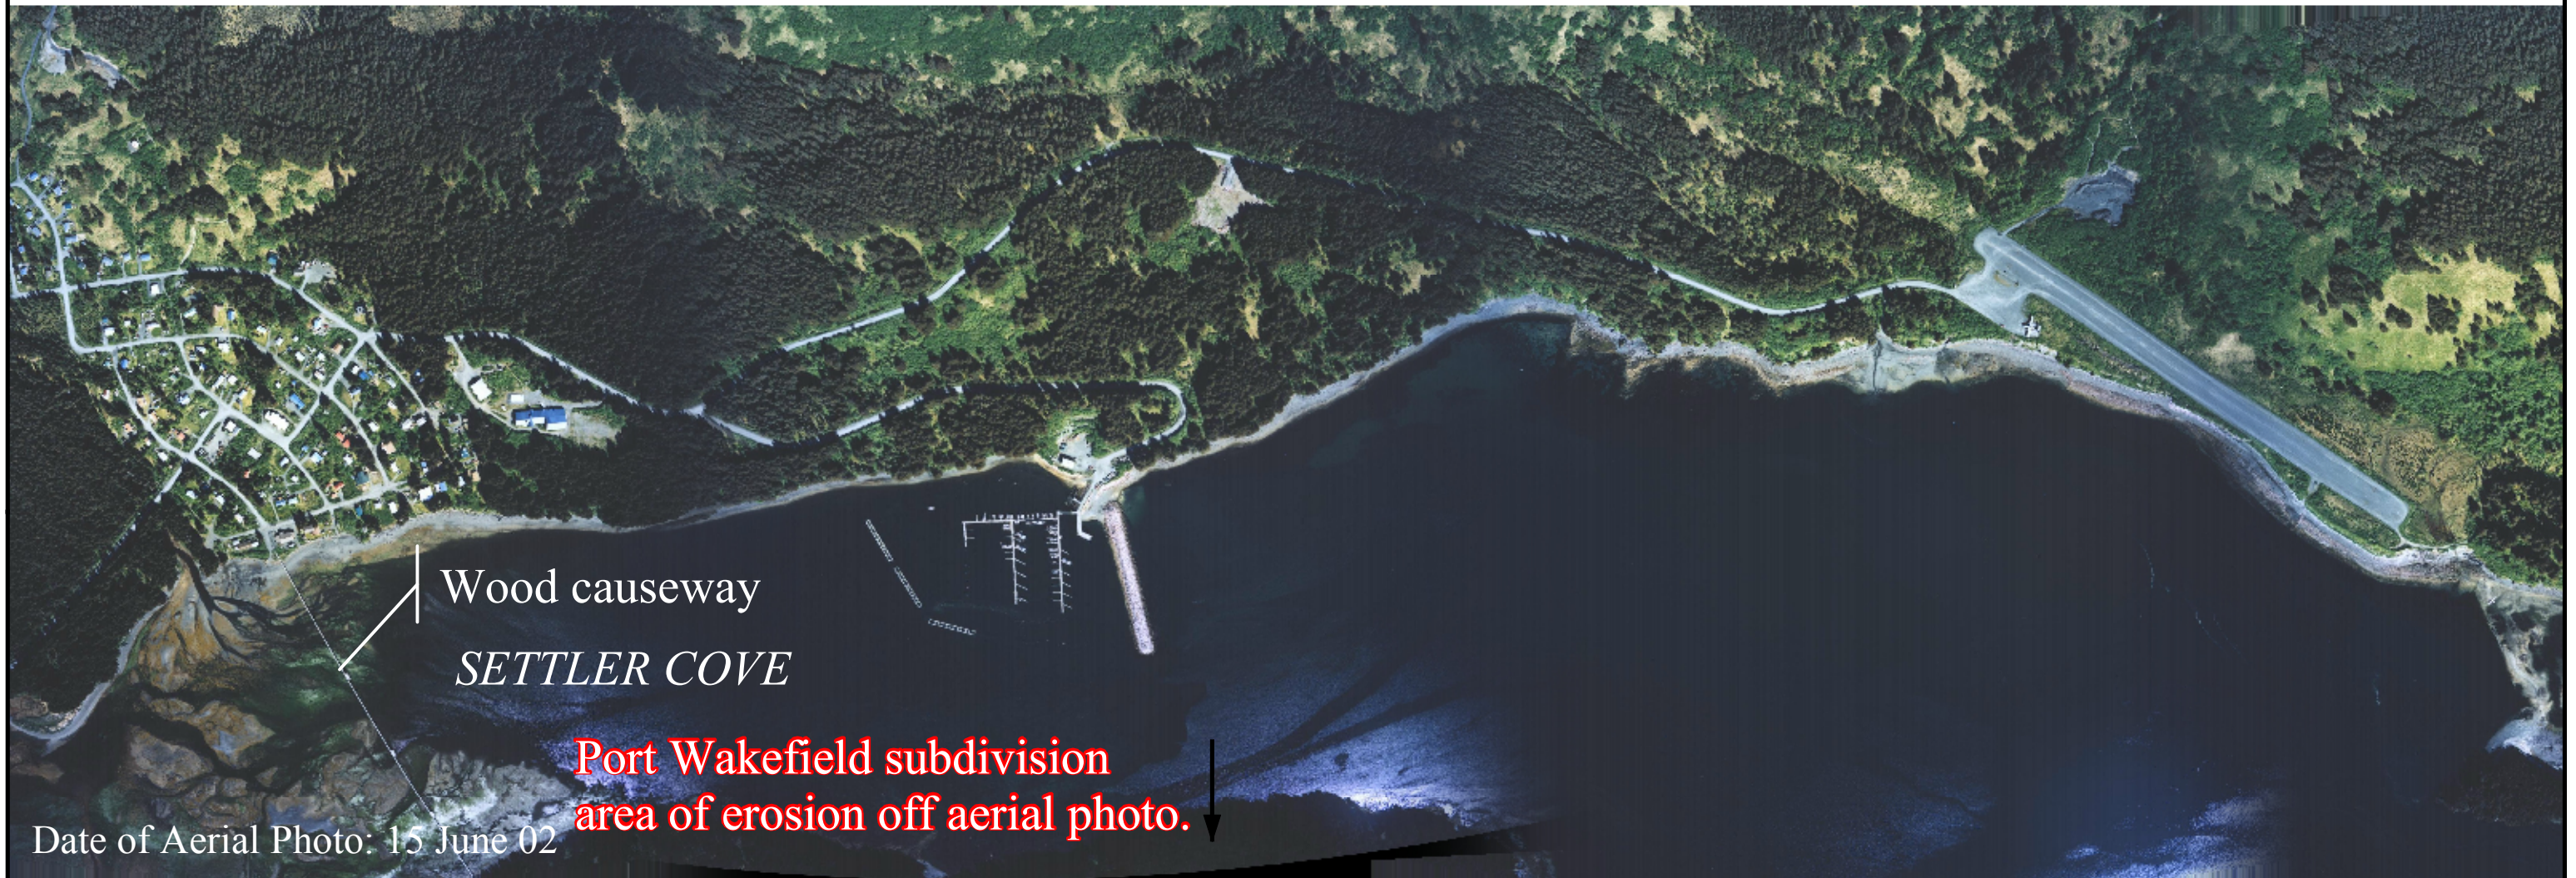
--- Linear Extent of Erosion

The shoreline is eroding adjacent to Settler Cove in the Port Wakefield subdivision of the community. Storm surges, high tides, and wind-driven waves reportedly cause and contribute to erosion. The shoreline is being undercut, and the undercut areas drop into the cove. A 2005 Corps *Navigation Improvements Feasibility Report* stated that east and southeast waves impact the Port Wakefield area. The eroding shoreline area was reported at 5 to 7 feet high and approximately 1 mile long with the rate of erosion around 3 feet per year.

NOTE: The extent of erosion shown on this figure is based on interviews with the community. This data has not been field verified. This figure is only intended to show areas of erosion, not rates or severity of erosion
