# DECISION DOCUMENT

Hazardous, Toxic, and Radioactive Waste

Project # F10AK0243-08

Umiat Air Force Station

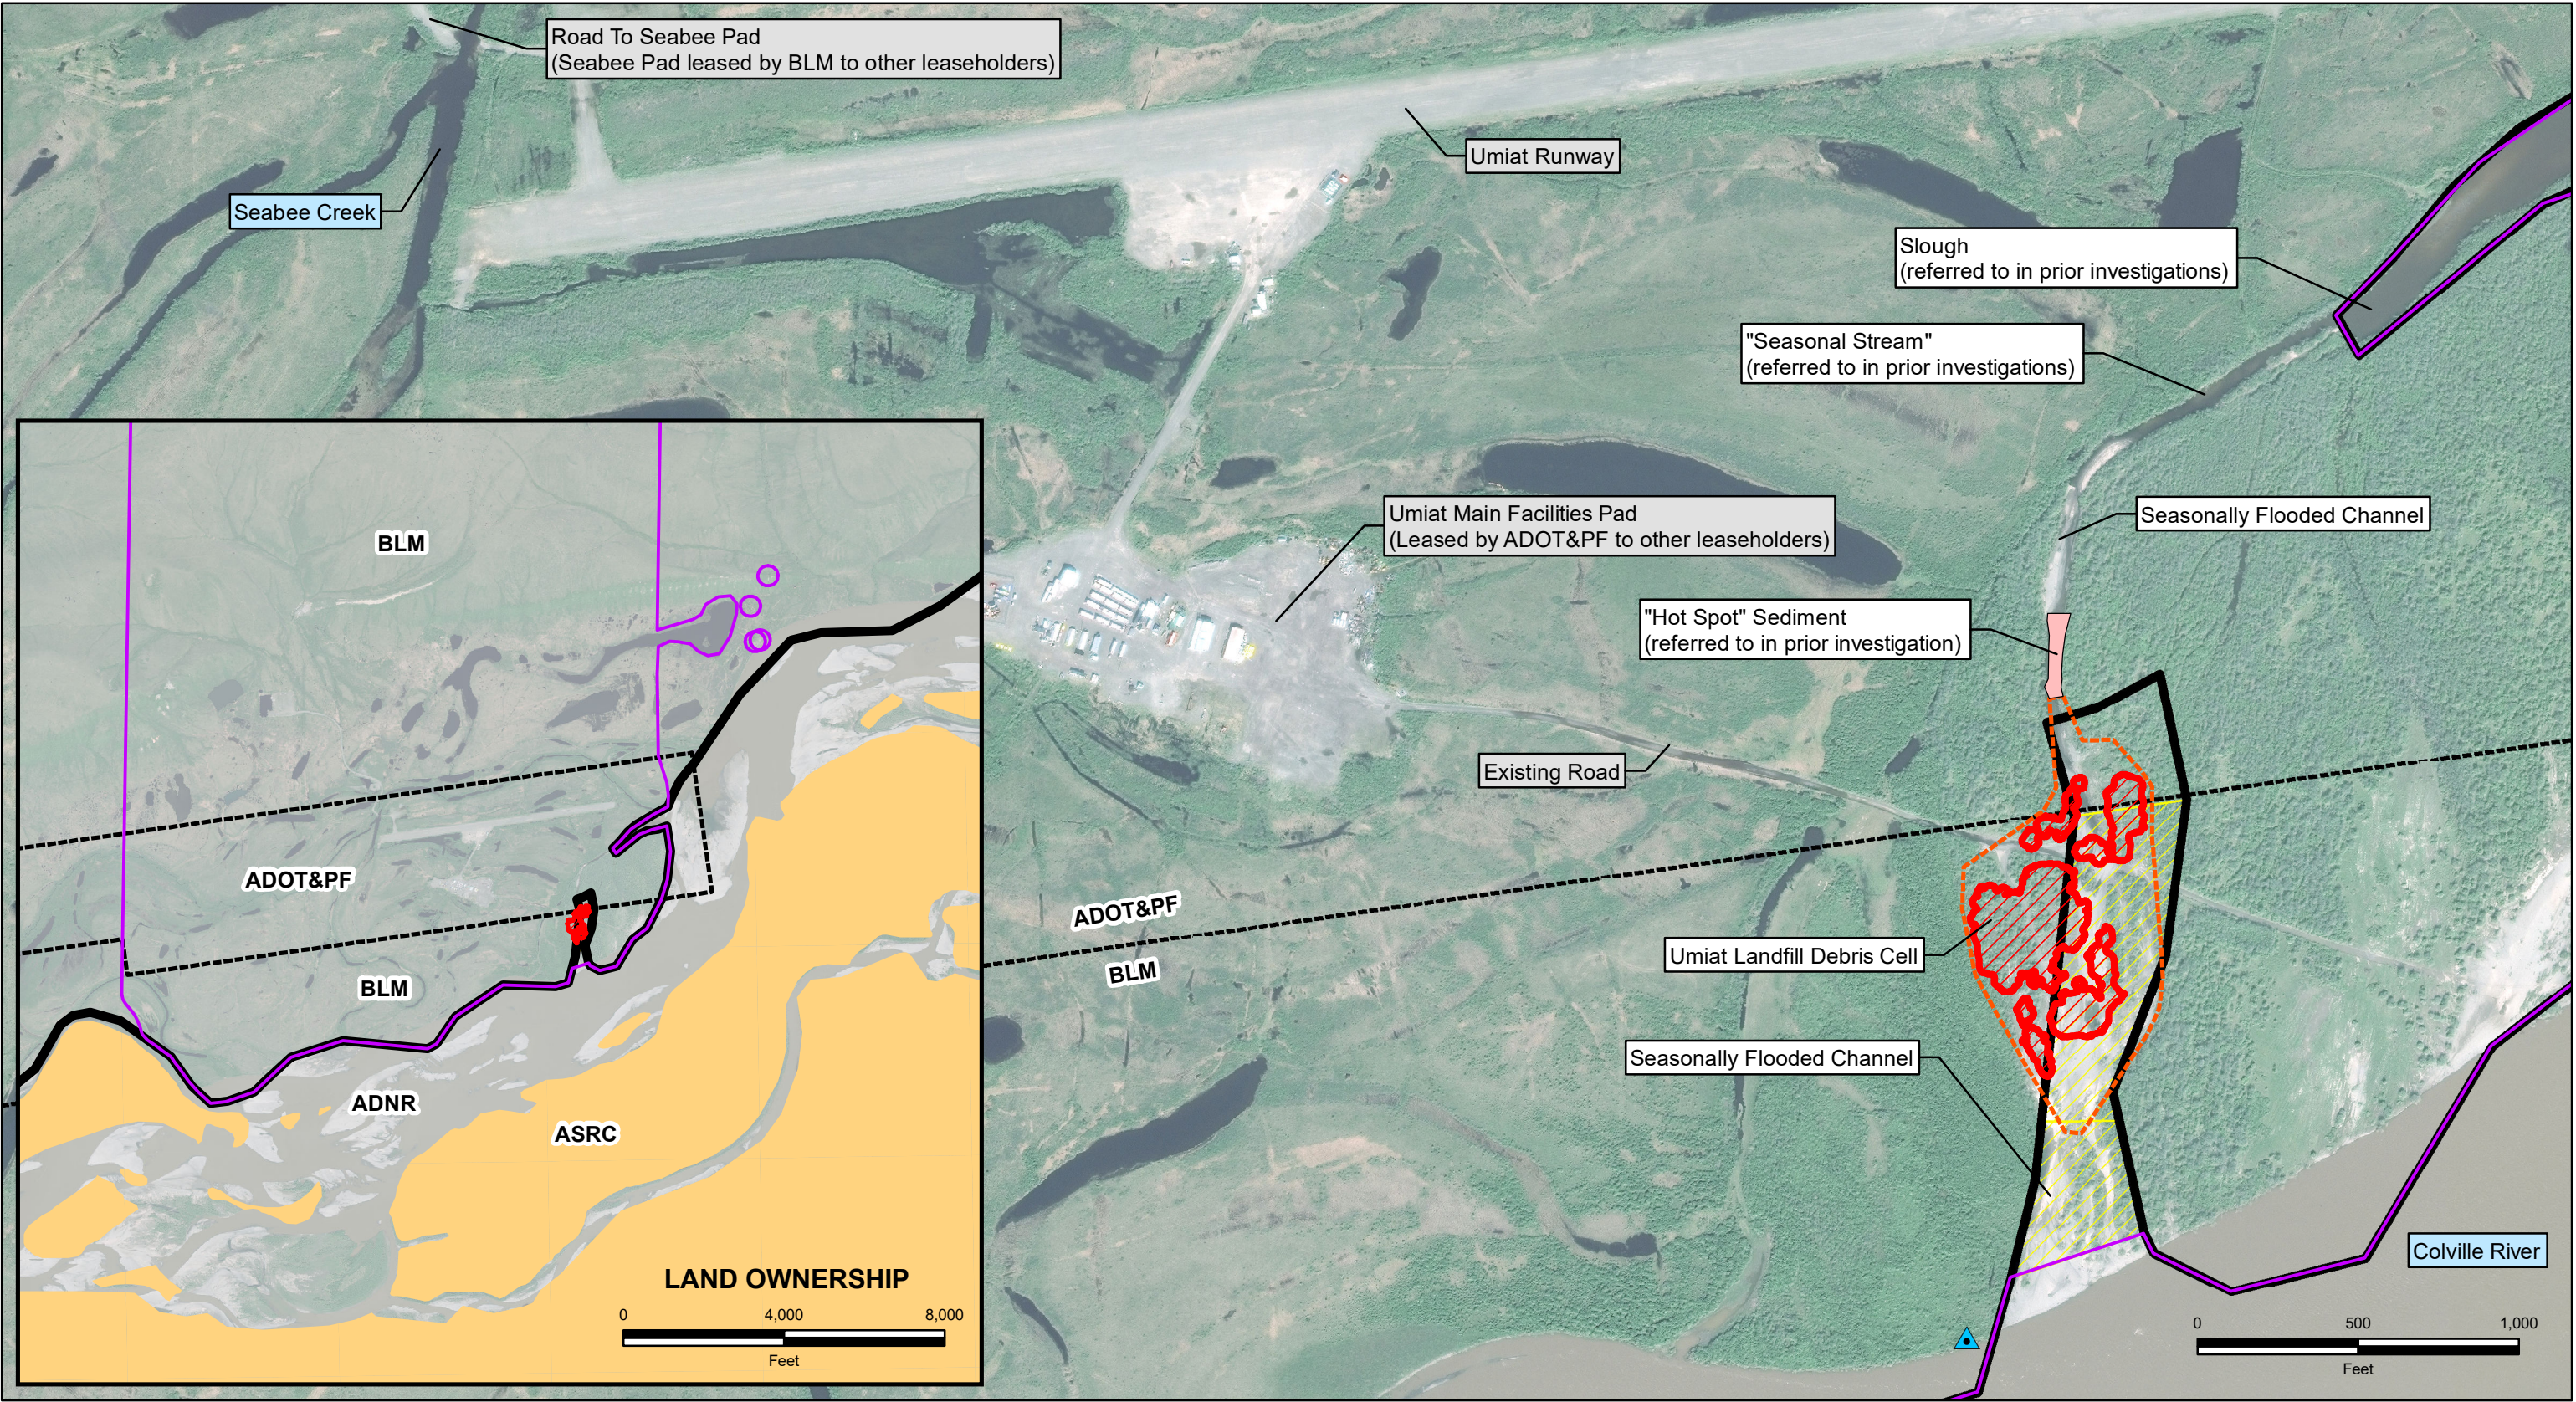
- NPRA Boundary
- Land Owned by ADOT&PF
- Land Owned By ASRC (ANCSA)
- Umiat AFS FUDS Property Boundary
- BLM Land (State Selected)

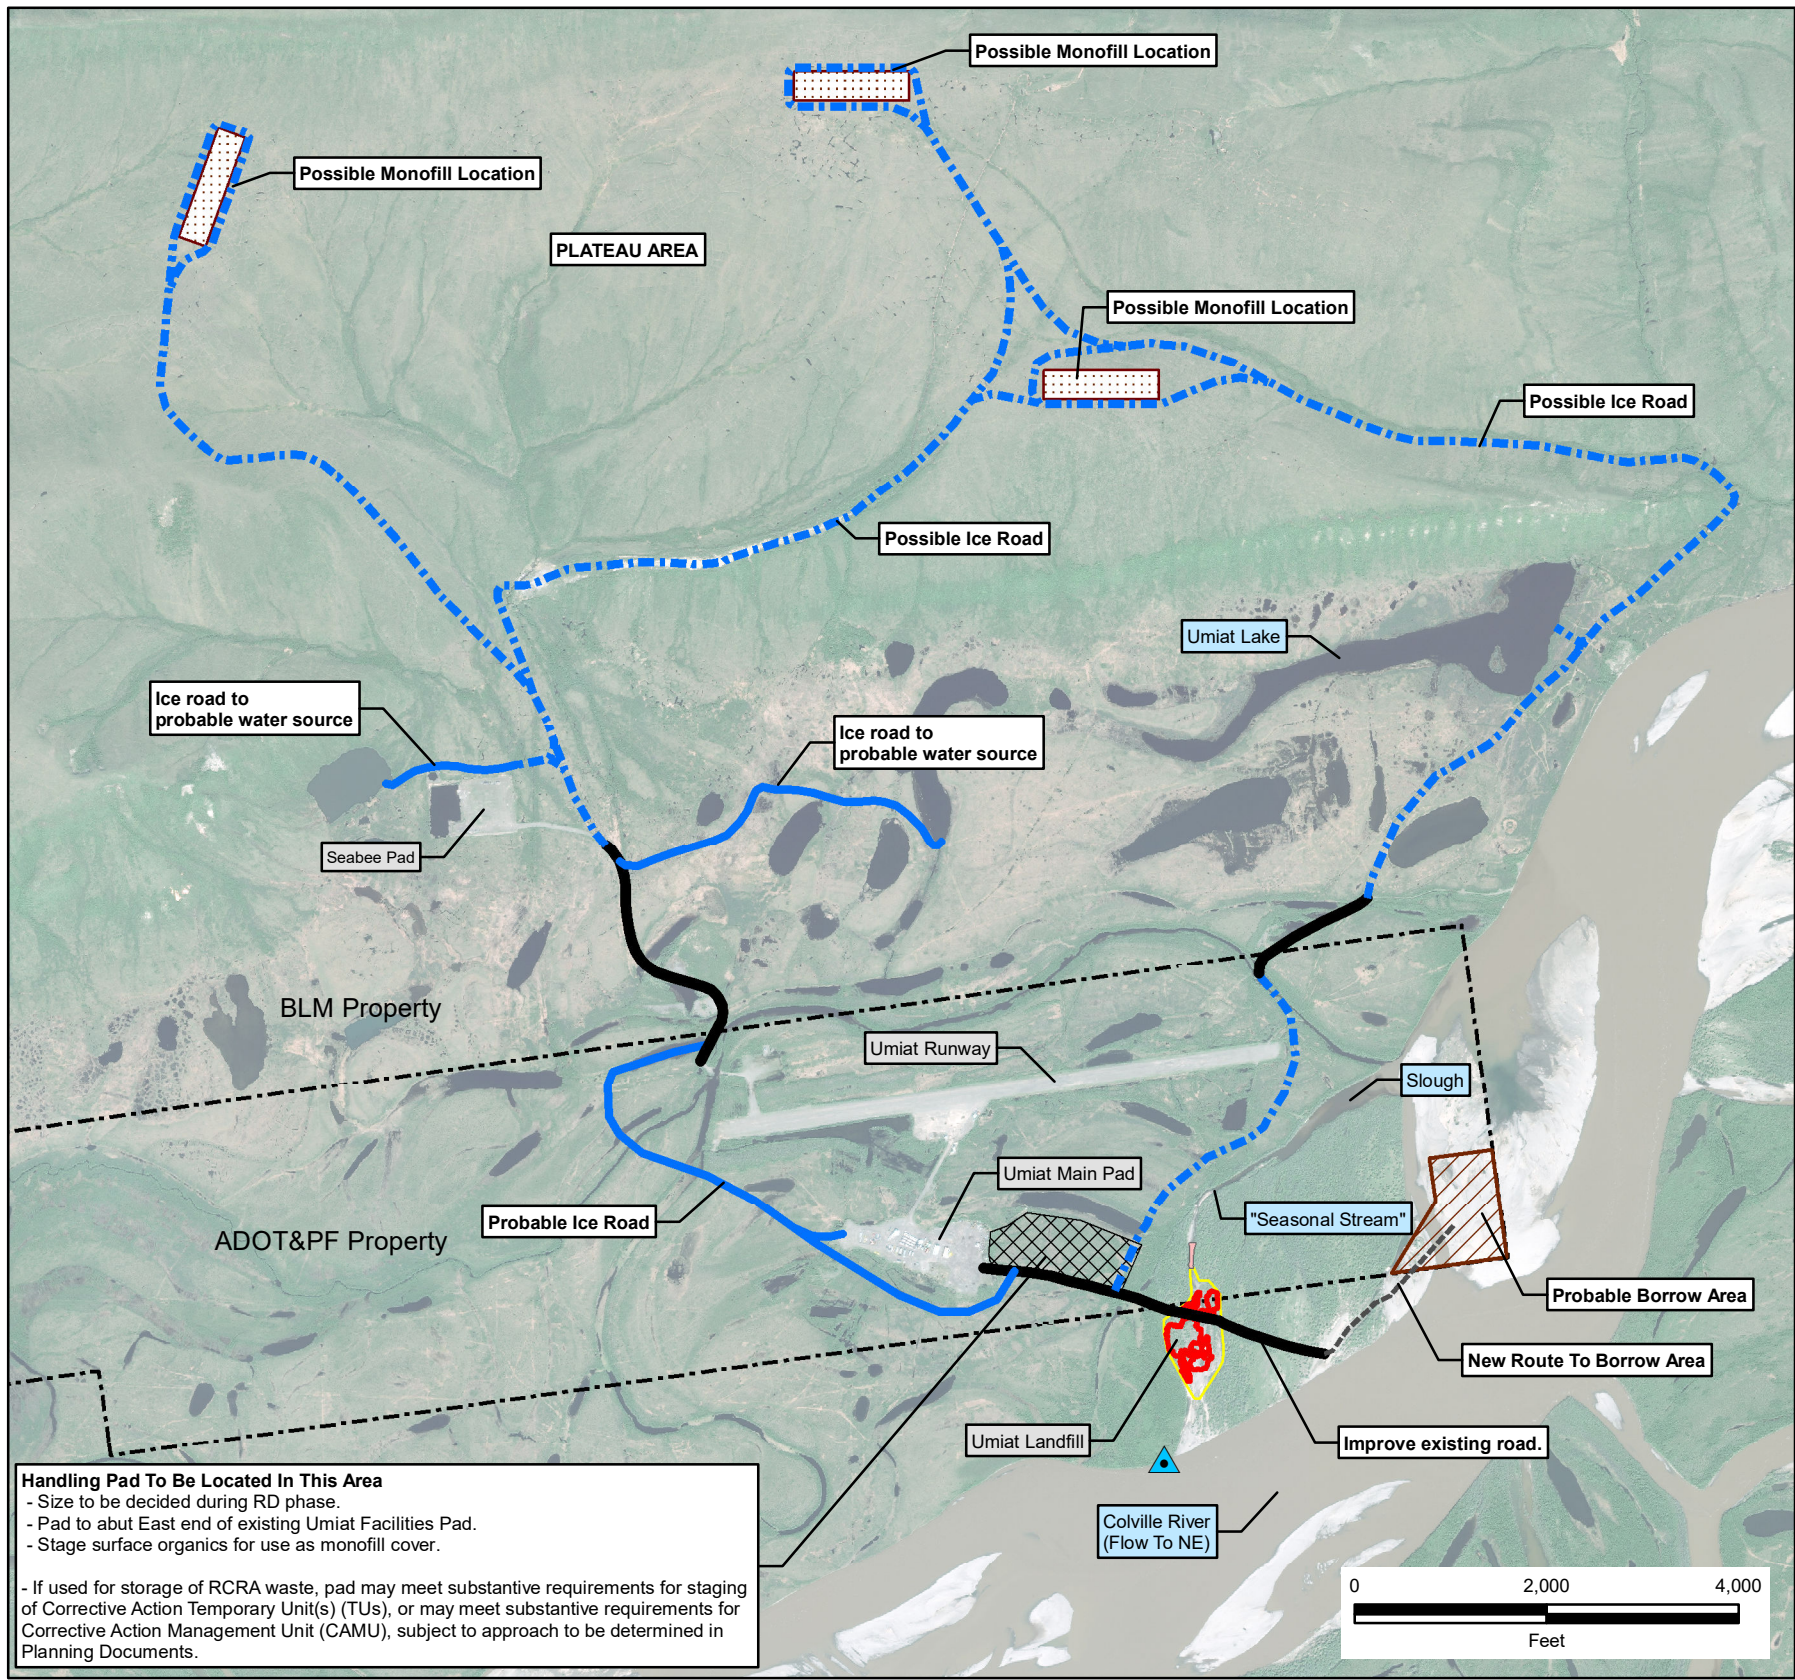
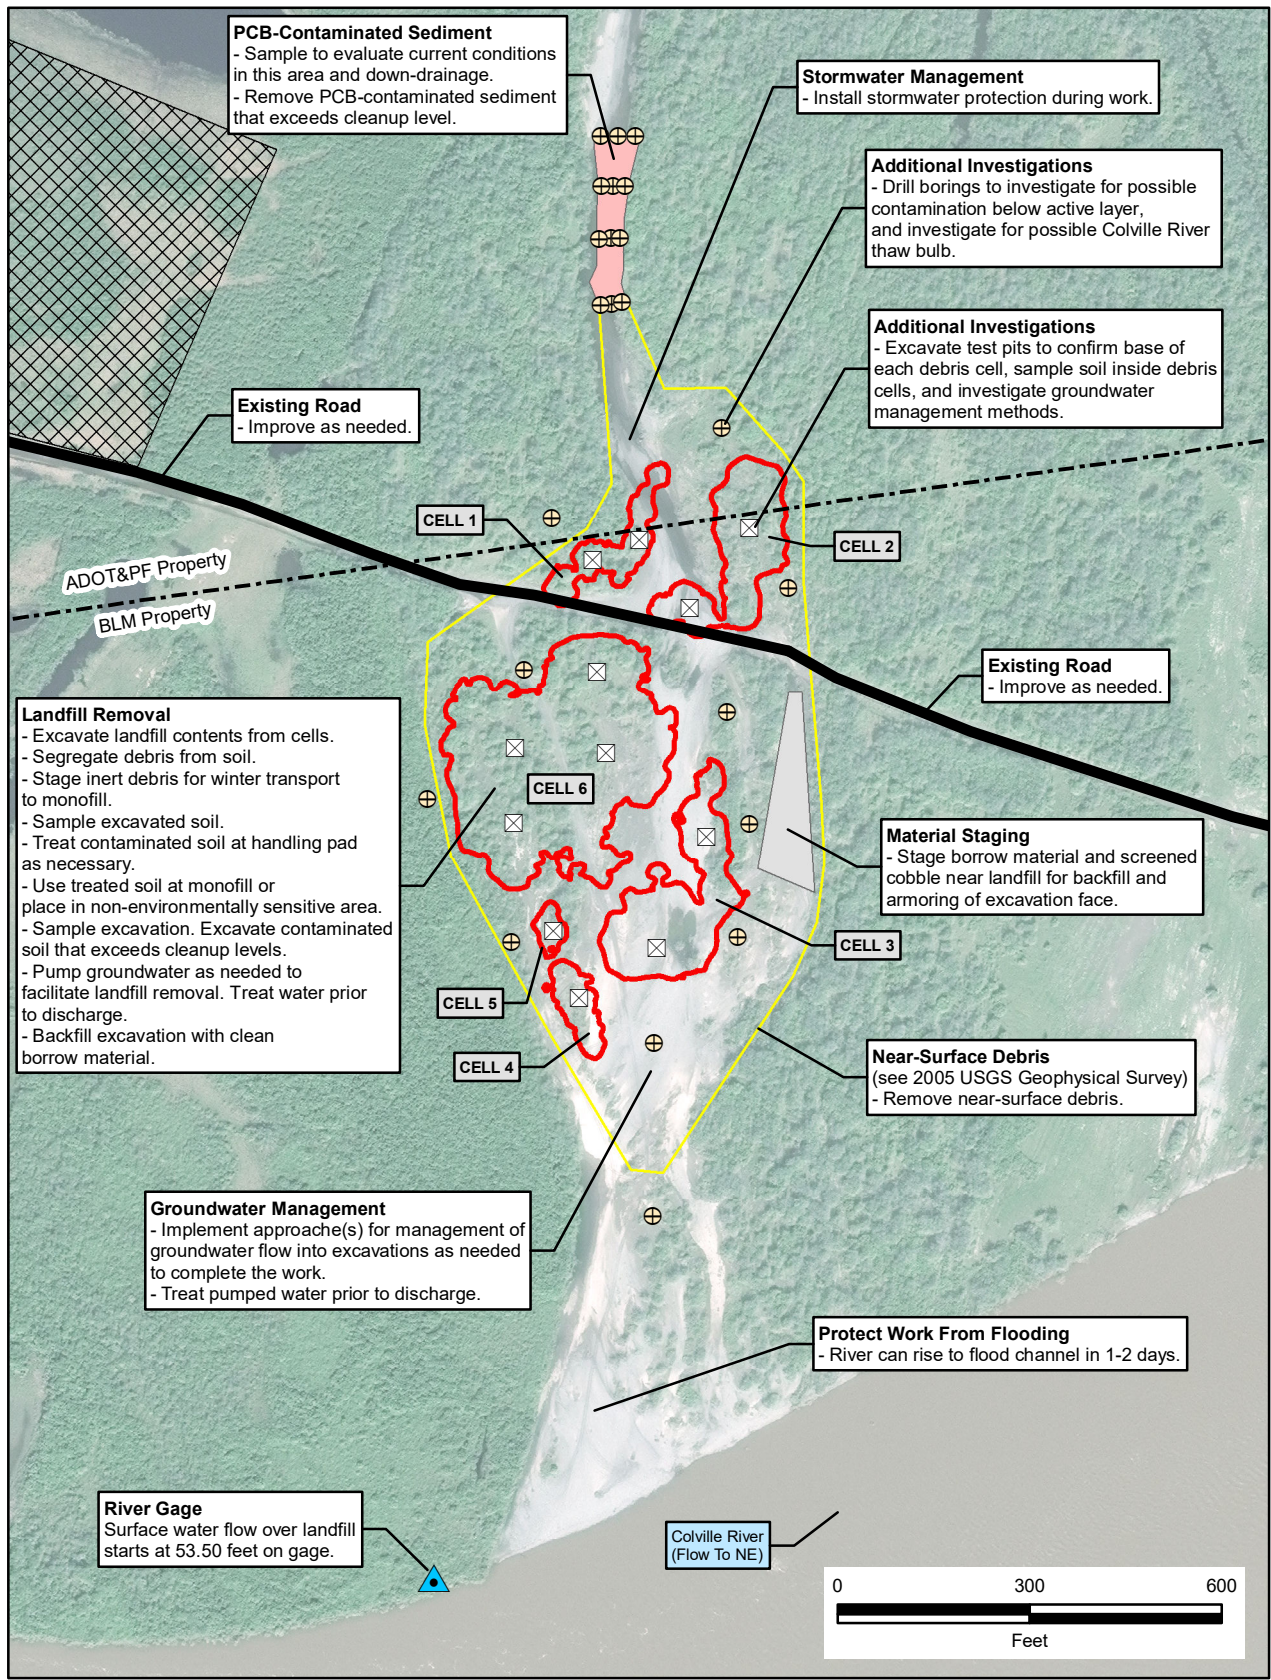
Figure 3

#### LEGEND

River Gage - Existing		Proposed Borrow Area		Proposed Boring
	Upgrade Existing Road		Proposed Handling Pad		Proposed Test Pit
	Probable Ice Road		Contaminated Sediment Prior		ADOT&PF Property Line
	Possible Ice Road		Landfill Debris Cell		
	New Access Route		Near-Surface Debris Area		
			Possible Monofill Location

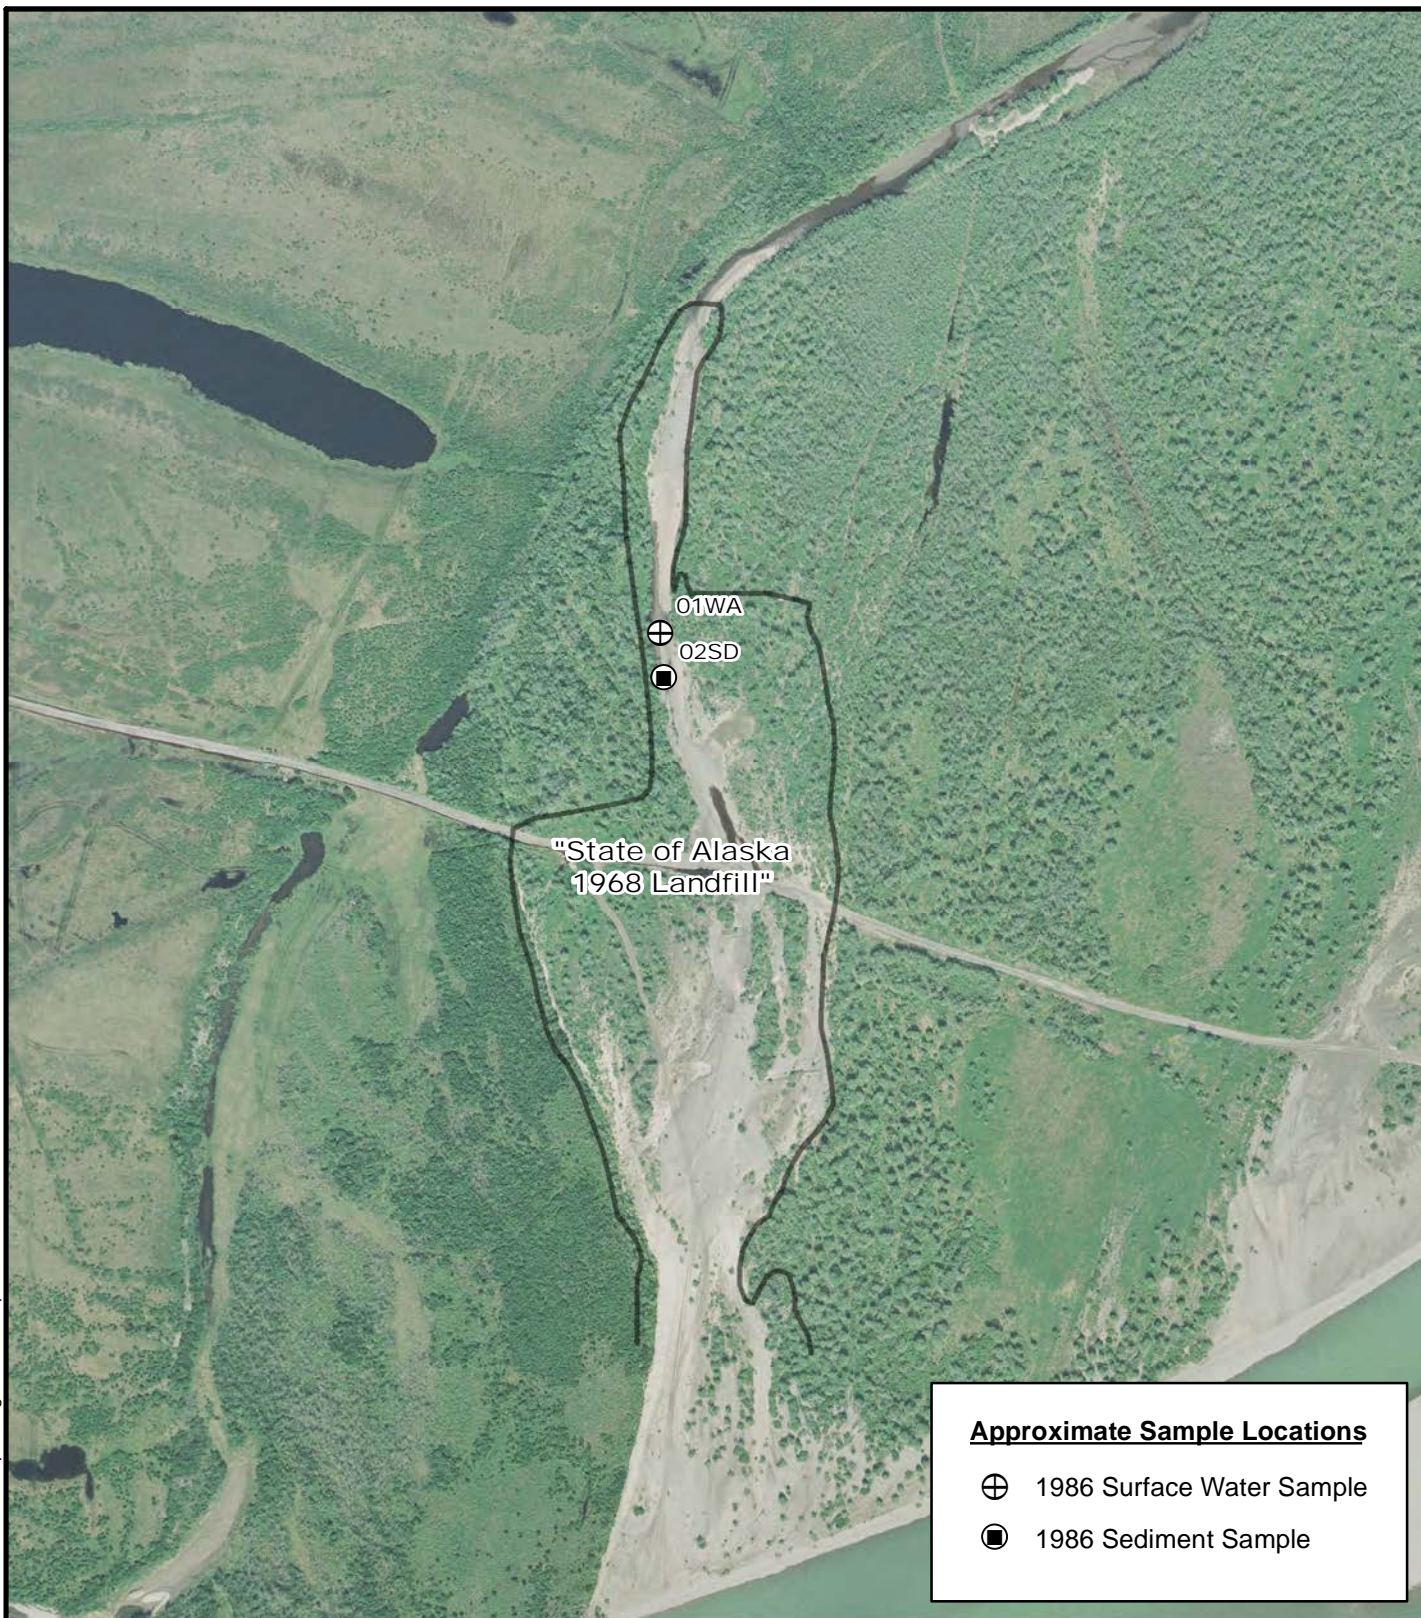
**FIG. 4-1**

**Approximate Sample Locations**

- ⊕ 1986 Surface Water Sample
- 1986 Sediment Sample

USACE initiated a hazardous waste sampling and assessment program at Umiat in 1986, under the FUDS Program. Analytical samples were collected from areas of obvious Petroleum, Oil, and Lubricants (POL) contamination and areas suspected to be heavily used, including the landfill east of the site, the subject of this document. At the landfill, USACE collected one sediment and one surface water sample at locations downstream (north) of the landfill in the seasonally flooded channel. The samples were analyzed for PCBs, pesticides, volatile organic compounds (VOCs), semi-volatile organic compounds (SVOCs), and extraction procedure (EP) Toxicity for metals. The purpose of analyzing samples for EP Toxicity was to determine whether site-sampled media might be considered hazardous waste under the Resource Conservation and Recovery Act (RCRA). 4,4'-DDT was detected in the water sample at 0.0003 milligrams per liter (mg/L). 4,4'-DDD was detected at 0.650 mg/kg and the PCB Aroclor 1254 was detected at 0.680 mg/kg in the sediment sample. Diesel-range hydrocarbons were tentatively identified in the sediment sample at 10 mg/kg. EP Toxicity analysis indicated the metals concentrations were below regulatory limits. Figure 4-1 from the 2013 RI Report (see Attachment A) shows the approximate location of the two samples.

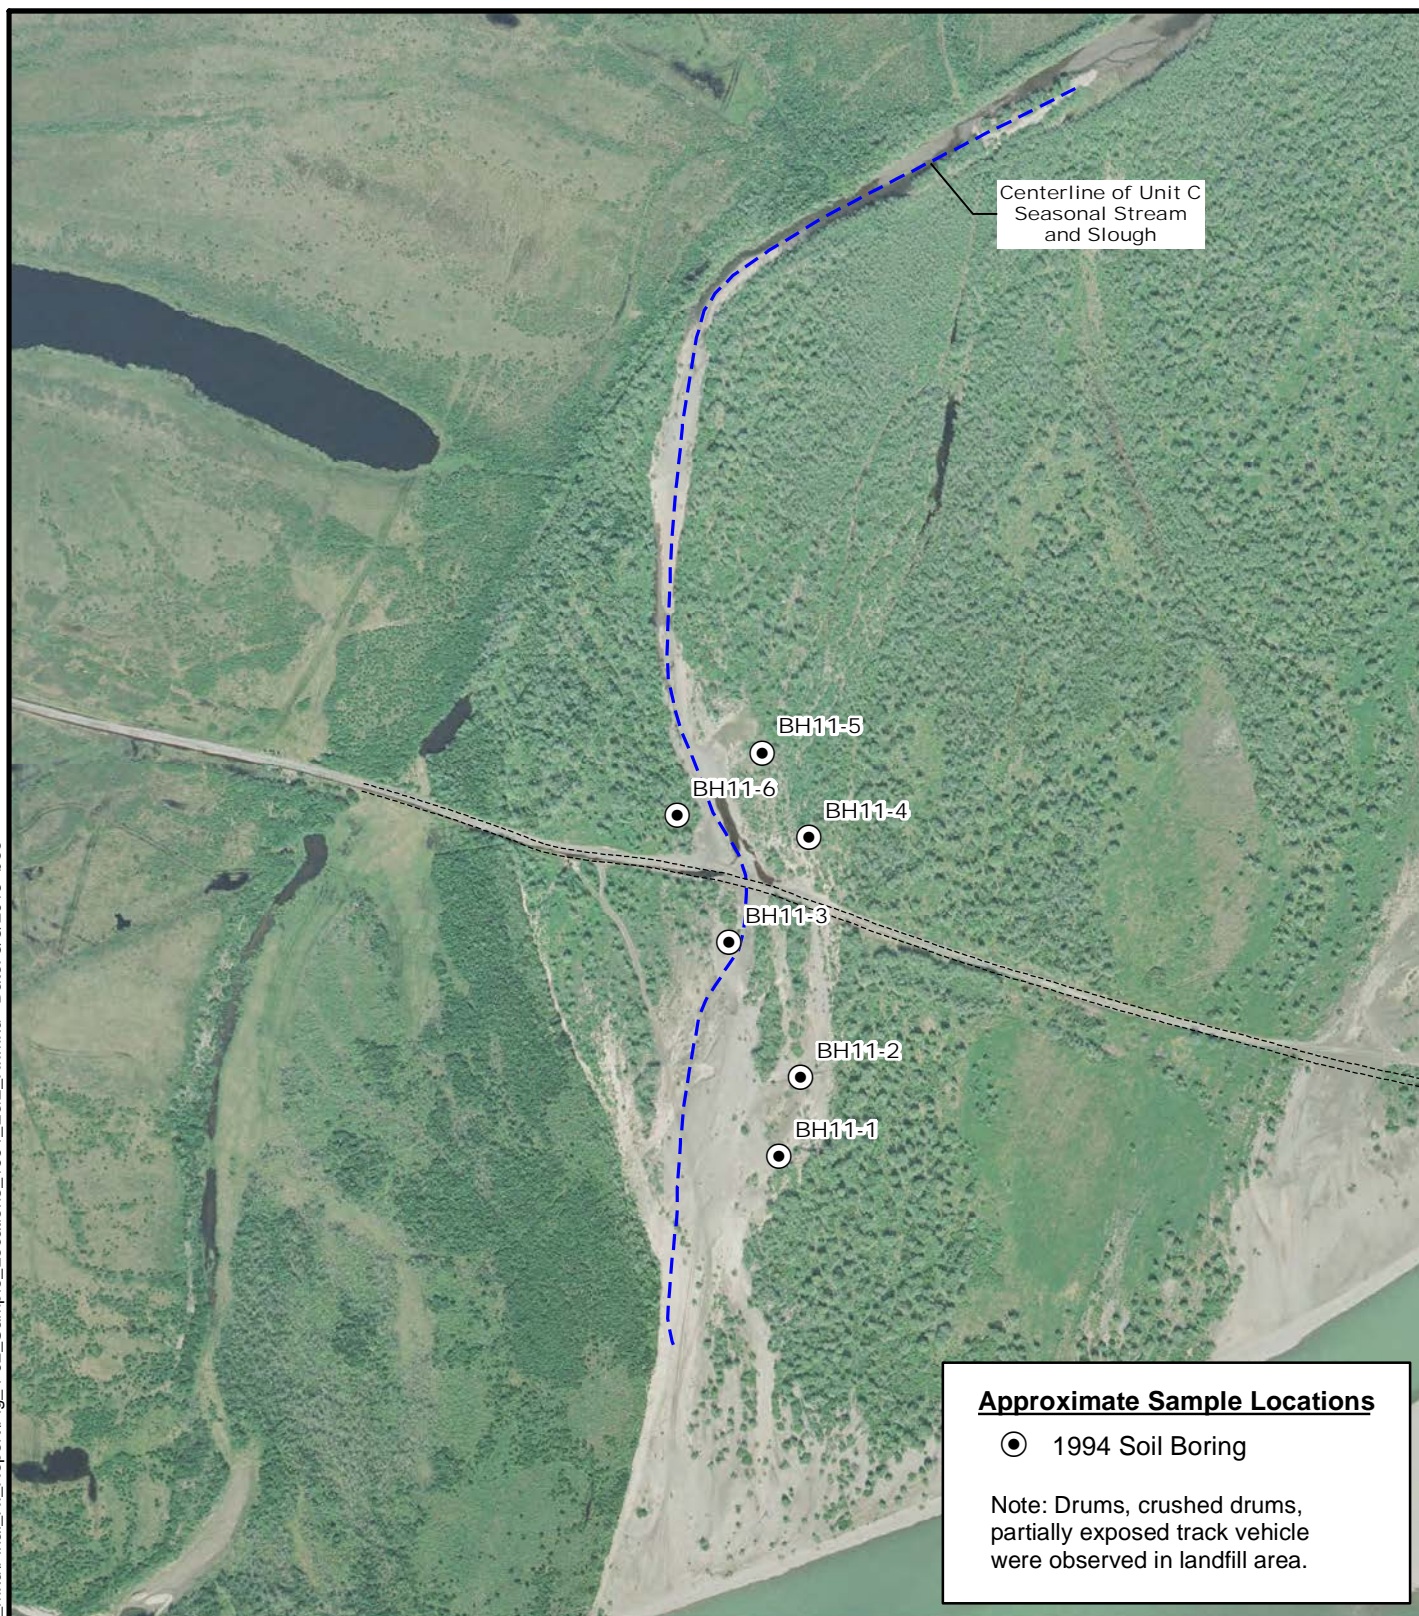
**FIG. 4-2**

#### Approximate Sample Locations

- 1994 Soil Boring

Six shallow borings were drilled at the landfill outside the debris areas and two soil borings were drilled at background locations. The approximate locations of the six shallow borings at the landfill are shown in Figure 4-2 from the 2013 RI Report (see Attachment A). The landfill borings were drilled to six, nine, or ten feet bgs and did not encounter permafrost. Soils were logged as sand and gravel. Six surface and 12 subsurface soil samples were collected at the landfill. The soil samples were tested for fuel constituents, PCBs, pesticides, VOCs, and metals. Diesel Range Organics (DRO) and total recoverable petroleum hydrocarbons (TRPH) were detected in all the landfill borings. 4,4'-DDT was detected at the surface, two-foot, and ten-foot depth of the boring, ranging from 0.029 mg/kg to 0.050 mg/kg in one boring (BH 11-6).

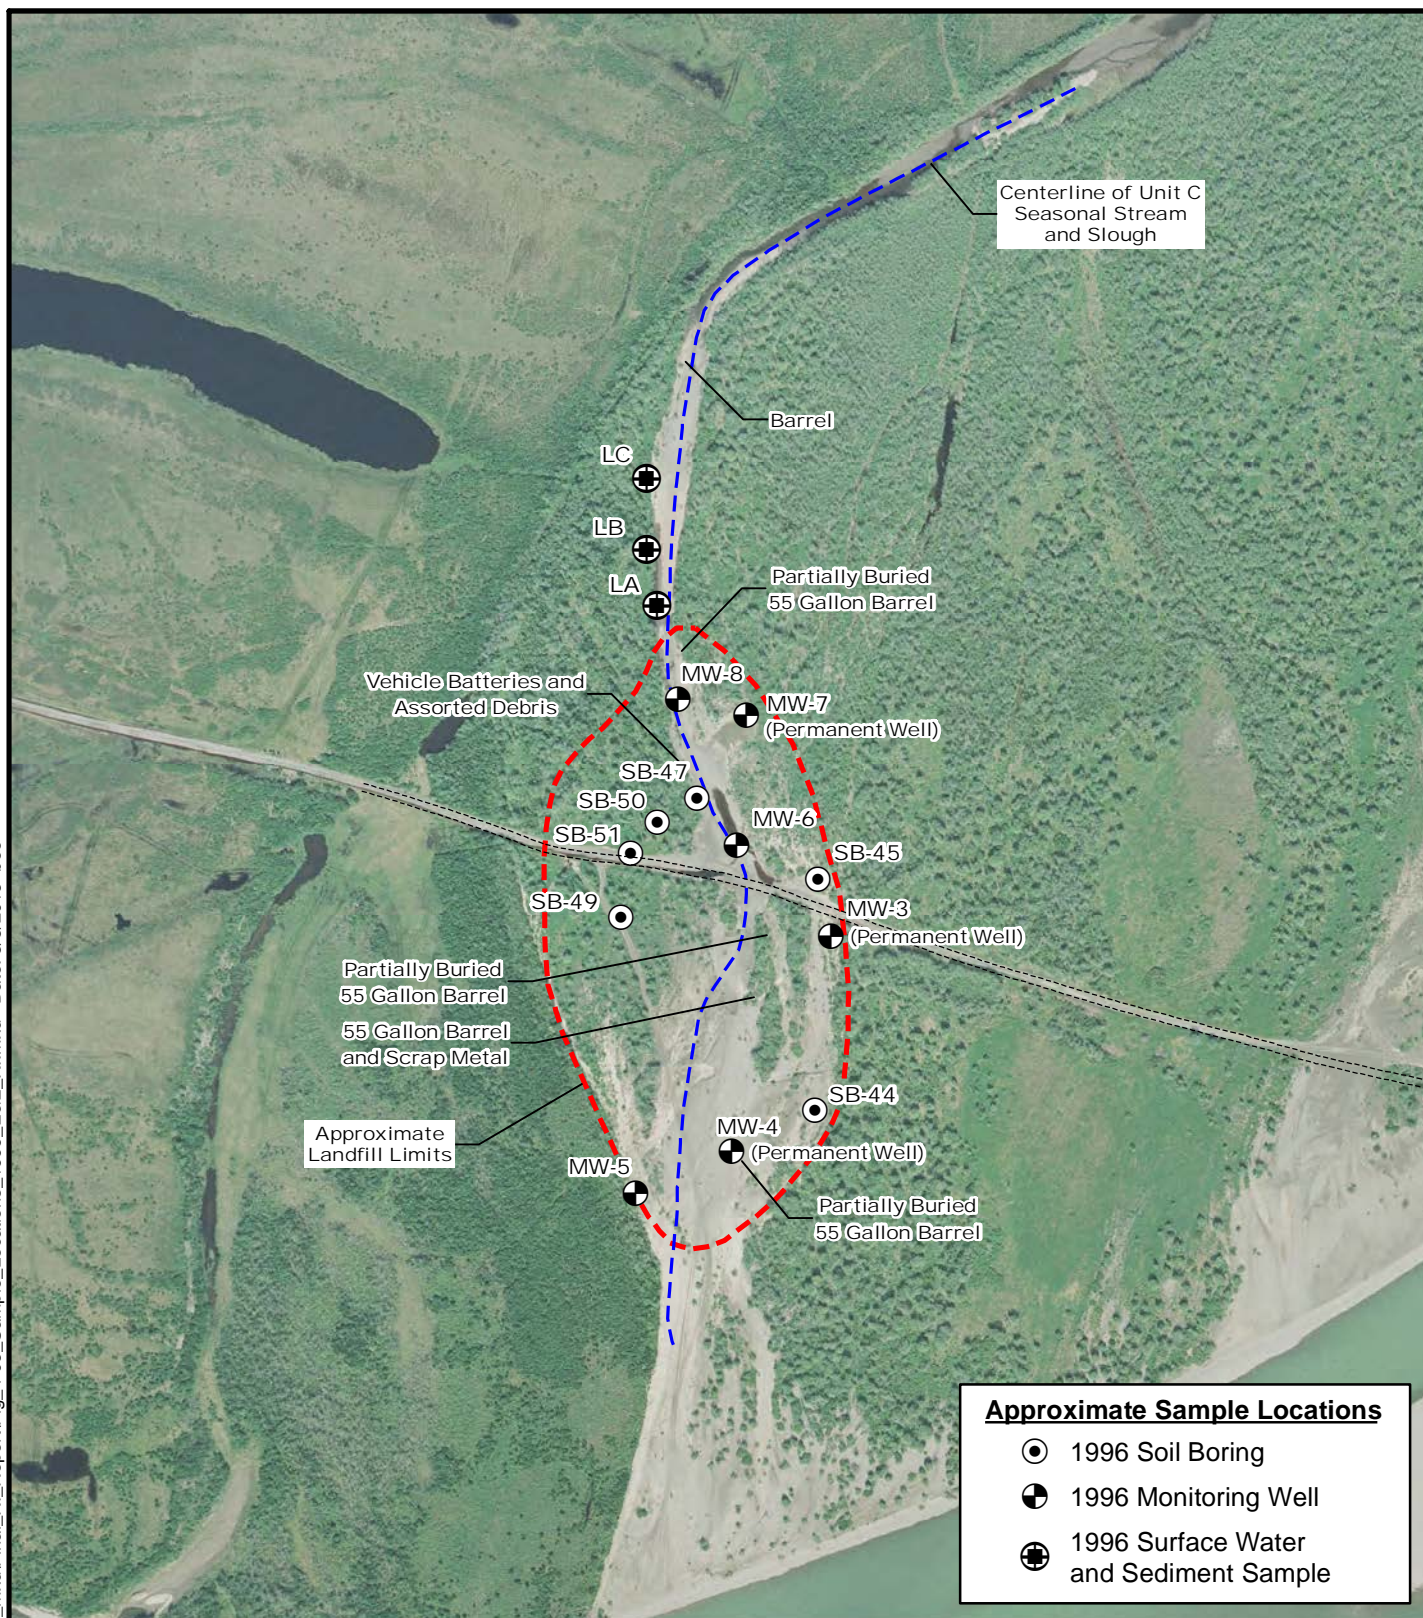
**FIG. 4-3**

#### Approximate Sample Locations

- 1996 Soil Boring
- ⊕ 1996 Monitoring Well
- ⊕ 1996 Surface Water and Sediment Sample

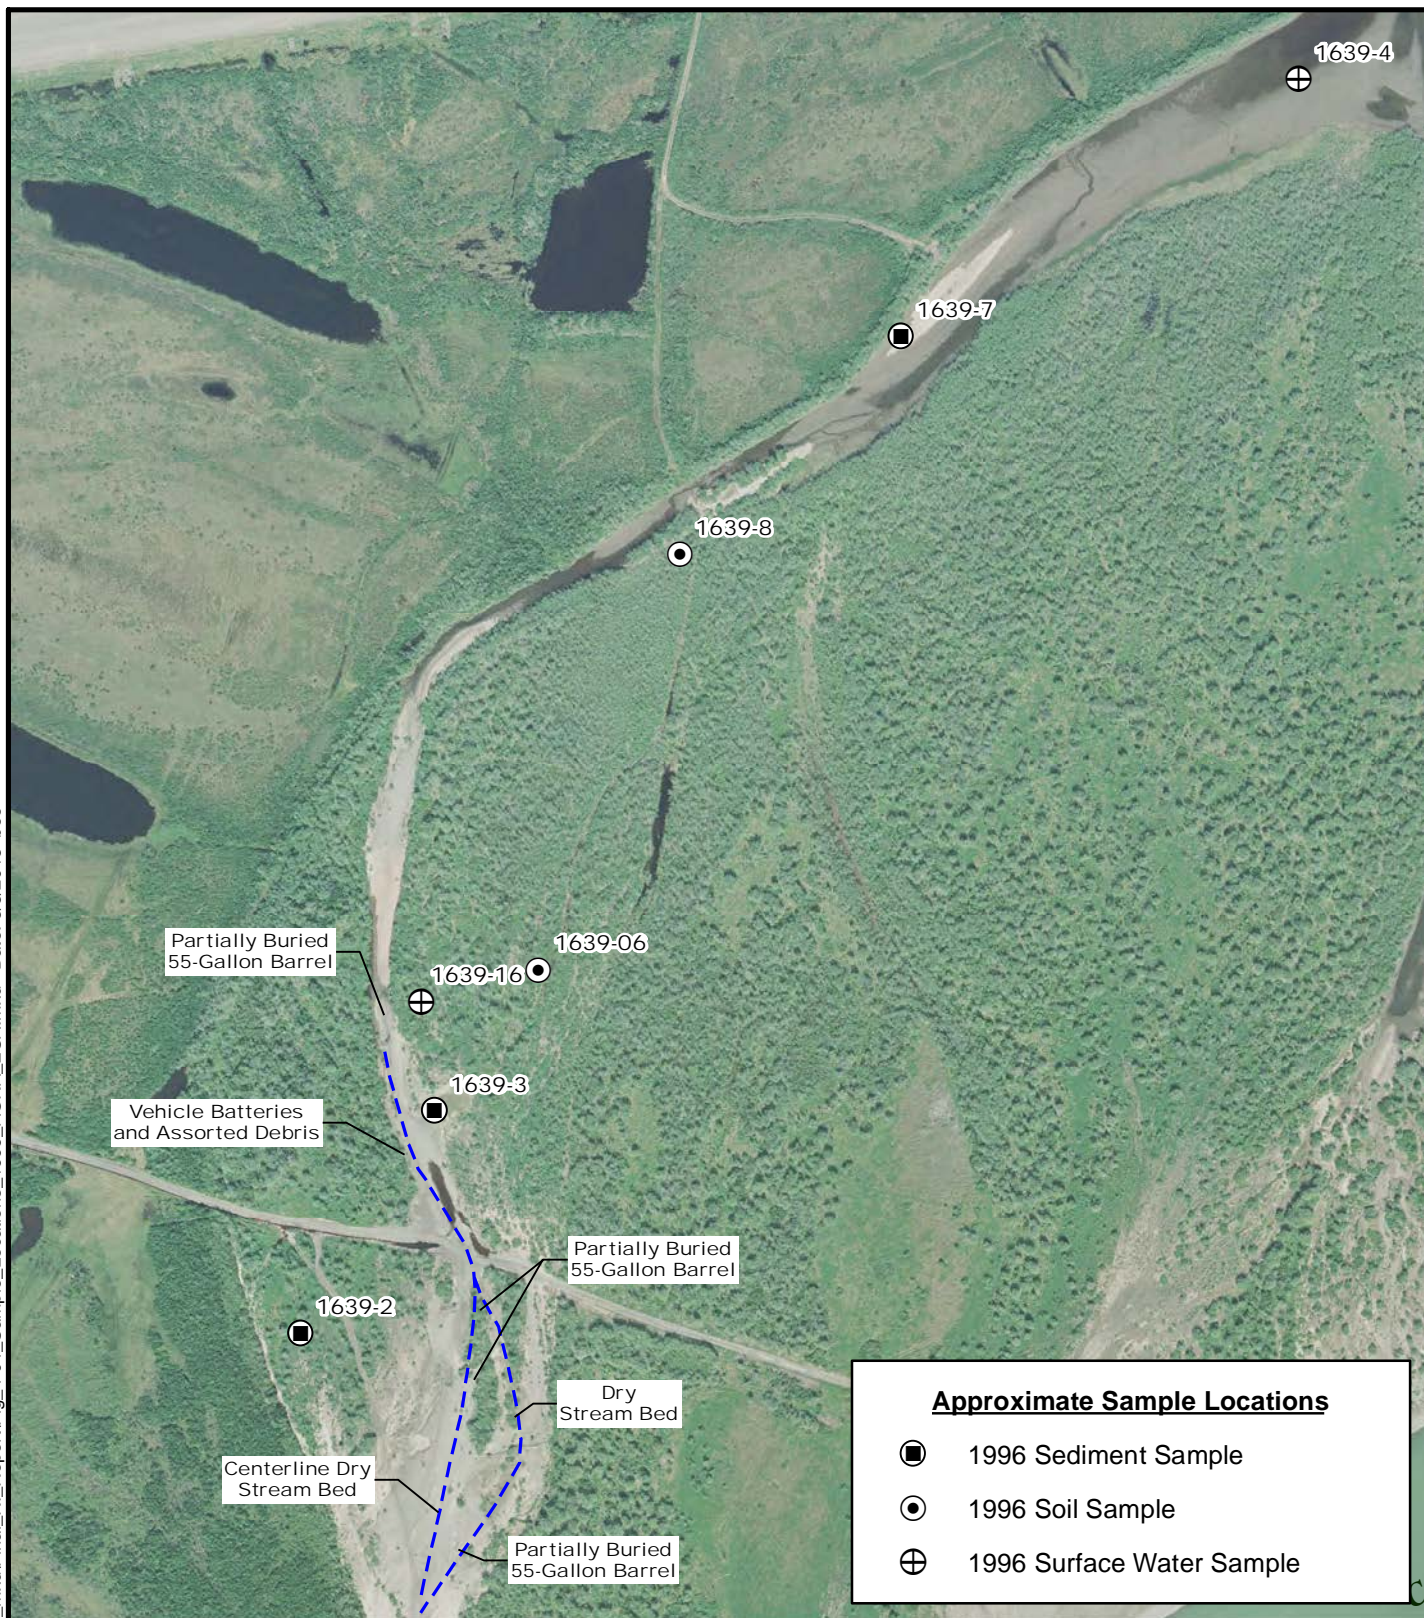
Surface soil and subsurface soil, groundwater and surface water, and sediment samples were collected at the landfill. Figure 4-3 from the 2013 RI Report (see Attachment A) shows the Phase II RI landfill sample locations.

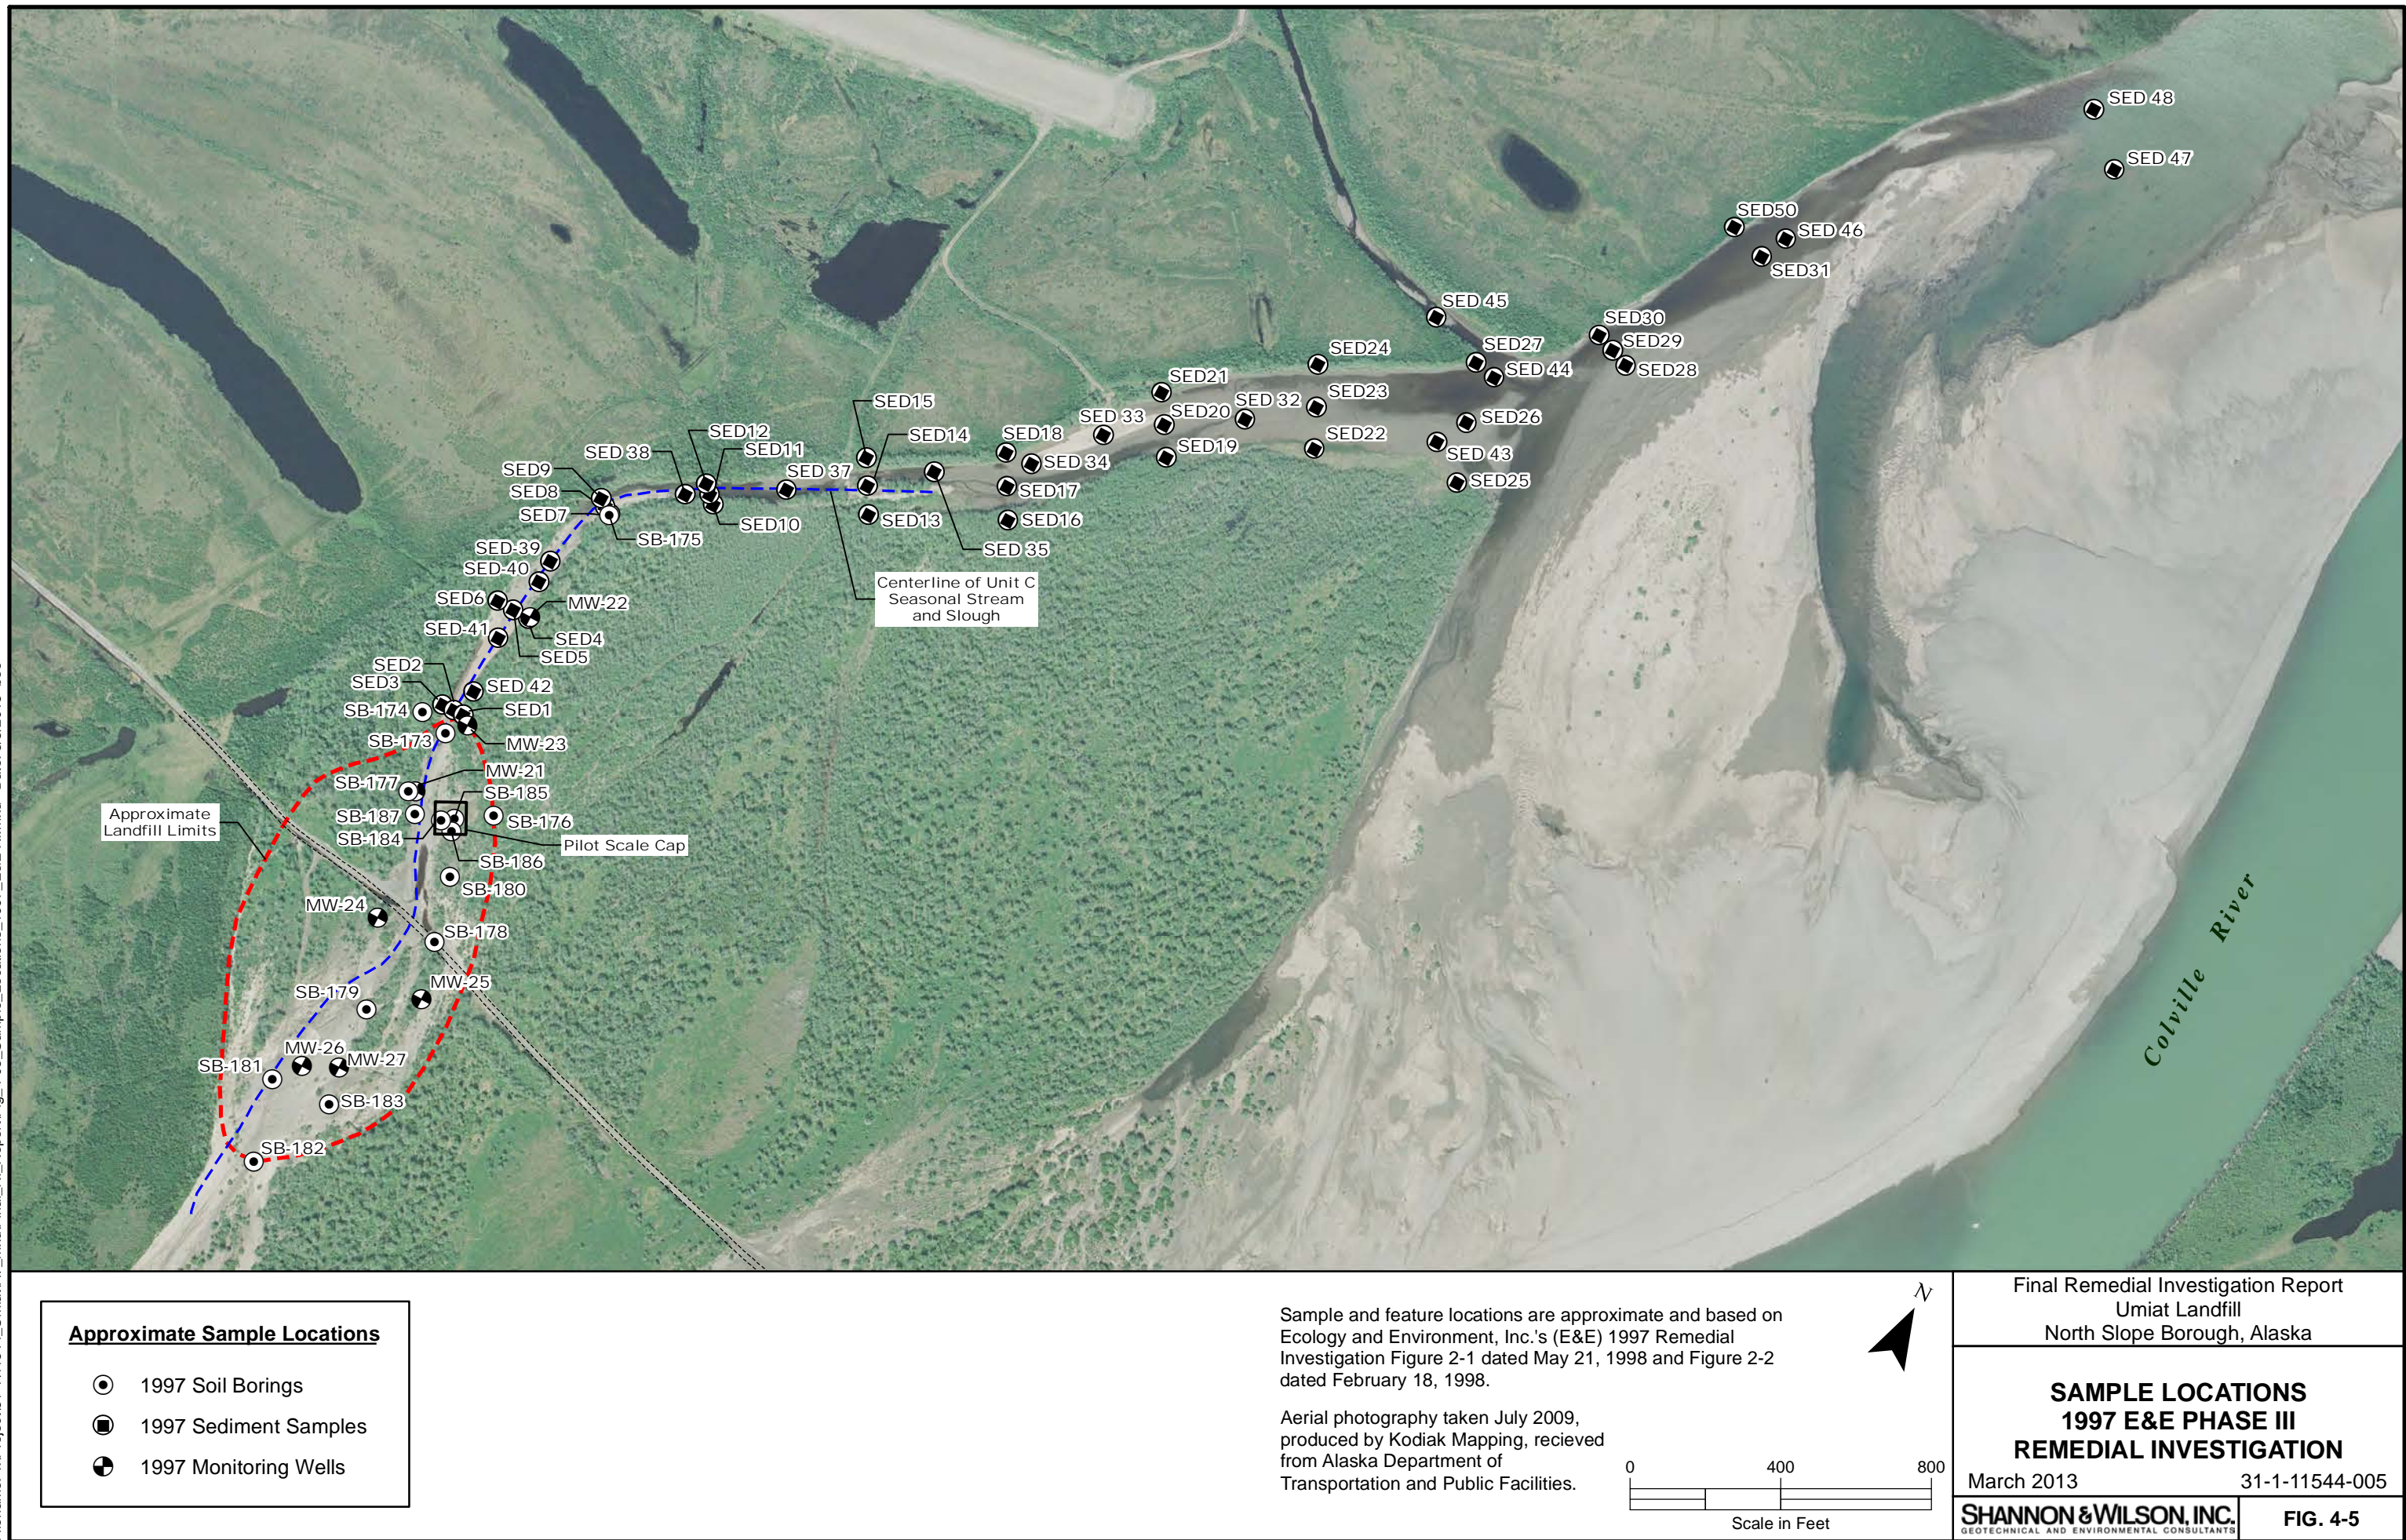
**FIG. 4-4**

Of the 31 samples collected at the Umiat facility during the site assessment, nine were collected at the landfill: two sediment samples in the landfill area and one sediment sample downstream, two soil and a duplicate sample north of the landfill, and three surface water samples. Locations are shown in Figure 4-4 from the 2013 RI Report (see Attachment A). Samples were analyzed for VOCs, PAHs, PCBs, pesticides, arsenic, and lead.
