# DECISION DOCUMENT

Hazardous, Toxic, and Radioactive Waste

Project # F10AK0243-08

Umiat Air Force Station

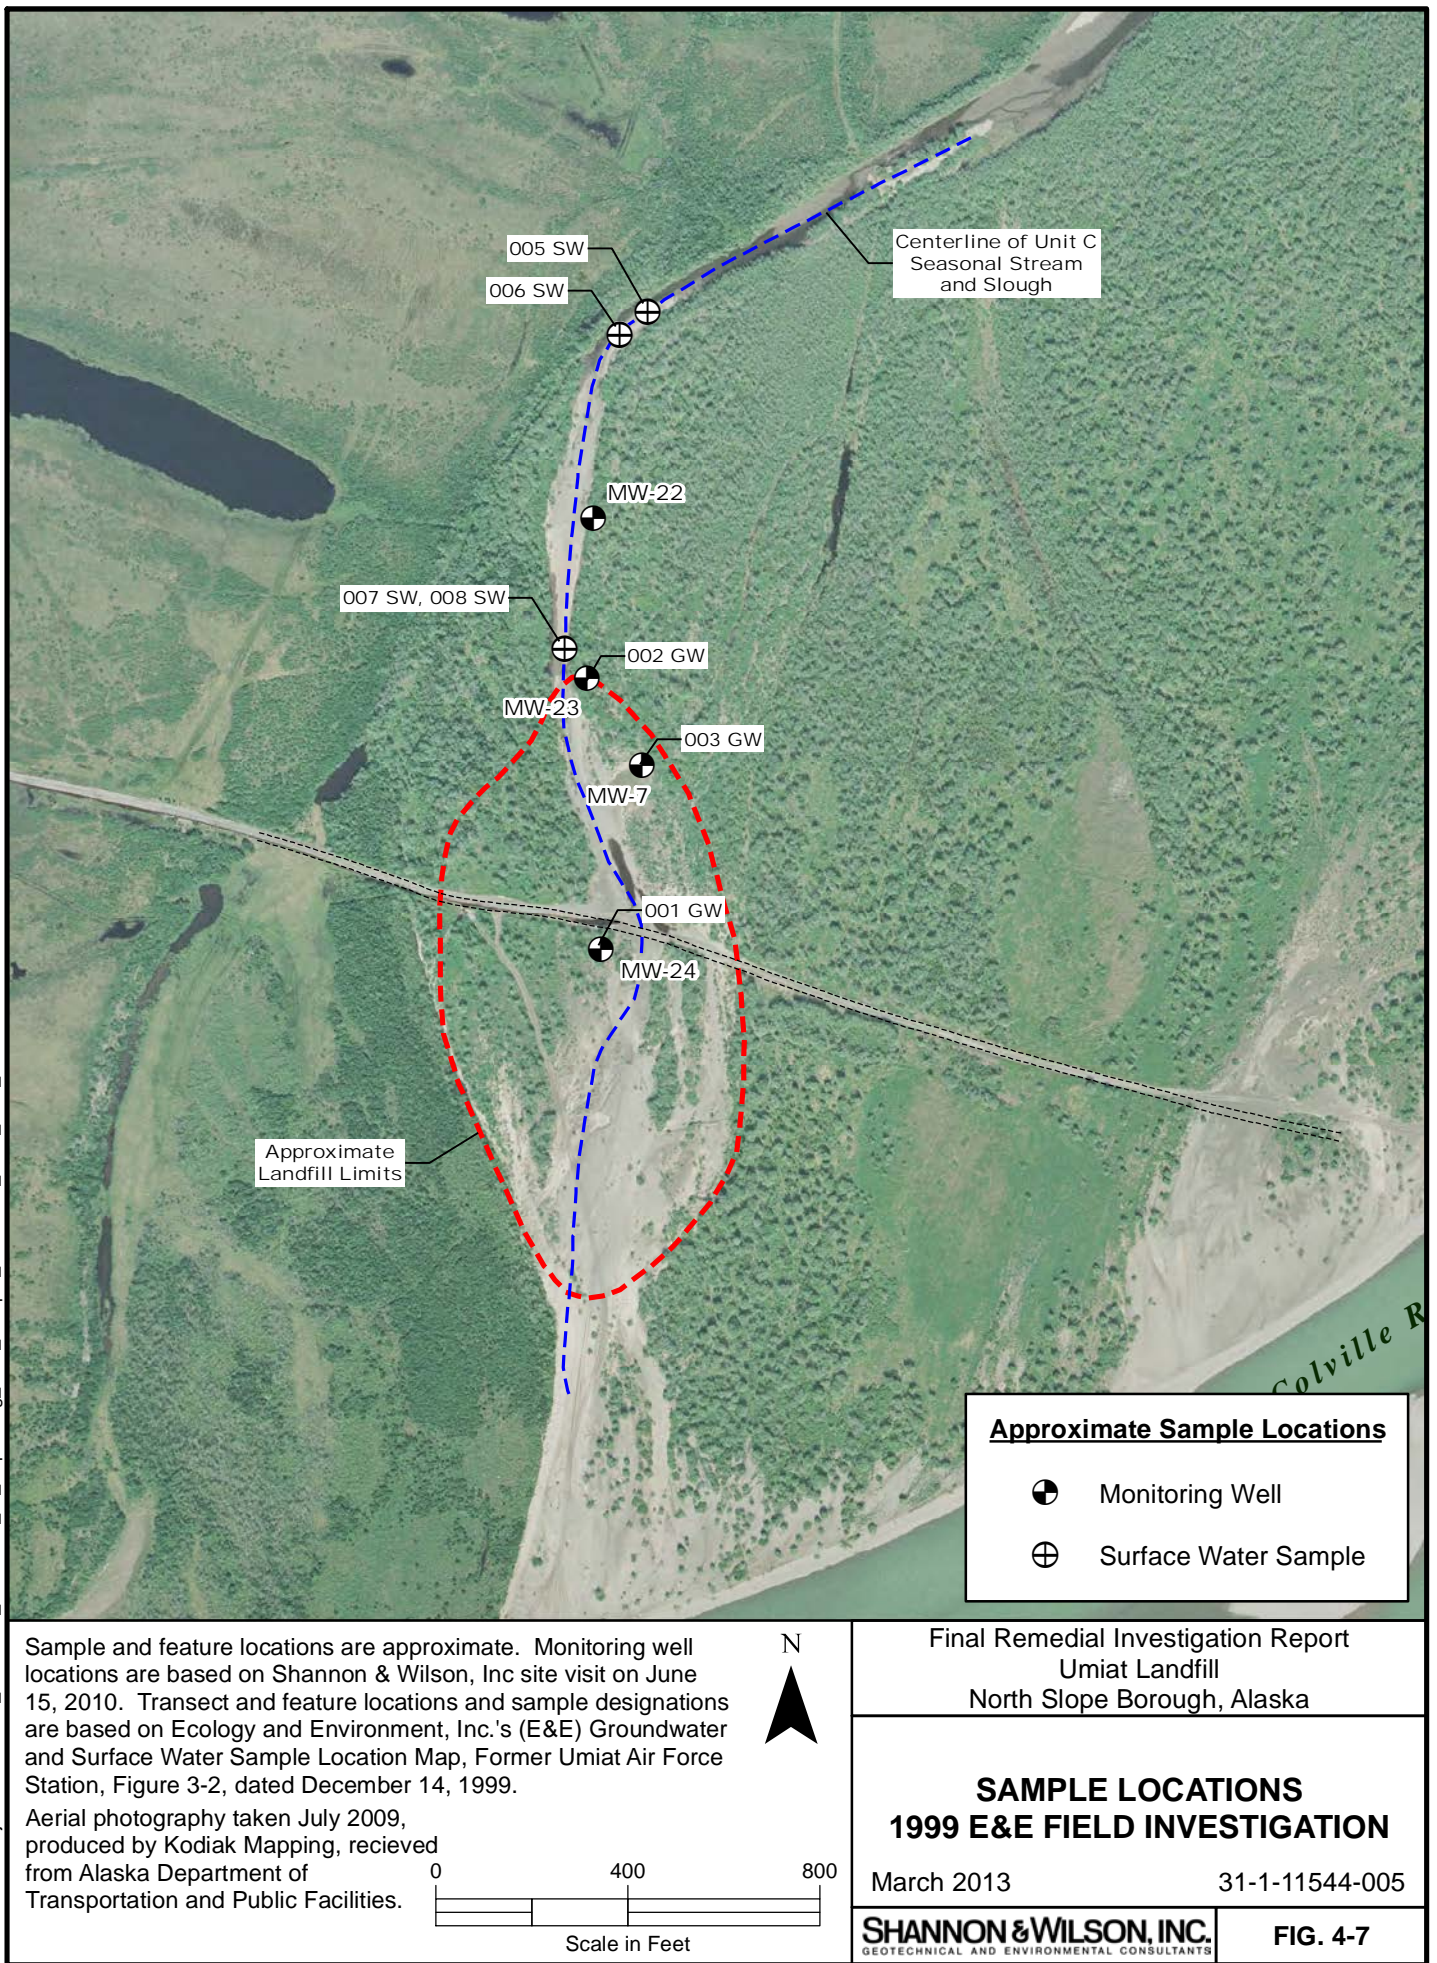
**FIG. 4-8**

# Information Related to 2001 Work by Jacobs Engineering Group, Inc.

- Soil Sample
- 1 ● Areas identified by Jacobs Engineering Group, Inc. (see table below)

Area	Source	Amount of Soils Removed
1	Small Alkaline Battery	Battery Only
2	Small Alkaline Battery	Battery Only
3	Small Alkaline Battery	Battery Only
4	Small Alkaline Battery	Battery Only
5	Battery	1/3 Cubic Yard Total
6	Battery	
7	Battery	
8	Battery	
9	Debris from Broken Battery	1/3 Cubic Yard Total
10	Small Alkaline Battery	
11	Single Sheet of Lead	
12	Single Sheet of Lead	
13	Small Alkaline Battery	Battery Only
14	Small Alkaline Battery	Battery Only
15	Possible Lead Shielded Wire	Debris Only
16	Possible Lead Shielded Wire	Debris Only
17	Possible Lead Shielded Wire	Debris Only
PCB	Transformer	1/3 Cubic Yard

Site inspections of the landfill area were conducted in July and August 2001, and one small transformer and areas containing debris from lead-acid batteries were found on the landfill surface. The visible lead debris was removed and surrounding soil was excavated until field instrument measurements indicated lead levels in surrounding soil were below cleanup levels. Approximately 1.3 cy of lead-contaminated soil were removed. The cleanup-verification sample collected from the excavation contained 1,170 mg/kg lead. A sample of the soil immediately beneath the transformer was analyzed and found to contain 52,700 mg/kg of the PCB Aroclor 1254. USACE containerized and removed the transformer and about one-third cy of contaminated soil for off-site disposal. A cleanup-verification soil sample contained 2.3 mg/kg Aroclor 1254. Figure 4-8 from the 2013 RI Report (see Attachment A) shows the sample locations for the 2001 removal action.

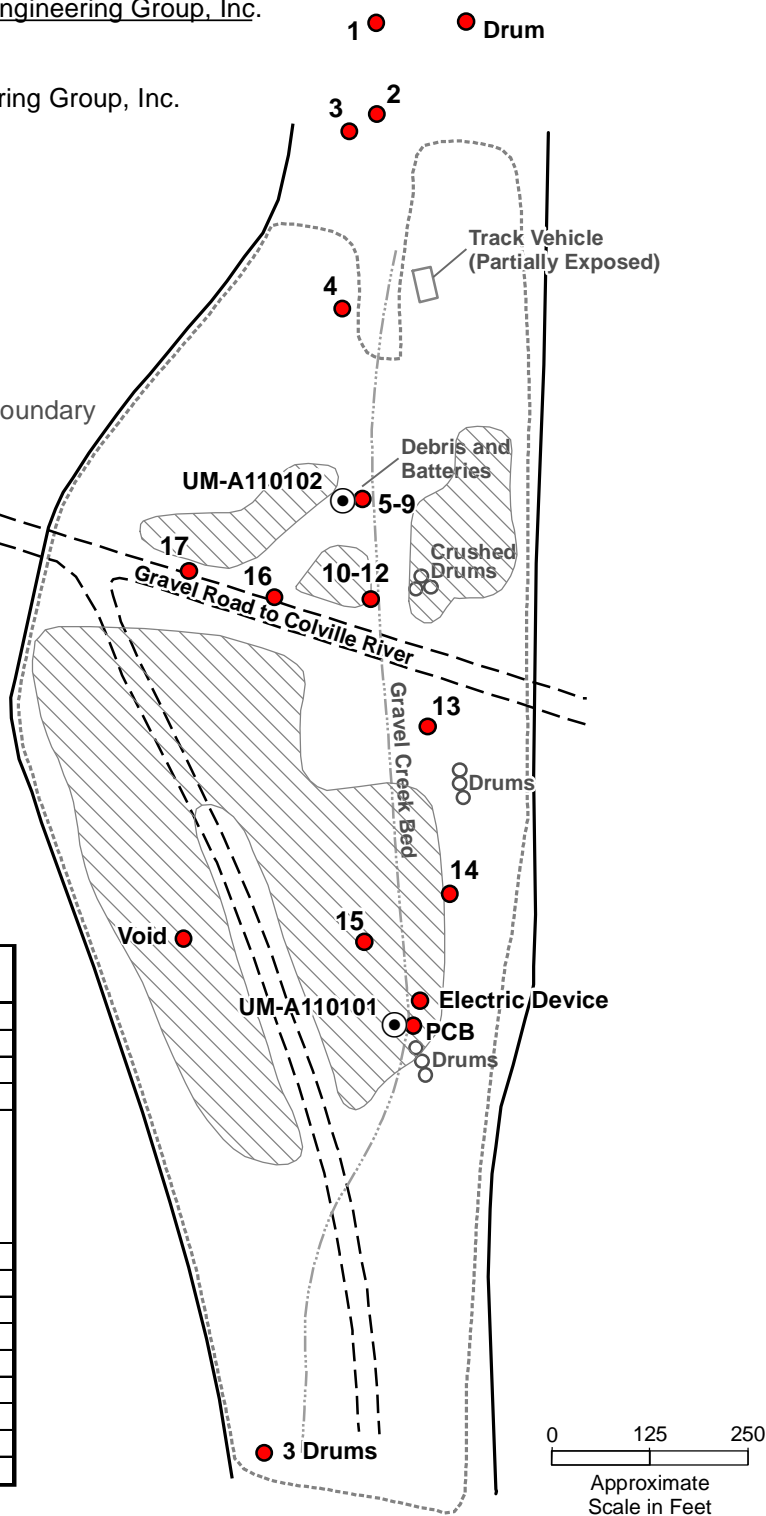
Figure re-created based on Jacobs Engineering Group, Inc. (Jacobs) Figure 2-1, dated September 26, 2001 and Ecology and Environment, Inc.'s (E&E) Draft Remedial Investigation (RI) Figure 3-5, dated December 20, 1993. Attempts to georeference features from Jacob's Figure 2-1 and E&E's Draft RI Figure 3-5 have not been successful without significant distortion. The positional accuracy of features shown here is unknown.

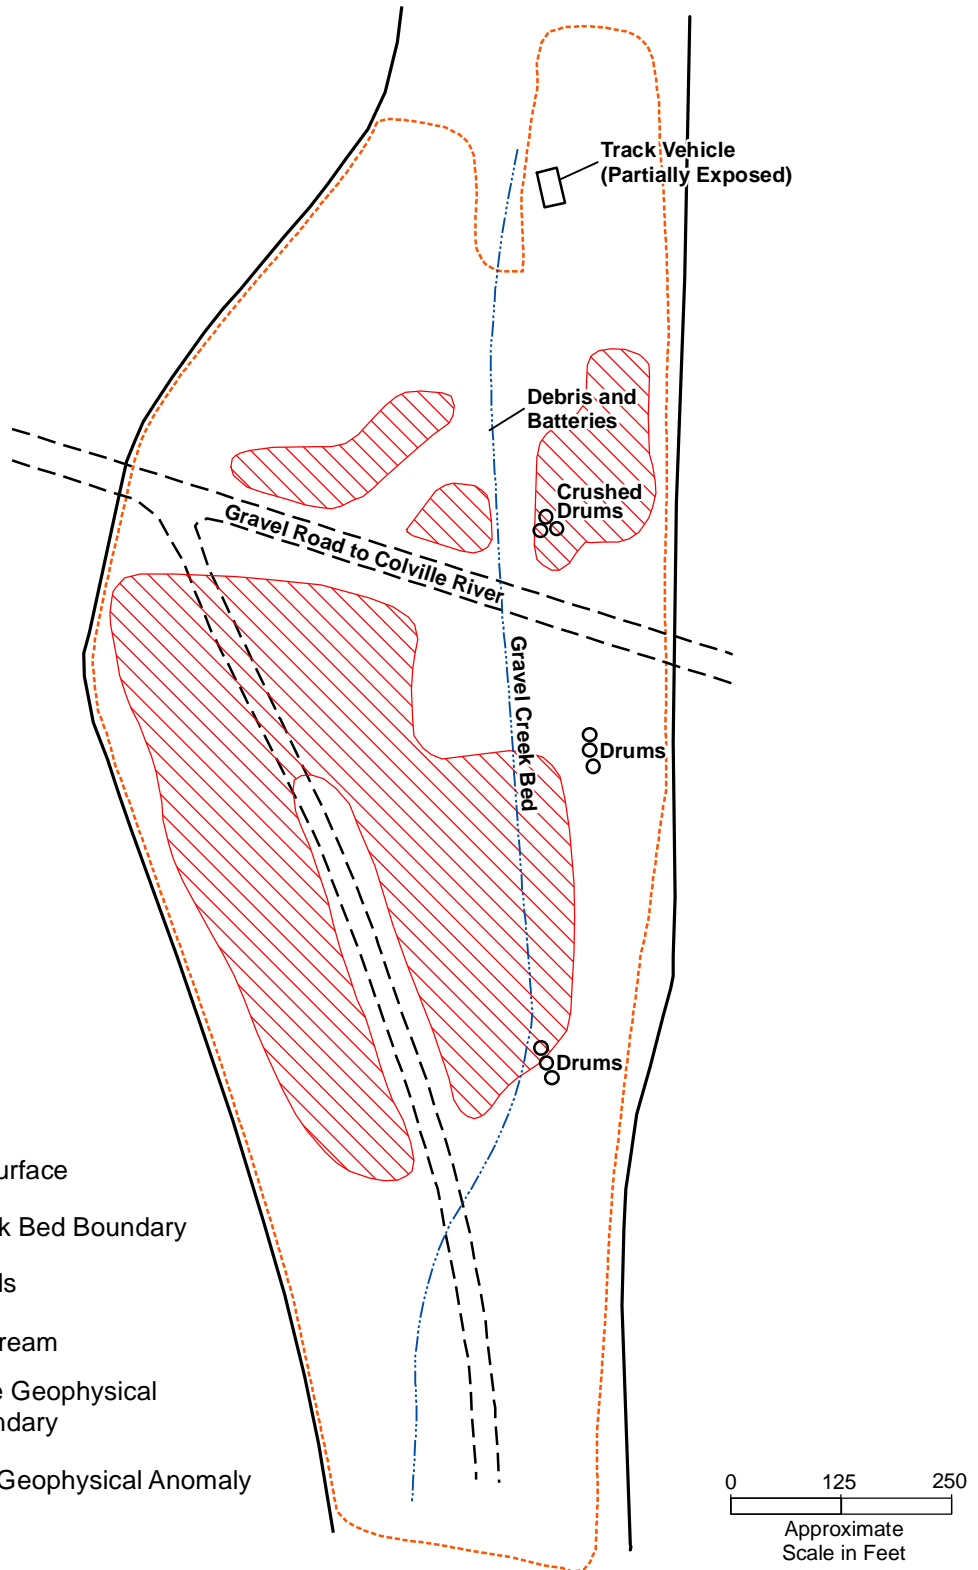
**FIG. 4-10**

Map is based on Ecology and Environment, Inc.'s (E&E) Draft Remedial Investigation (RI) Figure 3-5, dated December 20, 1993. Attempts to georeference features from E&E's Draft RI Figure 3-5 have not been successful without significant distortion. The positional accuracy of features shown here is unknown.

The EM-31 instrument readings (terrain conductivity) were off-scale where measuring within the suspected landfill boundary, indicating a significant volume of buried metallic debris. Readings inside the landfill boundary indicated buried metallic debris as deep as nine feet bgs. A large volume of metal debris buried potentially as deep as 18 feet bgs was indicated at a few locations in the southern portion of the landfill. The delineation results are shown in Figure 4-10 of the 2013 RI Report (see Attachment A).

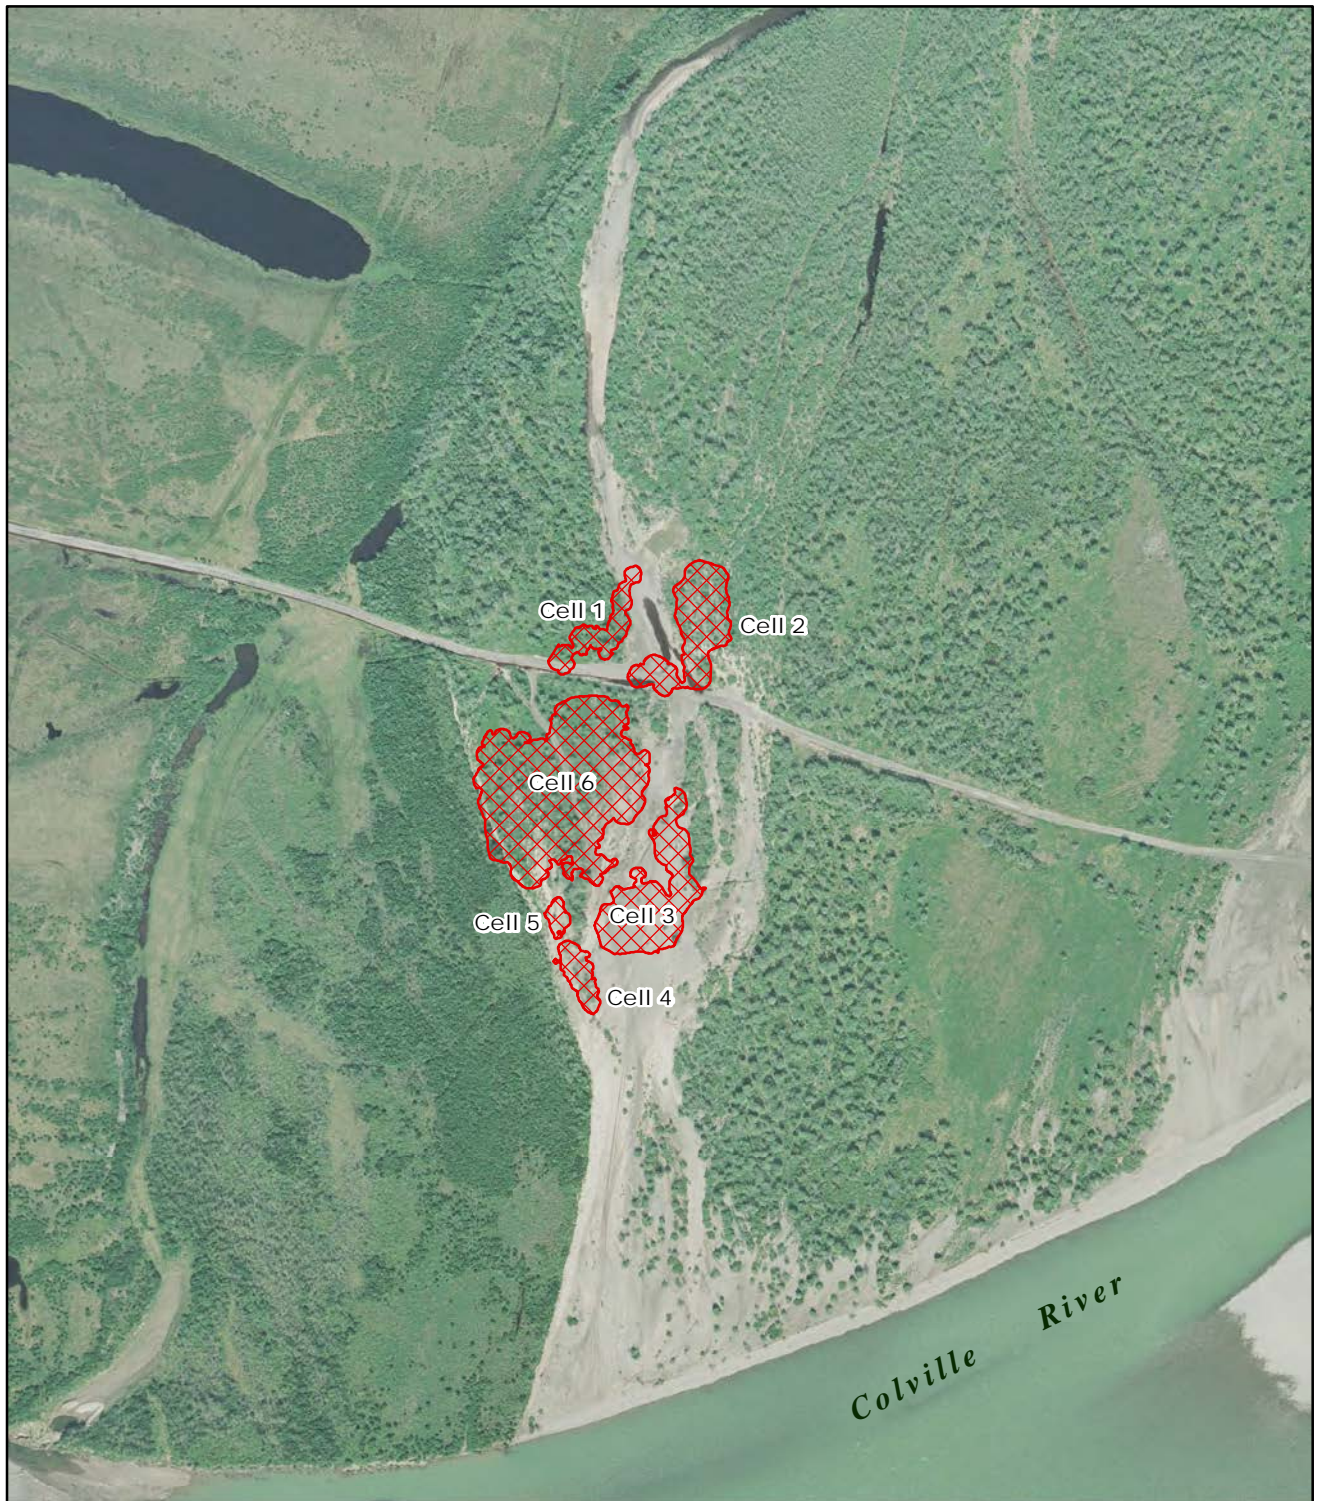
FIG. 4-12

Major Waste Cells

Major waste cells based on USGS, 2006, Geophysical Investigations of Selected Infrastructure Sites within the National Petroleum Reserve, Alaska.

In April 2011, USACE conducted another geophysical survey of the Umiat Landfill using ground-penetrating radar (GPR), EM, and Global Positioning System (GPS) instrumentation. The purpose of the survey was to reconcile the maximum depths of debris cells reported in 1994 (depths to 18 feet bgs) with those reported by the USGS in 2005 (depths to 43 feet bgs). The data acquisition plan included collecting data along a grid pattern; however, dense vegetation covered portions of the site, which limited data acquisition to open areas and natural paths through that vegetation. Five of the six debris cell locations previously identified by the USGS were confirmed. Within the area of geophysical data acquisition, data anomalies were identified and the vertical and lateral extent of the landfill pits or former ground surface prior to burial of debris were determined. See Figure 4-12 from the 2013 RI Report (Attachment A).

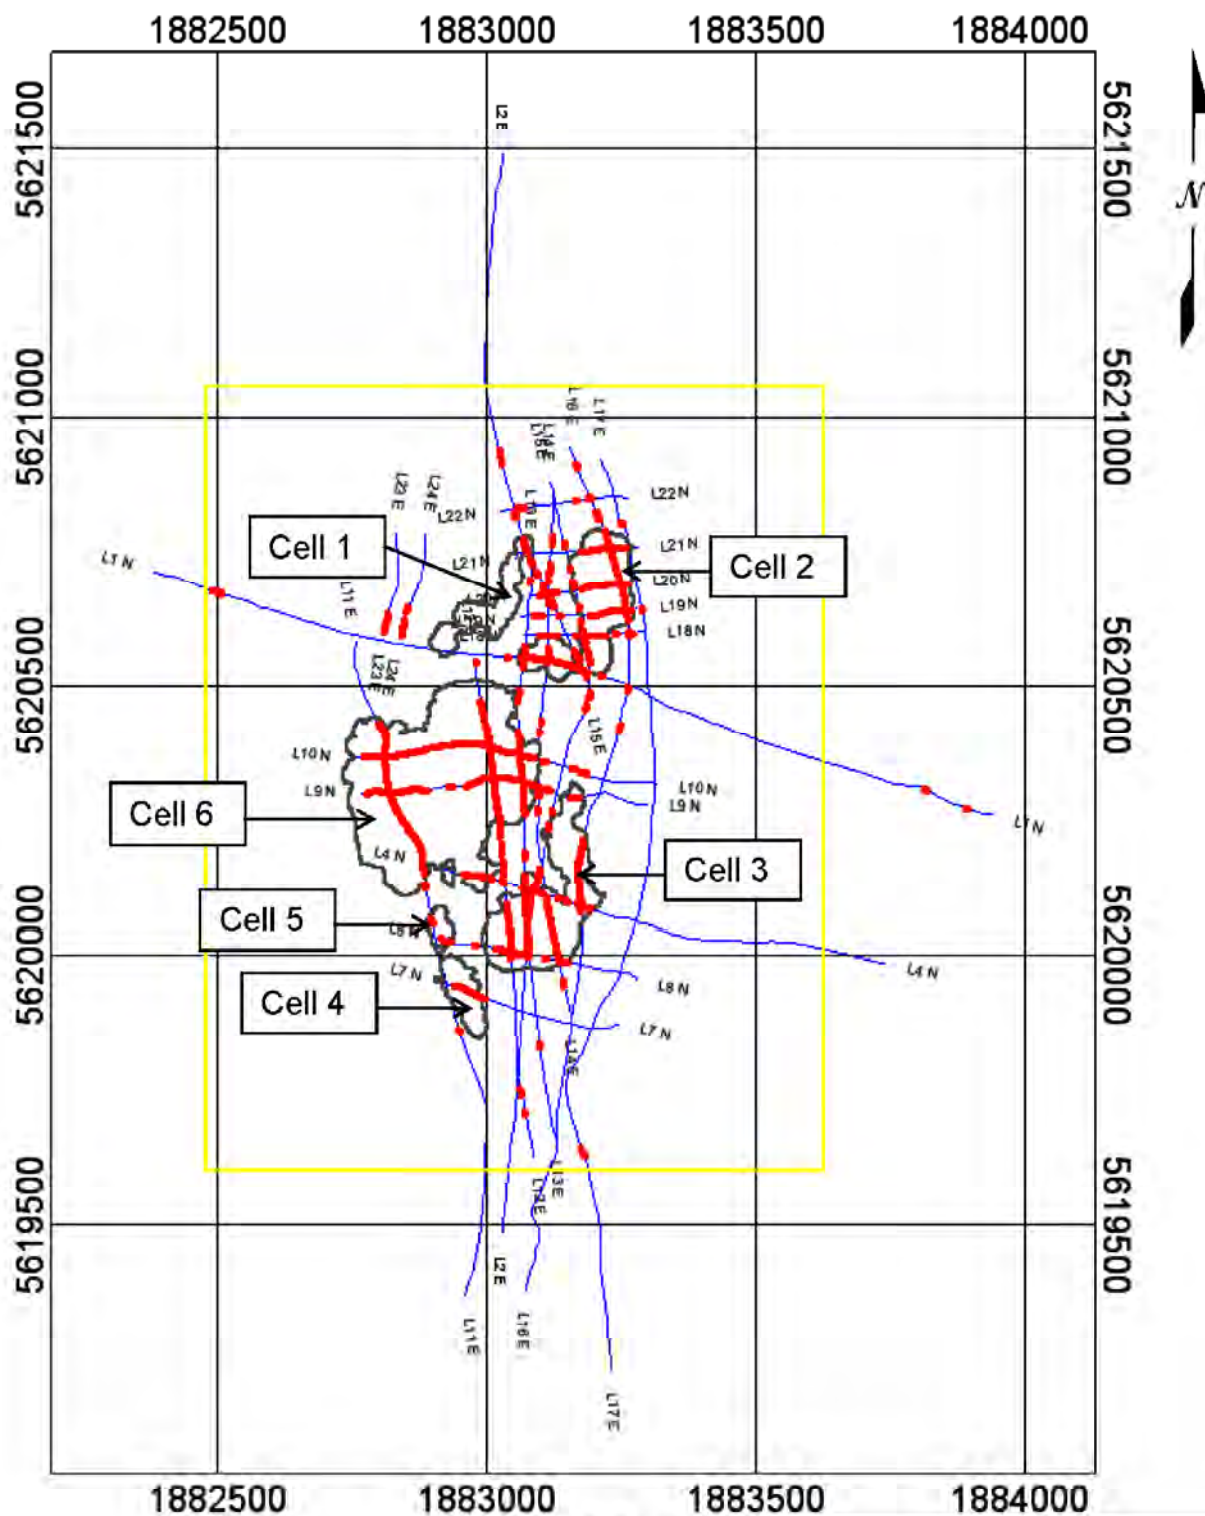
-   GPR / EM Profile Lines - 2011
-   EM Anomaly Extent - 2011
-   Debris Cell Outline - from USGS Report (2005)
-   Proposed Boundary of Data Acquisition (2011)

Figure from GeoTek Alaska, Inc.'s Figure 26: Marsh Creek, Umiat, Alaska, Geophysical Data Location, dated October 25, 2011.

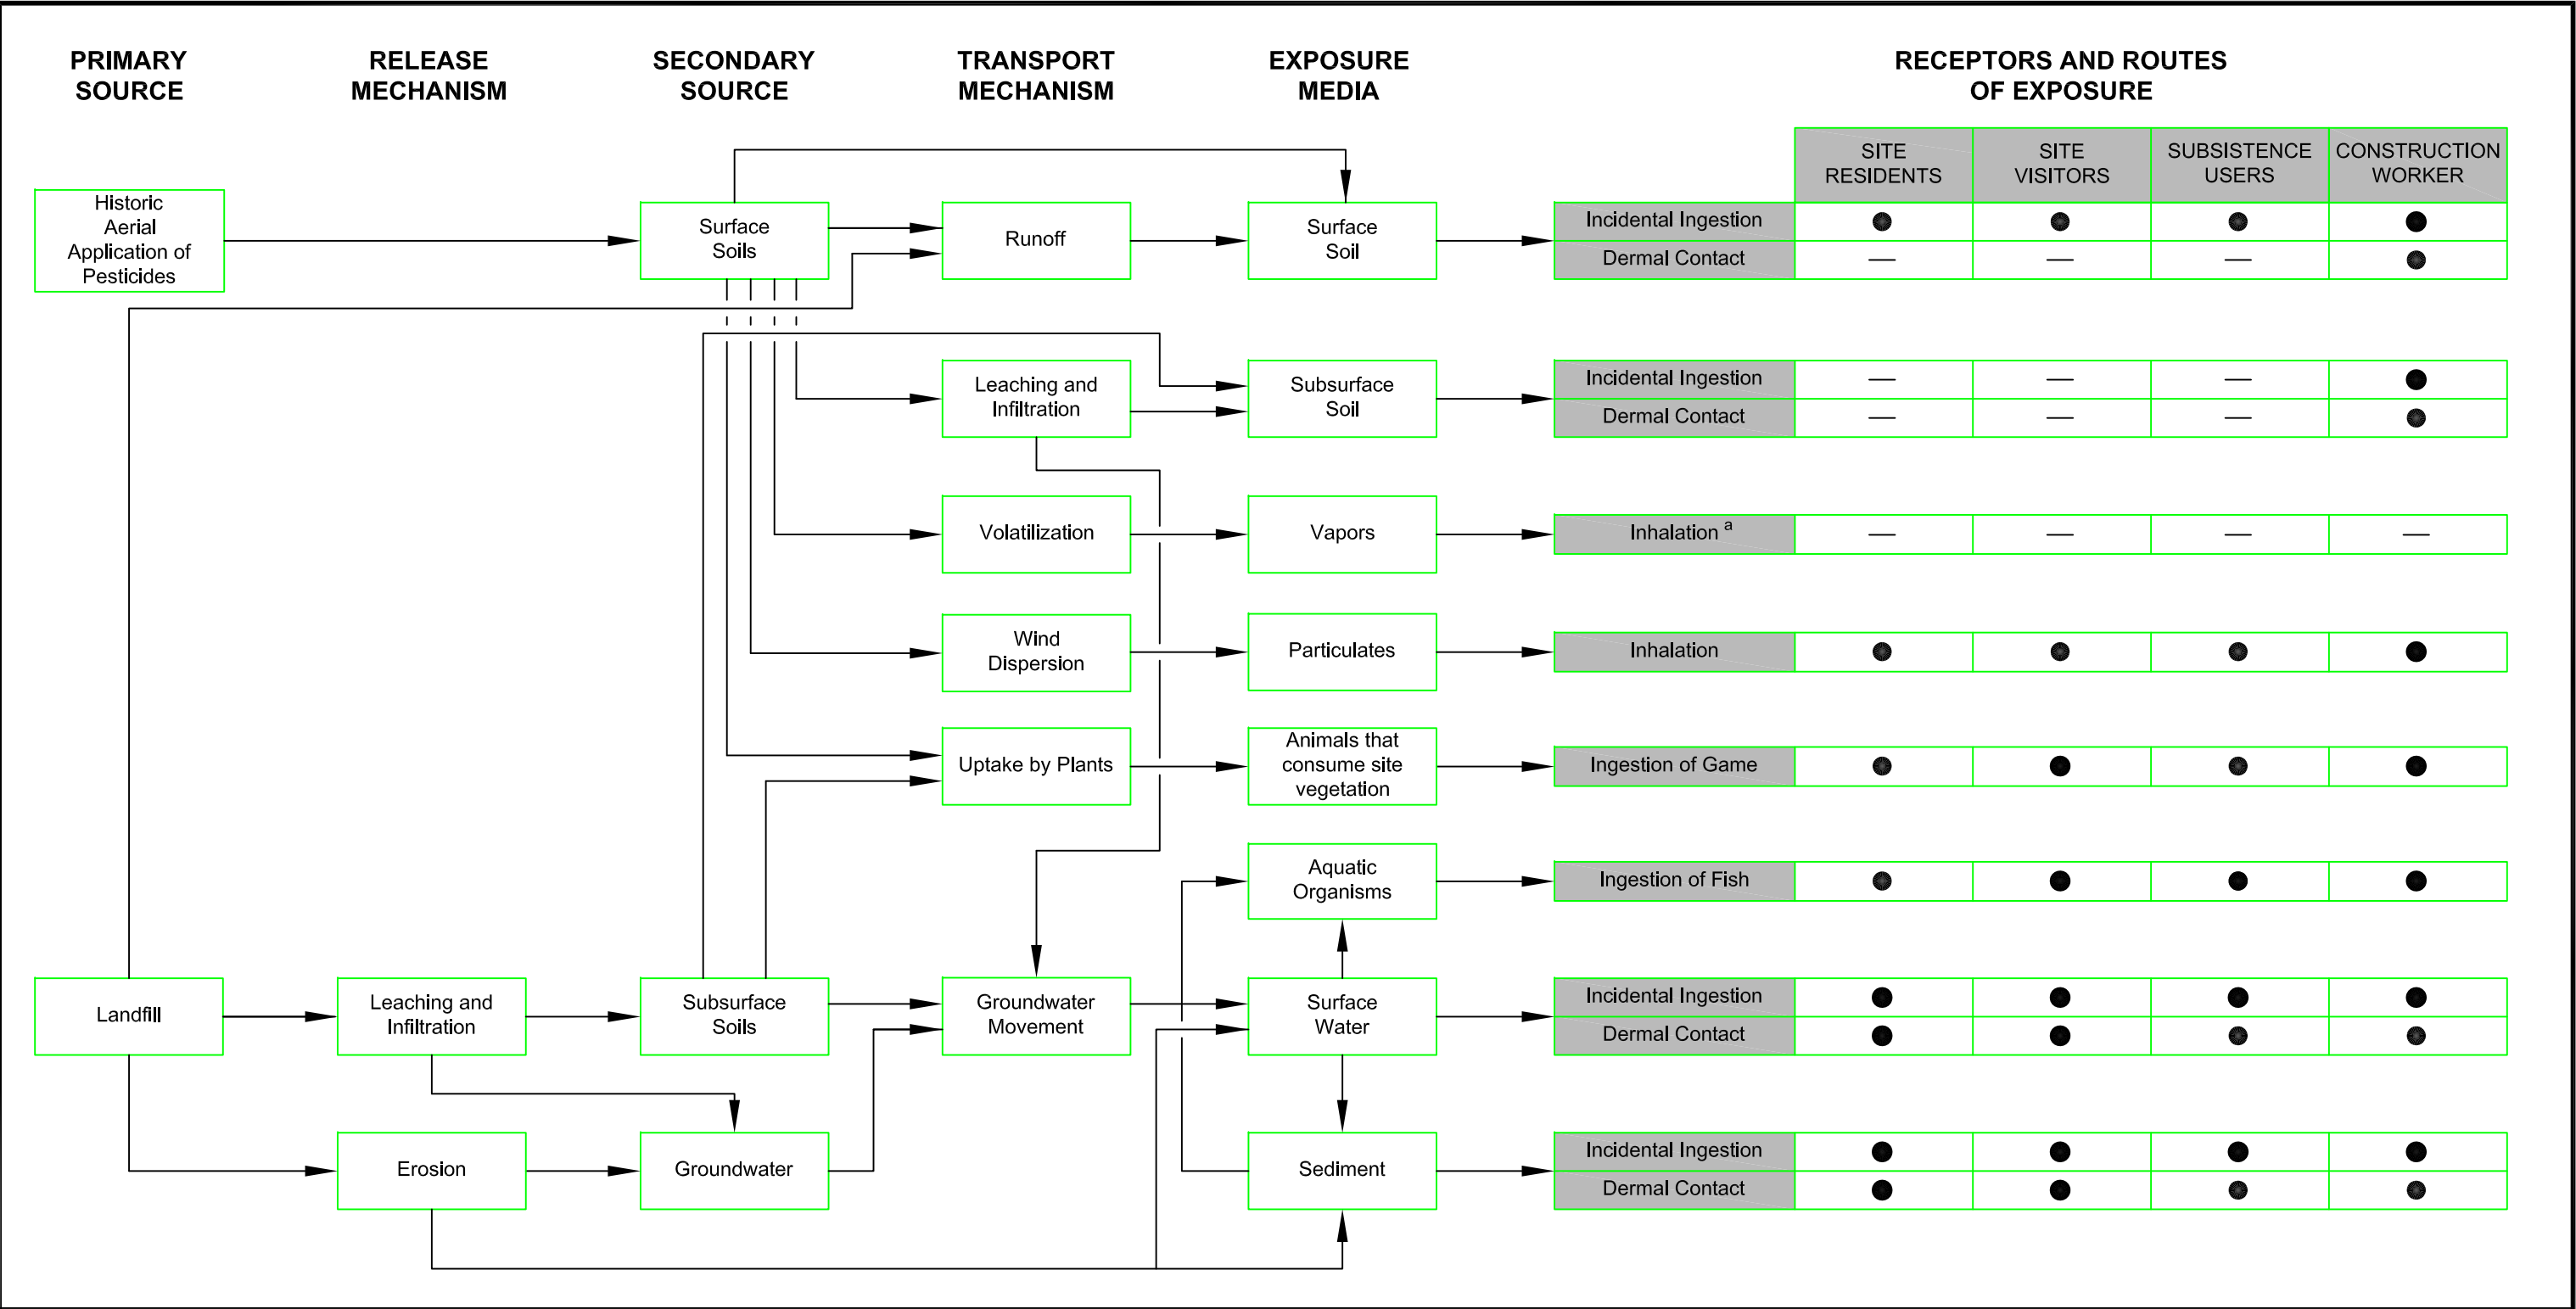
**FIG. 6-2**

a This exposure pathway is incomplete for the landfill because no volatile COPCs were identified.

Human health and ecological CSMs are depicted in Figures 6-2 and 6-3 of the 2013 RI, which are included in Attachment A.

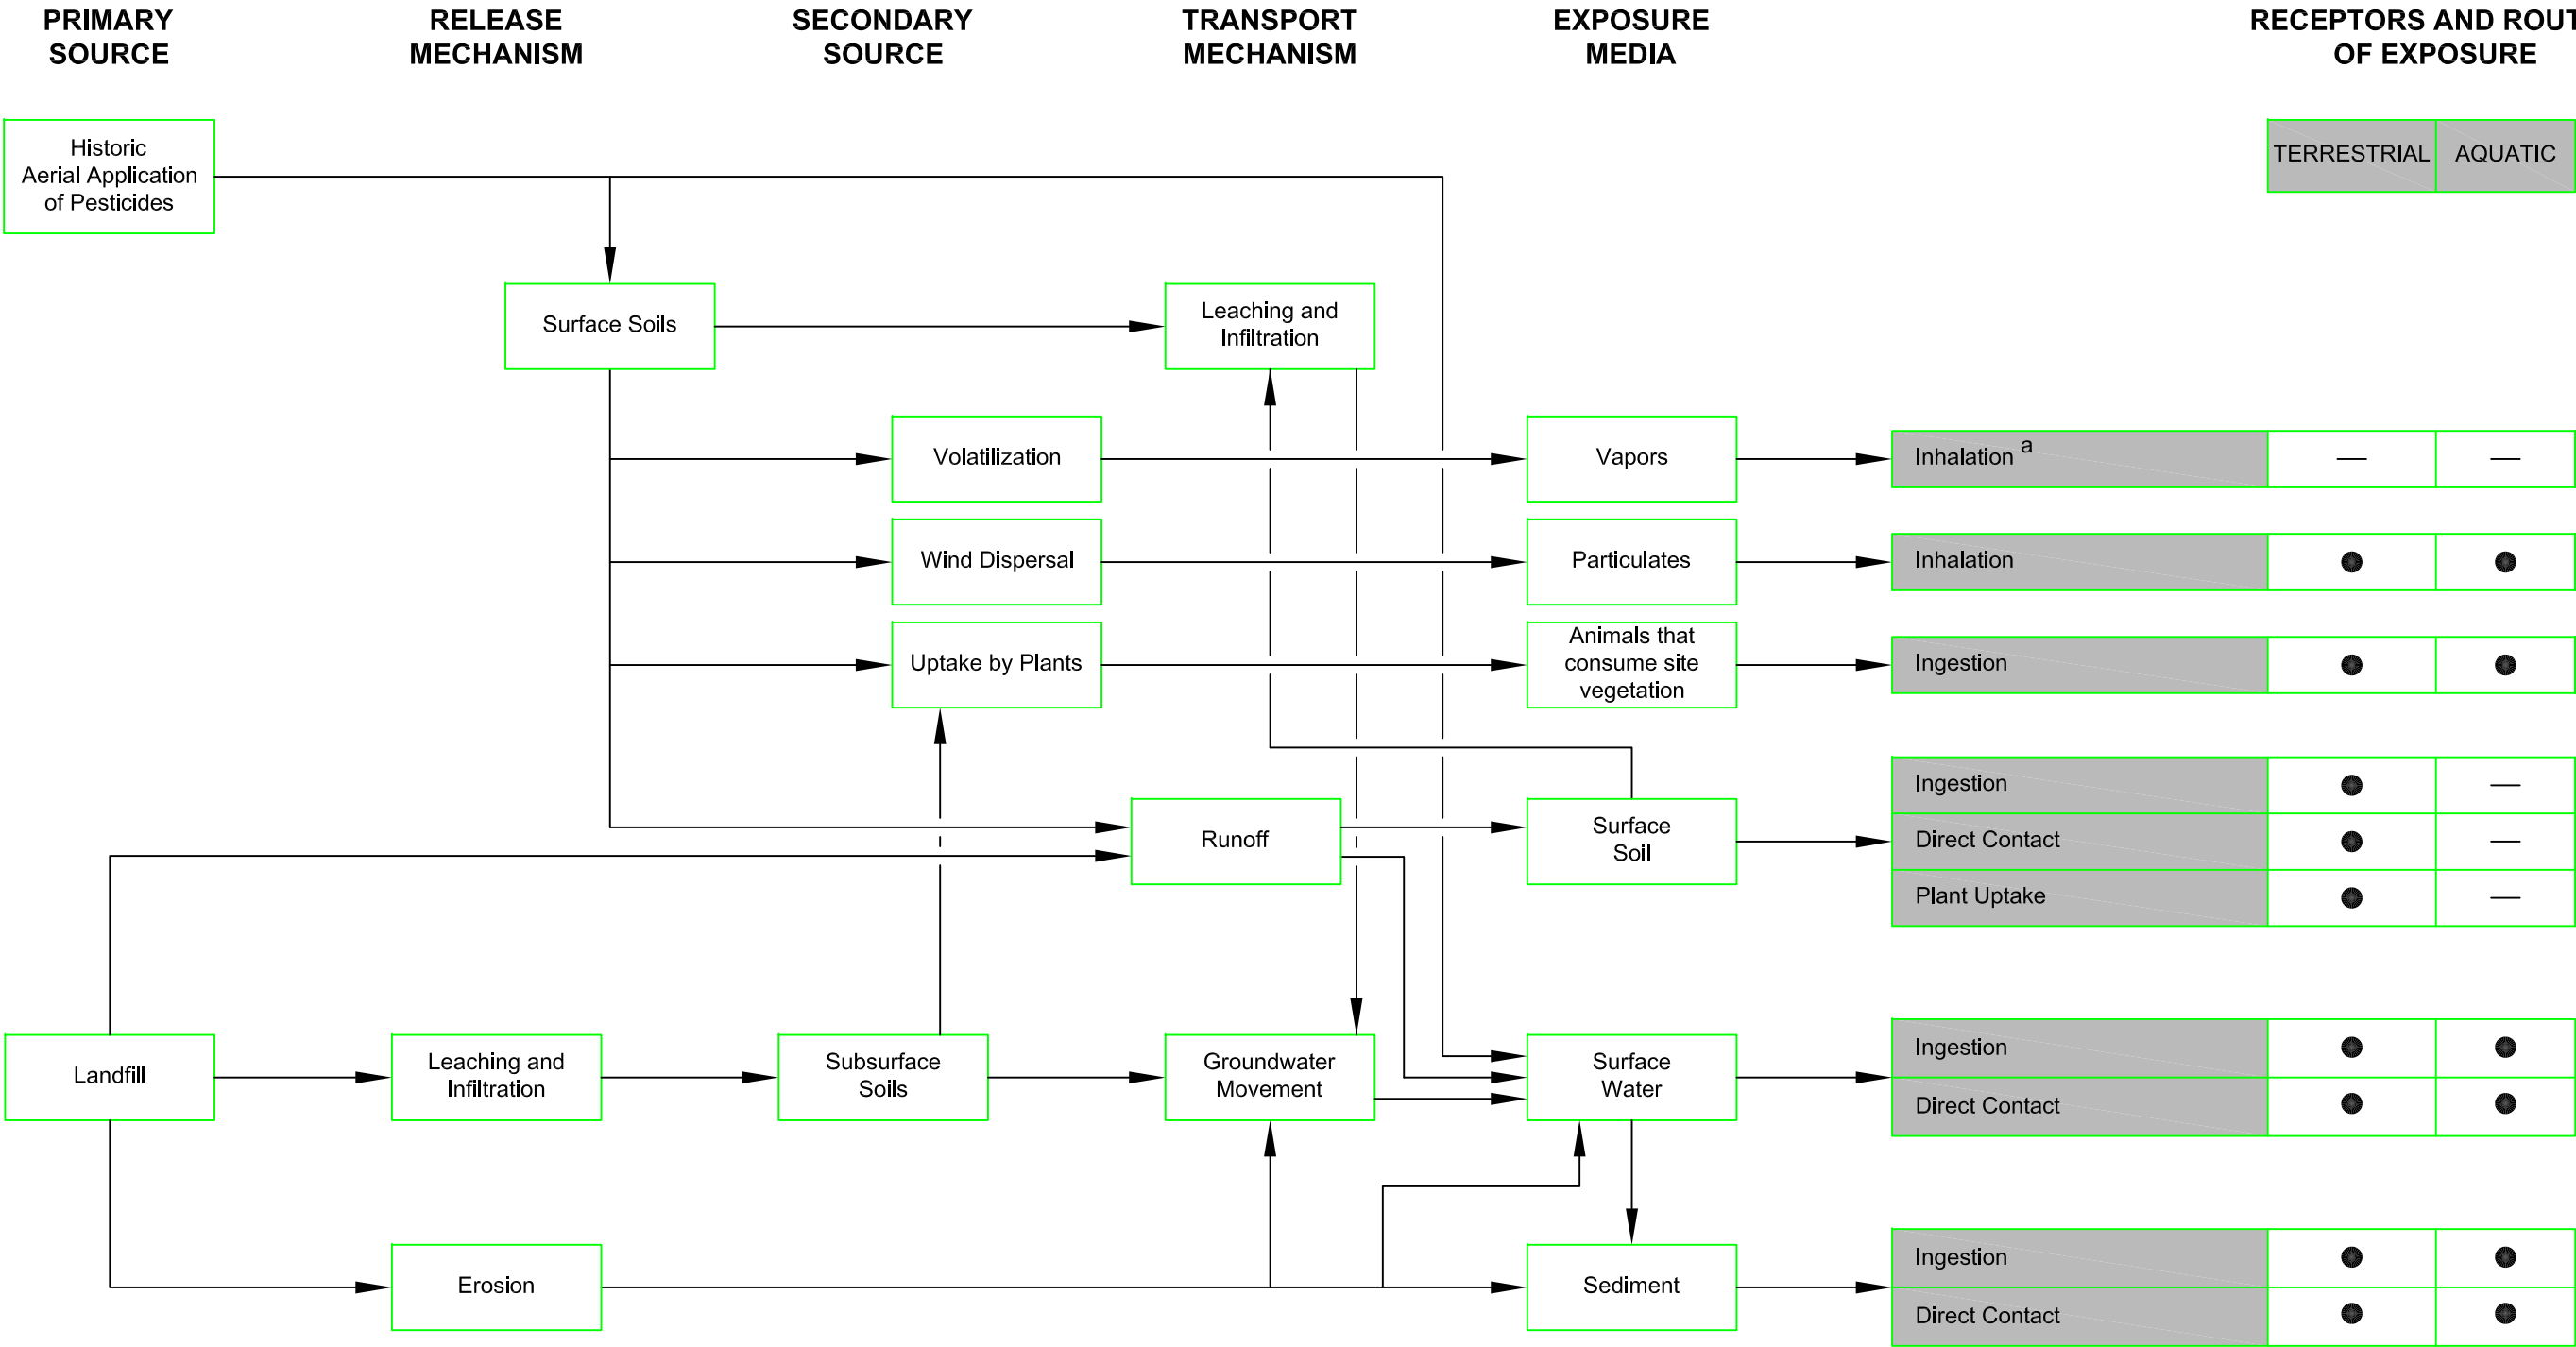
**FIG. 6-3**

- Complete Exposure Pathway
- Incomplete Exposure Pathway

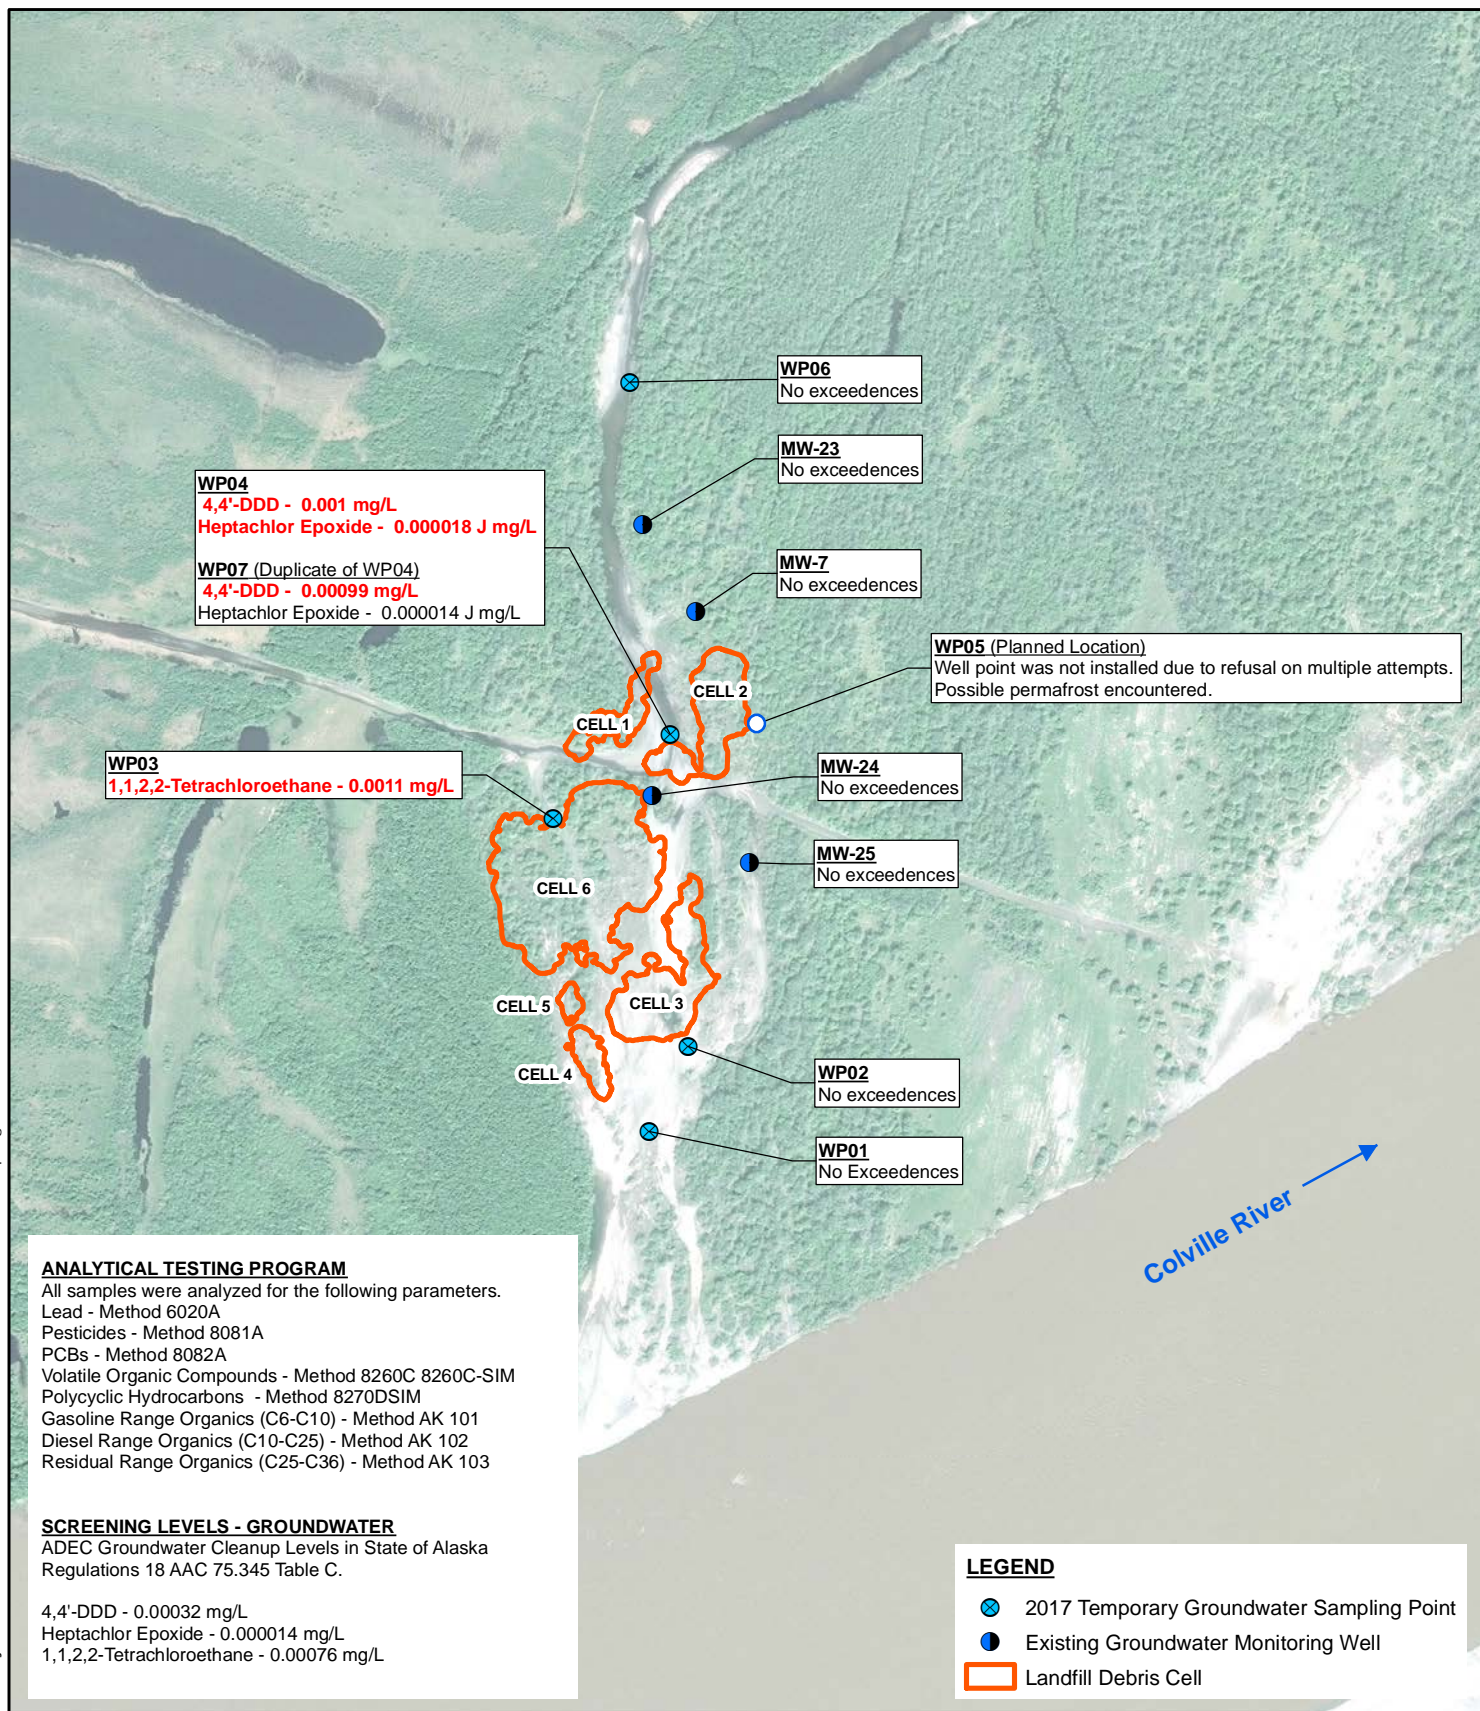
**Figure 3**

- Background imagery is dated 23 June 2016.
- Where the term "No exceedences" is indicated, this means no analyte concentrations exceeded the screening level.
- Analyte concentrations that exceeded screening levels are shown in bold red text.

USACE conducted groundwater sampling in June 2017 at the landfill area. Five temporary well points were installed and sampled, along with four existing groundwater monitoring wells that remain useable at the landfill area. The pesticides 4,4' DDD, 4,4' DDE, 4,4' DDT, Heptachlor Epoxide, and Endosulfan I were detected in groundwater samples. Concentrations of heptachlor epoxide, and 4,4' DDD exceeded 2017 screening levels. Volatile organic compound 1,1,2,2-Tetrachloroethane also exceeded the 2017 screening level in the sample from well point WP-04. A variety of VOCs and SVOCs were identified at levels below the reporting limit (J-flagged concentrations). DRO was detected up to 0.18 mg/L. Figure 3 from the 2017 groundwater sampling report (see Attachment A) shows the locations of sampling and concentrations that exceeded 2017 screening levels.
