# DECISION DOCUMENT

Hazardous, Toxic, and Radioactive Waste

Project # F10AK0243-08

Umiat Air Force Station

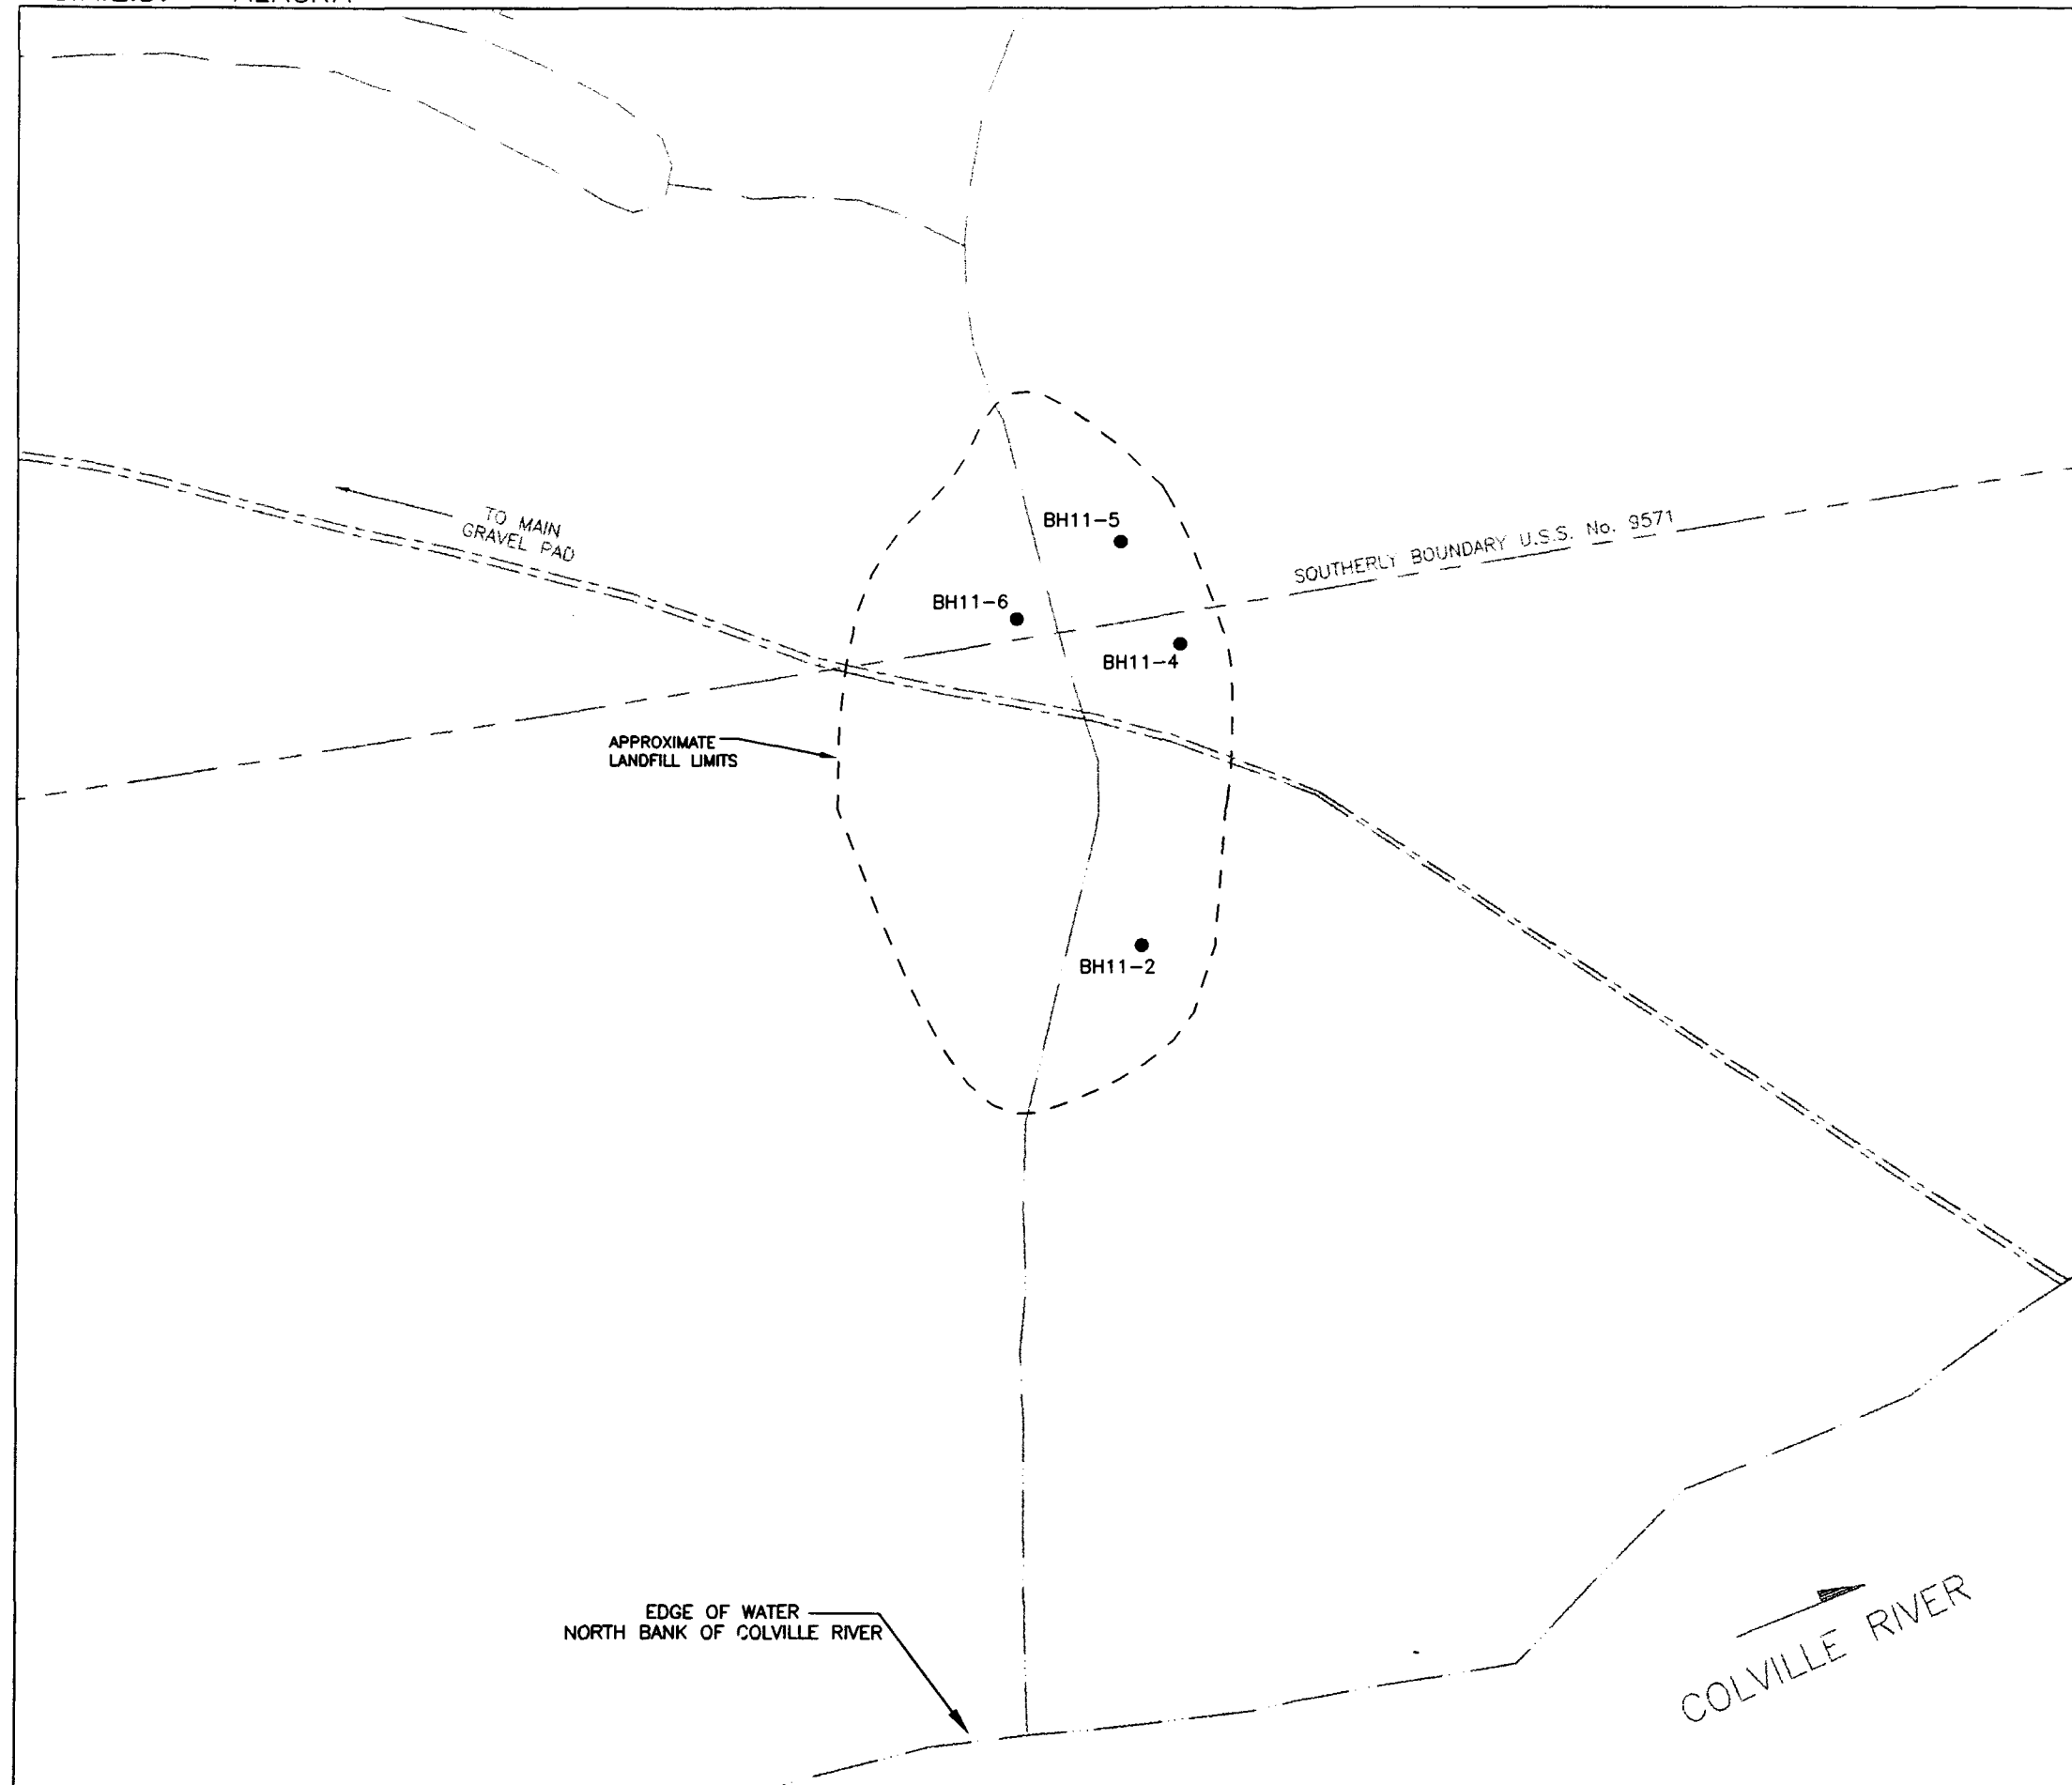
Figure 3-3  
1994 RI SAMPLE LOCATION MAP  
LANDFILL

- LEGEND
- BH11-4 ● 1994 RI SAMPLE LOCATION
  - EDGE OF GRAVEL
  - EDGE OF WATER
  - ➔ RIVER FLOW DIRECTION

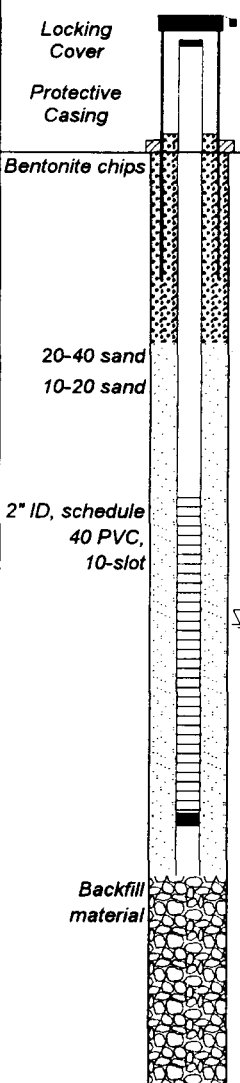
ground surface (gs)					
1								
2								
3								
4								
5								
6								
7								
8					3			Groundwater encountered at 7.5 ft.
9					7			
10					12		0	Sample: 97UMT112SB
11					13			
12								
13								
14								
15

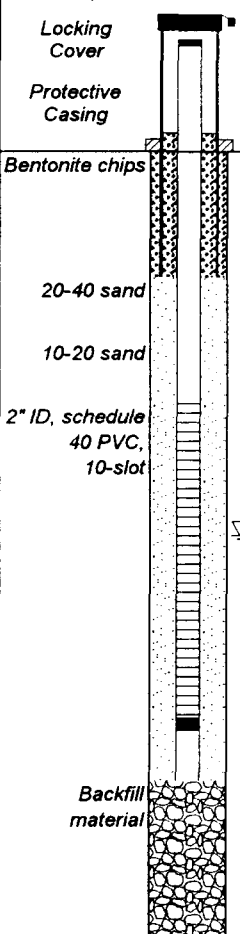
ground surface (gs)					
1								
2								
3								
4								
5								
6					17			Groundwater encountered at 6.1 ft.
7					26		0	Sample: 97UMT113SB
8			Sandy <b>GRAVEL</b> (GWS), 50% gravel, 40% sand, 10% silt, brownish gray, max. = 3 cm, saturated, no fuel odor, no sheen.	19				
9			8.0	32				
10								Monitoring well installed at 9.2 ft. BGS.
11								
12								Permafrost encountered at 12 ft.
13								
14								
15
